Article: Non-adhesive fills for wood Author(s): Tamsen Fuller Source: *Objects Specialty Group Postprints, Volume Three, 1995* Pages: 78-85 Compilers: Julie Lauffenburger and Virginia Greene © 1996 by The American Institute for Conservation of Historic & Artistic Works, 1156 15<sup>th</sup> Street NW, Suite 320, Washington, DC 20005. (202) 452-9545 www.conservation-us.org

# NON-ADHESIVE FILLS FOR WOOD

Tamsen Fuller

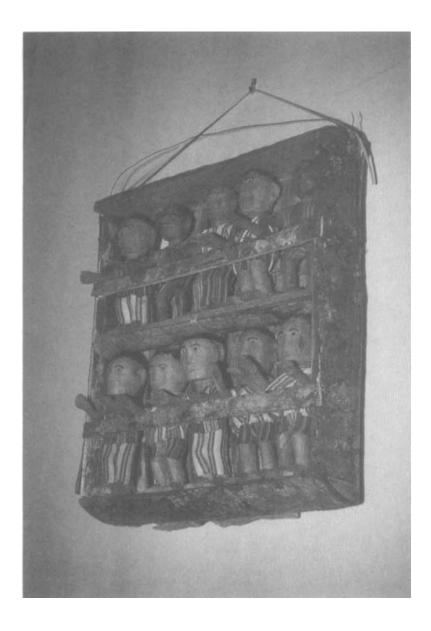
By coincidence, the next treatment was another Tau Tau artifact, a miniature rack with figures. The rack was the problem, coming apart as the fresh wood distorted and its bark came off (Figs. 1, 2).

Figure 1. The Tau Tau rack and figures after treatment.

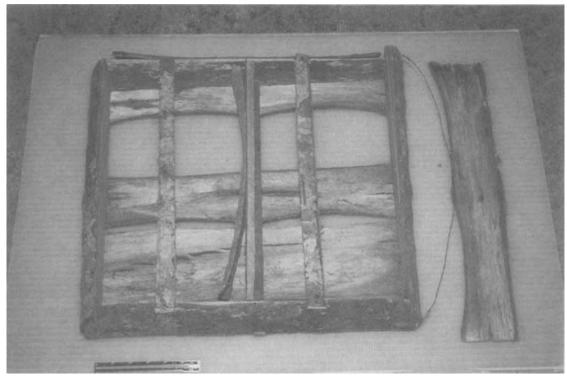
Figure 2. The rack before treatment, showing the warped back.

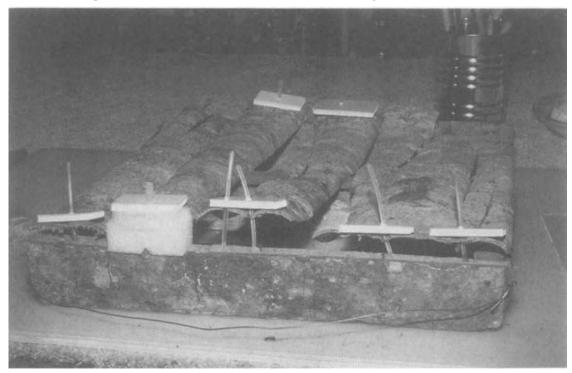
Figure 3. Clamping or pressure system with polypropylene rod pins and Coroplast.

The gaps between the back slats and the frame were filled and the upcurved slats supported with pieces of Ethafoam polyethylene foam. Pressure was brought to bear with pieces of Coroplast (corrugated polypropylene sheet) held in place with pointed lengths of polypropylene welding rod (Figs. 3, 4). The ends of the rod were heated to curl the end so that it protruded less and put more pressure on the Coroplast washer (Fig. 5).

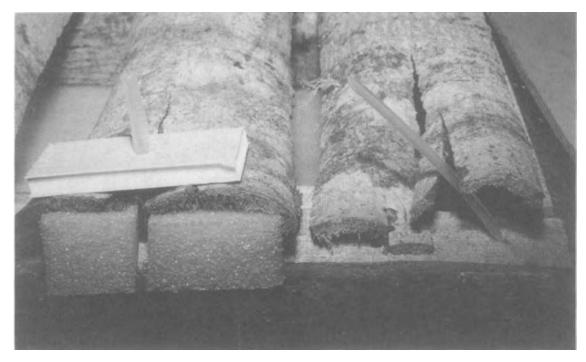
Figure 4. Same as Fig. 3, with the Ethafoam block wedges supporting the bark and completing the system.

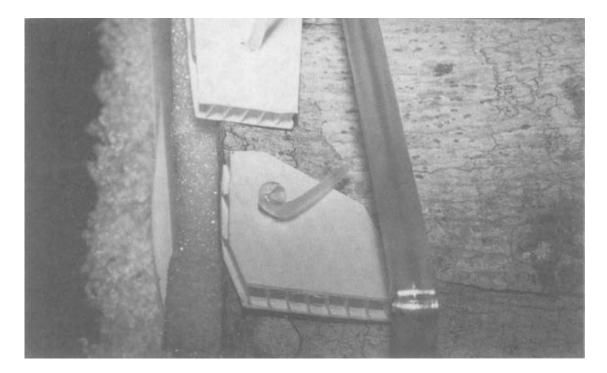
Figure 5. The polypropylene rod pin is heated locally and curled to make a head.

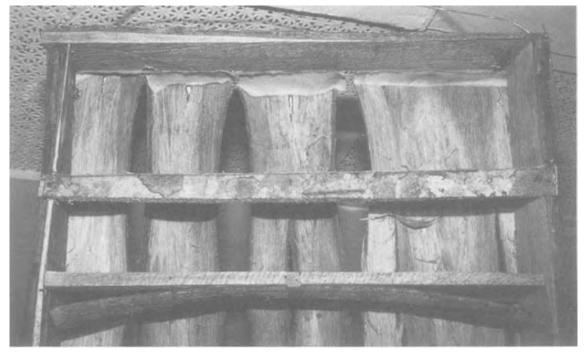
Figure 6. The rack showing tinted paper adhered to Ethafoam blocks with Rhoplex N580.

Thickened Rhoplex N580 acrylic emulsion was used to adhere pre-tinted Japanese tissue over the white foam where it showed through to the front of the rack (Fig. 6). Used as a contact adhesive, that is, applied to both substrates and allowed to dry before joining, this adhesive was a successful bonding agent.

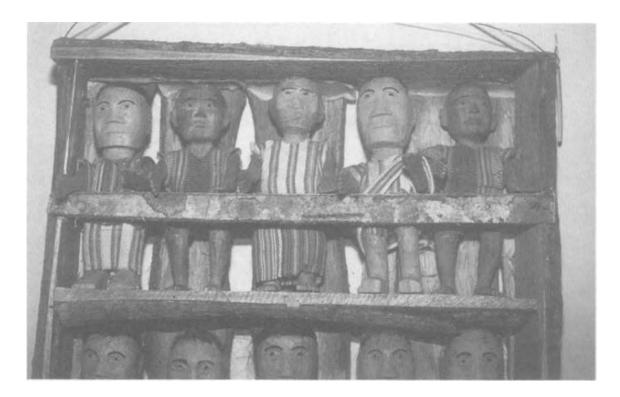
The system is visible from the side and top, but the object is not viewed from these directions while on display in the owner's home (Fig. 7). From the front, the white materials are

Figure 7. The figures installed, making the rack mends less noticeable.
