Source: *Objects Specialty Group Postprints, Volume Thirteen, 2006*

## **DON'T ROCK THE BOAT: RECONSTRUCTION AND MOUNTING OF A WATERLOGGED DUGOUT CANOE**

Howard Wellman

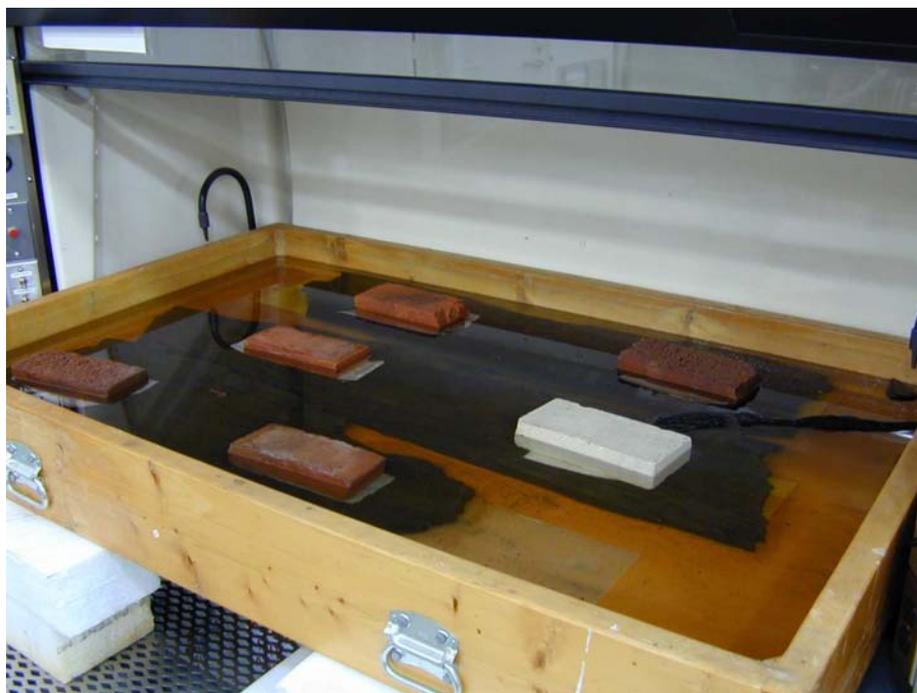
Figure 2. Immersion washing of hull fragments in a fume hood. Photo by H. Wellman.

Ultimately, it was decided to immerse the canoe pieces in a solution of 70% v/v ethanol/water. Ethanol improved the wetting of fine pore structures, and also speeded the drying while minimizing wood/water interactions. During immersion, surfaces were brushed to remove excess PEG and loose deposits of sand and mud. Where possible, washing was done under a fume extraction hood for safety (Fig. 2). For the largest pieces, the wash tank was placed in the MAC Lab's Solvent Workroom, which is equipped with spark-proof fixtures and separate air-extraction. Lab staff wore respirators and other personal protection as required by health and safety regulations. Washing time for the individual pieces was variable, but based on the tests the time was kept to a minimum. Larger and denser pieces were allowed a longer immersion time to get maximum penetration into deep crevices. Some pieces were re-washed and brushed more frequently if excess PEG was not removed from the surface. The bow and stern sections of the canoe (about 2m and 1m long respectively and up to 10cm thick) were immersed for three days over the weekend, and this still did not remove deep deposits, or all the surface coating. Slow-drying was done in the Solvent Workroom, with the objects initially tightly bagged and wrapped in polyethylene sheet. Drying was monitored by measuring weight changes. The bags were opened slowly over the course of two weeks, and the final weights stabilized in two to six weeks depending on the size of the piece. The used wash solution was recycled in the MAC Lab's solvent still to reclaim the ethanol.

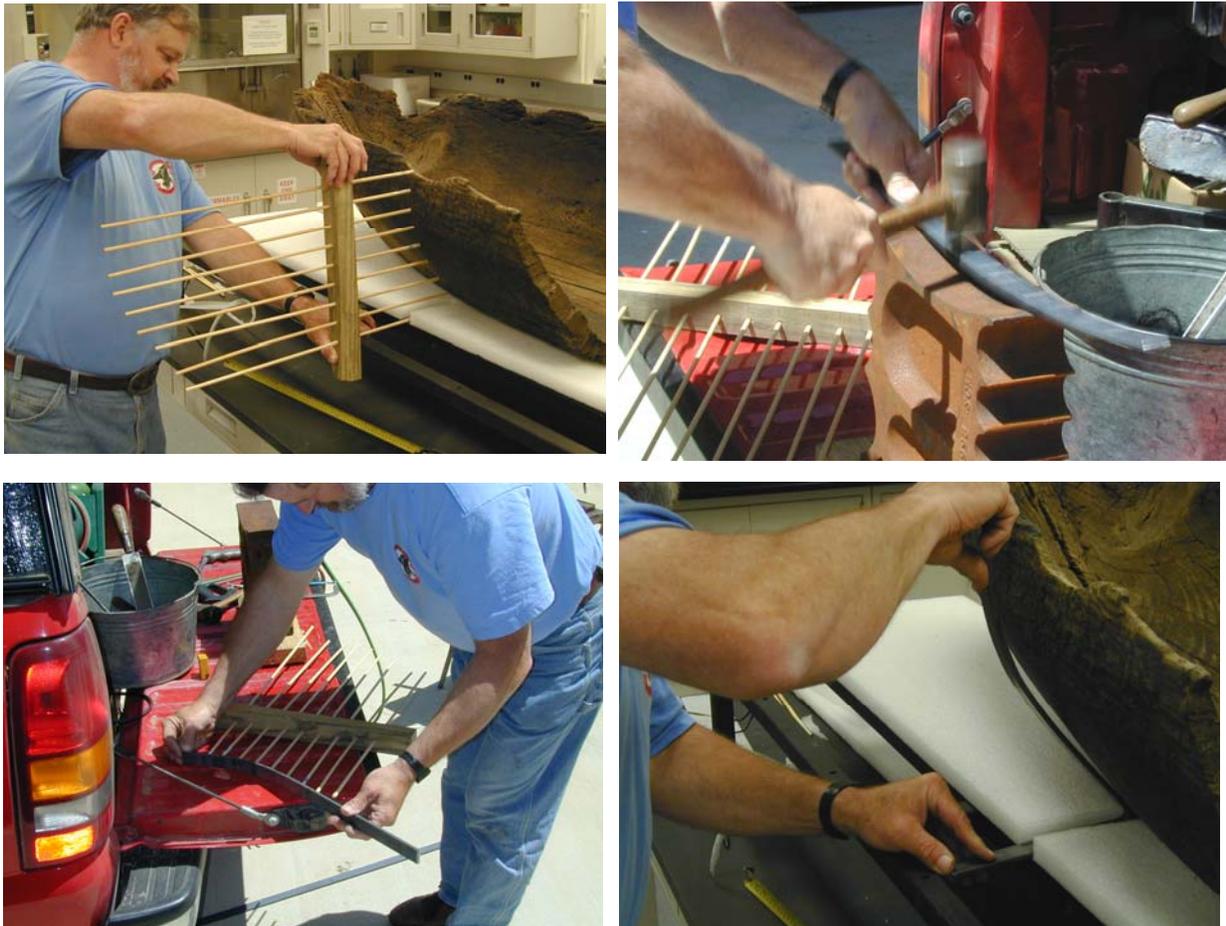
Figure 3. Blacksmith Pat Fulcher shaping support ribs. Upper Left: Measuring hull curve. Upper Right: Shaping the rib. Lower Left: Checking the curve. Lower Right: Installing the rib on the armature. Photos by H. Wellman.

The canoe was pre-fitted in sections, and Mr. Fulcher shaped support ribs to individual sections with a home-made contour gauge and his portable forge (Fig. 3a-d). Ethafoam padding protected the wood while fitting continued.

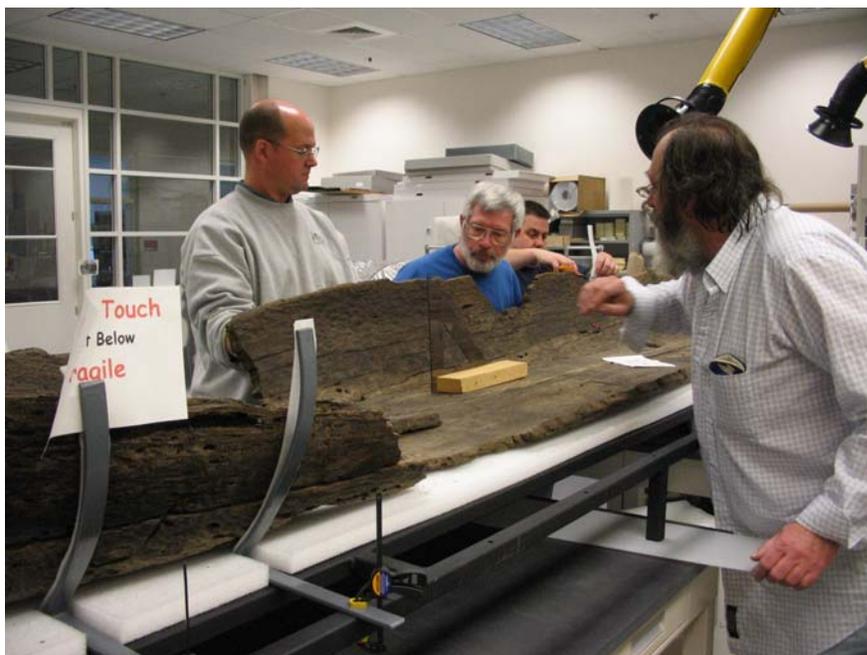
Figure 4. Assembling the hull fragments. Photo by B. Seifert.

With the ribs clamped temporarily in place, the canoe could be reassembled. A new team including the author, the original excavator Bruce Thompson, and volunteers Chris Martin and Steve Pratt (a professional boat restorer) gathered to examine and fit the pieces together (Fig. 4).

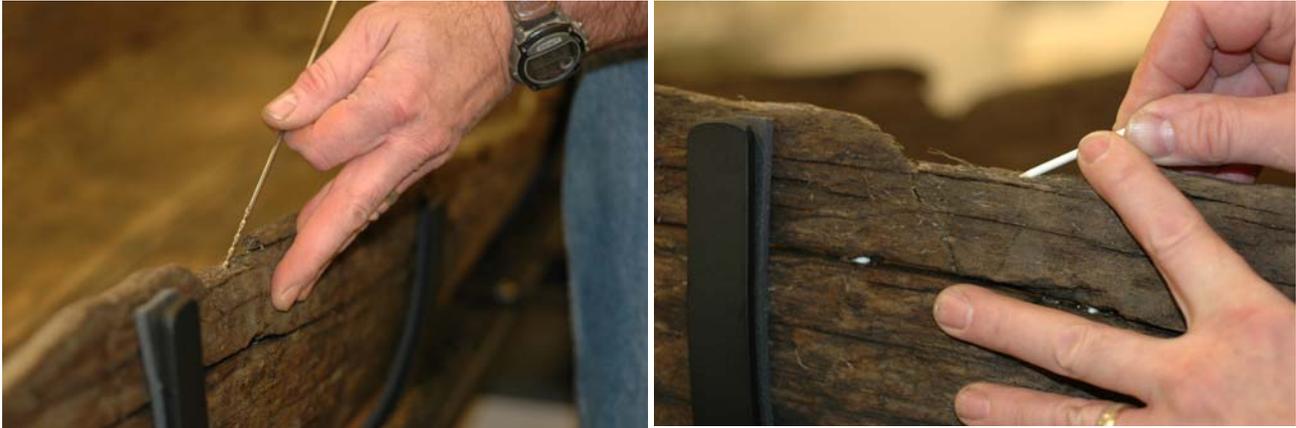
Figure 5. Pinning the hull fragments together. Left: Pre-drilling the pin hole. Right: Inserting a fiberglass pin. Photos by H. Wellman.

The canoe fragments were laid out on the padded frame, and fitted to the ribs with plastic clamps while the sequence of joints was mapped out. The assembly technique was adapted by the author from a procedure used at Texas A&M University by Peter Fix on the hull of *LaBelle*, a French colonial ship recovered in Matagorda Bay by the Texas Historical Commission (Fix 2000). Hull fragments are prefitted, dowel holes are drilled, and the sections are pinned together with fiberglass rods. In this case, 1/8" or 1/4" rods were used. The experience of Steve Pratt was invaluable, bringing together interpretive needs, the requirements of the fragile wood, and best possible boat restoration techniques. Where possible, the drill holes and rods were concealed inside the joints, but a few had to be inserted through the exterior surface (Fig. 5). Where possible, these pins were located inside existing root or worm holes. Butvar B-98 (polyvinyl butyral, 50% in ethanol) was used as an adhesive in the joints and inside the dowel holes to provide additional support. The rods were also used to bridge gaps and provide support where wood was missing.

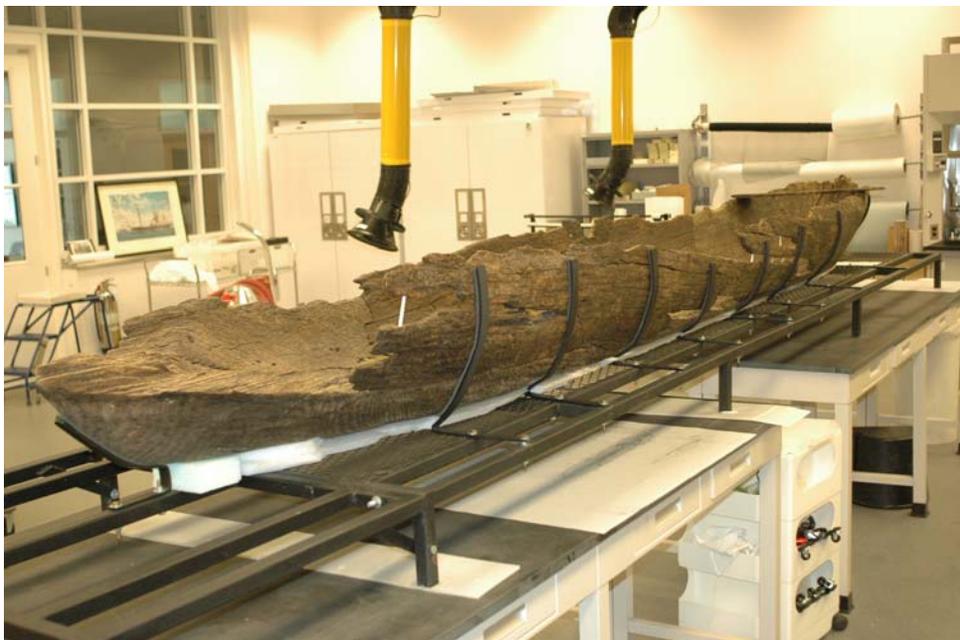
Figure 6. Canoe, completed. Photo by H. Wellman.

Once the entire hull was pinned and held rigidly, the ribs were removed one by one and given a final trimming and shaping, then painted with commercial epoxy sealant and enamel paint (Rustoleum flat black). The ribs were then bolted to the frame, and padded with black Volara (closed-cell polyethylene foam). While the frame was painted black to minimize the visual effect, the borrowing institution requested that the visible pins and bridges be left white for educational purposes (Fig. 6).
