Article: The restoration of outdoor stone sculpture: Traditional methods revisited

Author(s): Peter S. Champe

Source: *Objects Specialty Group Postprints, Volume Five, 1997*

THE RESTORATION OF OUTDOOR STONE SCULPTURE: TRADITIONAL METHODS REVISITED

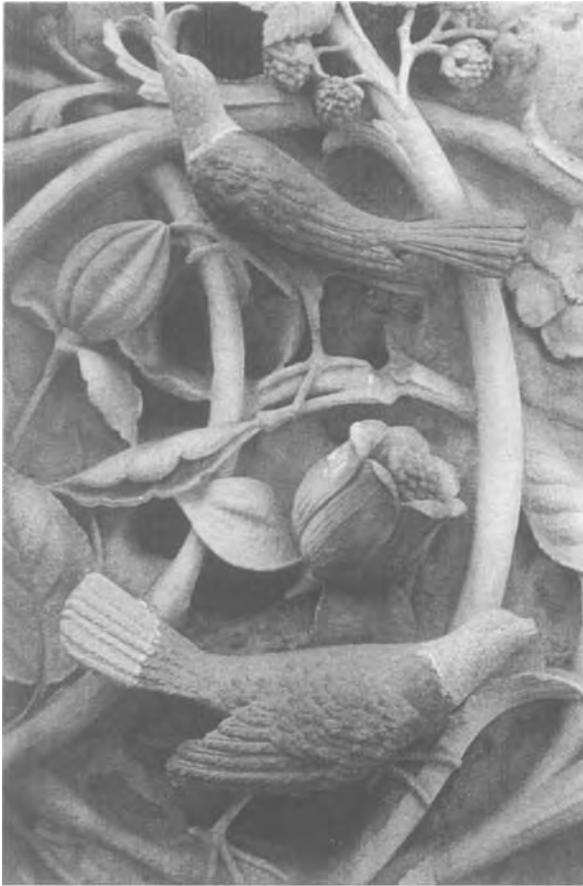
The sandstone carving at Bethesda Terrace in Central Park offers an excellent example of the effects of conspicuous restoration. The exquisitely carved New Brunswick sandstone panels depicting birds amidst scrolling foliage, designed by Jacob Wrey Mould in the 1870's, are a frequent target for vandals. The damaged elements, usually the heads and wings of the birds, have been replaced over the generations with finely carved dutchmen¹ only to be frequently broken off again. It was clear that a contributing factor in the vulnerability of the panels was the fact that the newly carved New Brunswick sandstone stood out against the original soiled and weathered stone, with a distinct join line between the two.

**Figure 1. Bethesda Terrace.
Before Treatment.**

A toning material for the newly carved stone must exhibit chemical stability, be insoluble in water and render a flat stone-like appearance. Of the various paints we tested, including, acrylics and oils, the most suitable material was Keim Granital potassium silicate paints². The liquid potassium silicate binding medium of the paint, also known as "water glass," is a mineral which forms a durable chemical bond with mineral substrates such as sandstone. The paints employ mineral pigments which are chemically stable and unaffected by UV light.

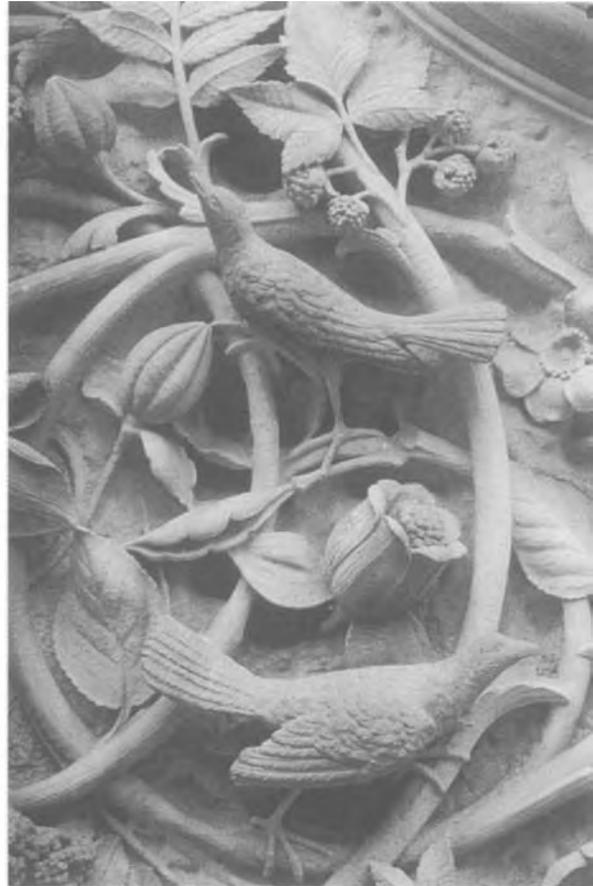
**Figure 2. Bethesda Terrace.
After Treatment.**

In addition to toning the carved stone restoration, we concealed the epoxy join-line by carving a channel with a small diamond burr on a flexible-shaft drill. We filled the resulting channel with Jahn M1003 mortar to blend the join-line and applied Keim paint as with the stone.

One year after the application of the Keim paint, some fading of the color had occurred. The reason for this is not clear, but it could be due to lack of sufficient protection from rain during the critical cure-period (7-10 days) so that the paint actually washed away. Despite this, the stone restoration blends significantly better with the original stone than before the treatment. In a one year period, no subsequent vandalism has occurred to the stone carving where previously, birds' heads were being lost due to vandalism at a rate of approximately 2-3 per year. While this success cannot be attributed solely to the treatment, as conditions in Central Park in general have improved, there is no doubt that the treatment not only restored the appearance of the carved panels, but increased their chances of survival in a harsh urban environment.

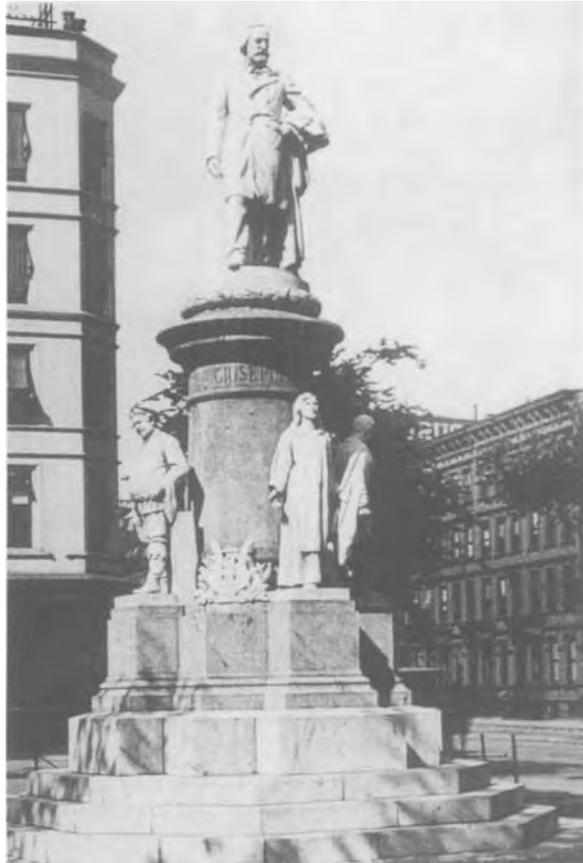
**Figure 3. Giuseppe Verdi Monument.
Historic Photo circa 1908.**

The restoration of the Giuseppe Verdi Monument at West 72nd Street in New York City, sculpted by Pasquale Civiletti in 1906, presented several challenges in the area of loss compensation and required a reexamination of previous treatment approaches. The Verdi Monument is composed of two types of stone, Carrara marble is used for the sculpture depicting Verdi, Aida, Falstaff, Leonora and Othello while the steps and pedestal are a Monte Chiaro breccia limestone. The Carrara marble had suffered significant loss due to acid rain erosion and breakage: the finely carved details of the figures (particularly the faces) were eroded and several of the hands were broken. In examining the archival photographs of the monument from circa 1908, we were surprised to find that at some point in the sculpture's treatment history, the form of the hands had been altered: Falstaff's right hand was transformed from its original open and expressive gesture to a closed fist and Leonora's individually articulated fingers had become joined to form solid block-like hands.

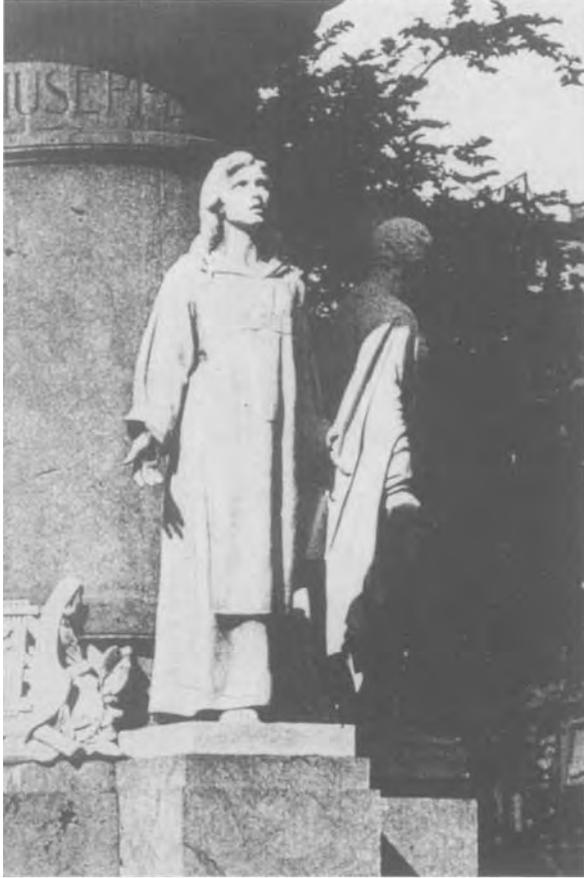
Figure 4. Figure of Leonora. Detail of circa 1908 photo showing articulated fingers before 1945 restoration.

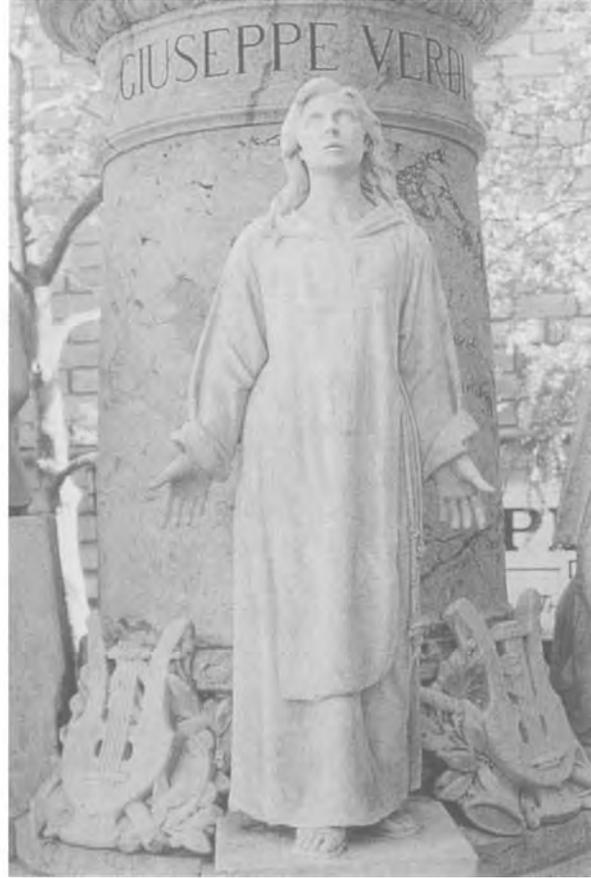
Figure 5. Figure of Leonora. After restoration of hands employing polyurethane composite material.

The method devised for fabricating the hands is outlined below:

1. Missing hands were sculpted in clay on the basis of historic photographs.
2. Two-part flexible molds of the clay models were made.
3. A putty composed of the liquid polyurethane and 90% by weight marble powder was pressed into each side of the two-part flexible mold, to a thickness of approximately 1/8" to establish a "face-coat". This proportion of resin to marble powder was found to offer the best balance between strength and the simulated appearance of marble.
4. Quarter-inch stainless-steel rods were laid into the fingers of each hand to serve as structural reinforcement.
5. The two halves of the mold were closed and polyurethane poured in to fill the remaining void and form a solid mass.

The hands were attached to the statue using threaded stainless-steel rod and Sikadur 317 epoxy. This method has application in any situation where restoration of fragile sculpted stone elements requires greater strength than the original stone can provide. While accelerated aging tests in the laboratory suggest that the material will remain stable in high UV environments, this material is untested in outdoor conditions and only actual weathering will determine its stability.

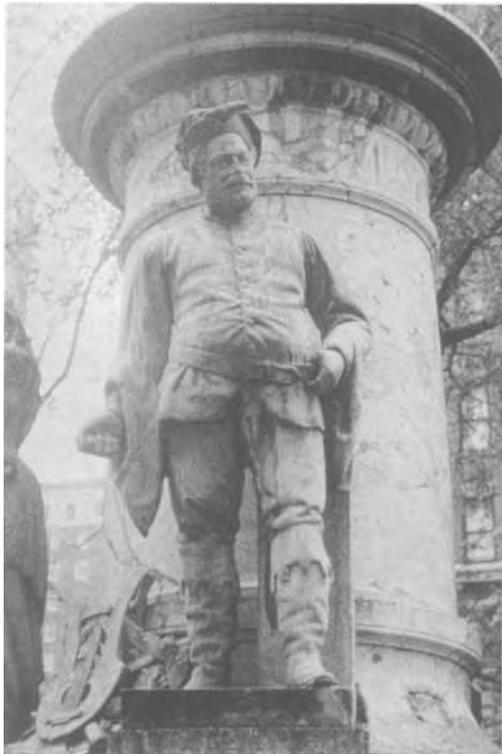
Past treatment reports indicated that during the last major restoration in 1945, the hands had been recarved as solid masses, presumably to compensate for the inherently fragile nature of the marble. While this solution is understandable and indeed, was partially successful (while Leonora's hands were broken, Falstaff's fist was still intact 51 years after treatment), it was clear that this treatment solution had sacrificed the expressive function of the hands for the sake of durability. Our intention in this treatment was to restore the hands to their original expressive form using historical photographs, while achieving a sufficient durability. This would necessarily exclude any restoration method employing carved stone, and forced us to explore appropriate cast materials.

Figure 7. Figure of Falstaff showing fist from 1945 restoration.

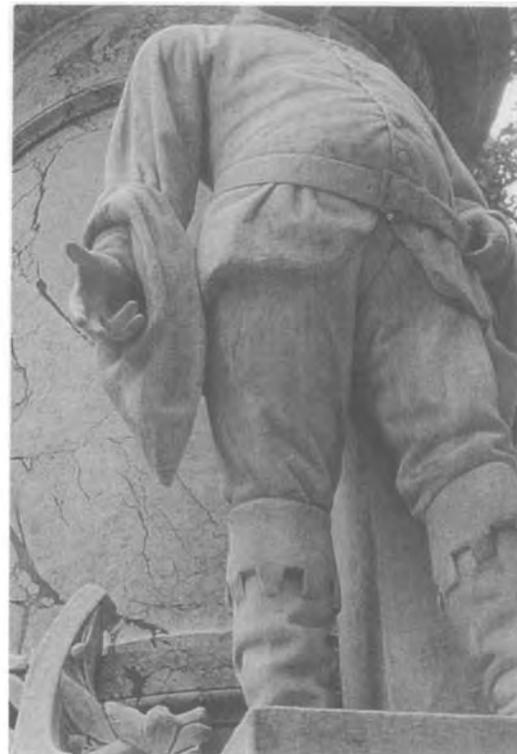
Figure 8. Figure of Falstaff. After restoration of hand employing polyurethane composite material.

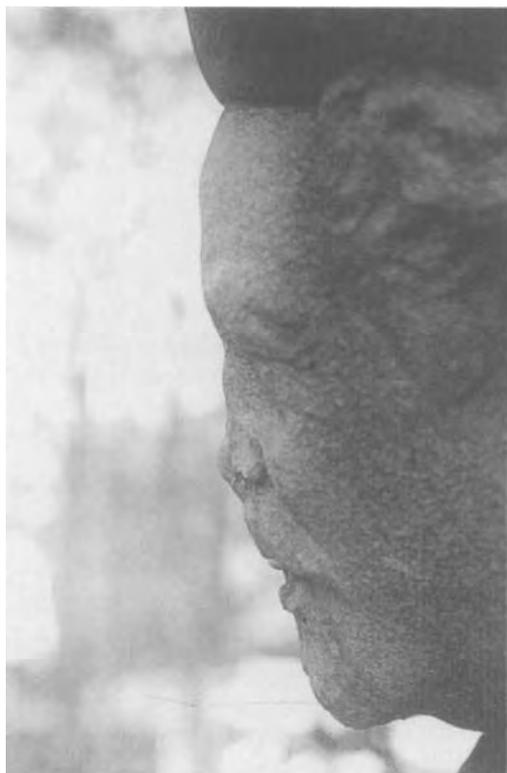
The problem of loss compensation due to erosion is more complex than that due to breakage. Whereas damage due to breakage is clear and the element can be recarved or cast and reattached, erosion results in a gradual overall diminution of surface detail. The question then arises at what point the loss is no longer acceptable so that restoration must be chosen as a course of action? The figures of the Giuseppe Verdi Monument had suffered significant loss of carved detail due to erosion, particularly in the faces, resulting in a highly disfigured appearance which compromised the function of the monument.

Figure 9. Figure of Falstaff displaying severe erosion.

Composite repair in this case is defined as a cementitious material applied directly to the surface of the marble and modeled in situ. Composite restoration was chosen over the dutchman method as the overall erosion did not call for the unit replacement as much as a minimal, localized build-up of the surface. Furthermore, the composite restoration affords a much greater degree of reversibility than the dutchman method which requires preparation of the stone and insertion of pins.

The composite repair material developed here was based upon a traditional 1:1:5 type "N" mortar and modified in the following way for this application:

1. One part white Portland cement, one part lime and five parts marble powder were ground with a mortar and pestle and passed through a sieve stack to achieve a particle size no greater than 250 micrometers. The reduced particle size increases plasticity and adhesion.
2. Fumed silica to a proportion of 25% by volume was added which further reduced the average particle size and rendered the material lighter and increased thixotropy, thus reducing the tendency of the mortar to sag while being modeled on vertical surfaces.
3. A proprietary acrylic emulsion Edison Custom 458 (3% solids in water) was added to the composite mortar to increase plasticity and adhesion.

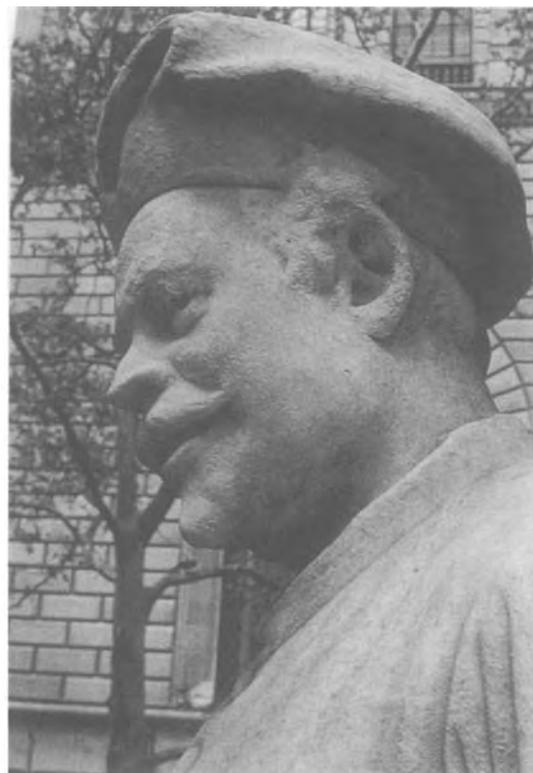
Figure 10. Figure of Falstaff after Composite repair treatment.

The entirely reversible composite repair succeeded, with only minor intervention, to significantly revitalize the sculpture.
