Article: Mosaic conservation at the Worcester Art Museum

Author(s): Paula Artal-Isbrand

Source: *Objects Specialty Group Postprints, Volume Eight, 2001*

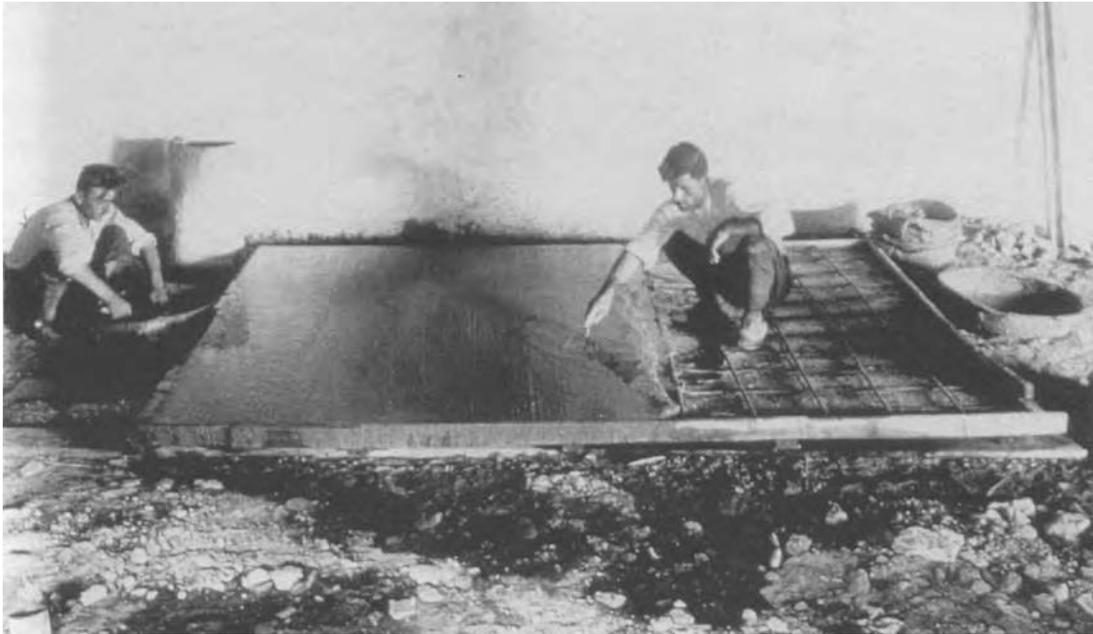
Figure 1. Syrian workmen backing a mosaic with concrete that is reinforced with iron bars and chicken wire, shortly after excavation in the 1930's. Photograph courtesy of the Department of art and Archaeology, Research Photograph Collection, Princeton University.

When a mosaic first came to the conservation laboratory it was checked for loose tesserae by tapping its entire surface. Any loose ones were secured with Paraloid B-72 adhesive. The mosaics were also checked for cracks. All mosaics had been backed with concrete reinforced with iron bars and chicken wire mesh immediately after excavation (Fig.1). This system over time led in many cases to cracking due to the rusting of the iron in the concrete matrix (Fig.2). For mosaics that had been exhibited or stored outdoors over the years this was especially a problem. If the cracks did not extend to the tessellatum on the front, Flexi-Weld 520 epoxy was used to fill them. Otherwise, cracks were filled with Paraloid B72 adhesive bulked with 3-M glass micro-balloons.

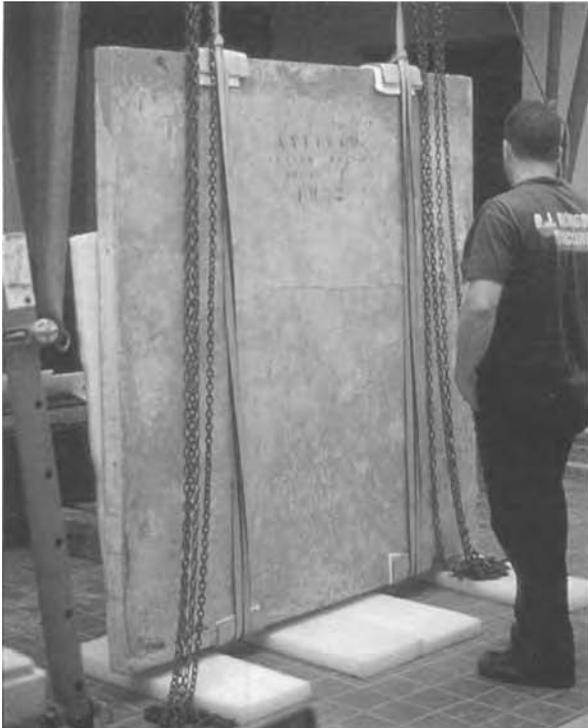
Figure 2. Mosaic with a cracked concrete backing at the Worcester Art Museum in 2000.

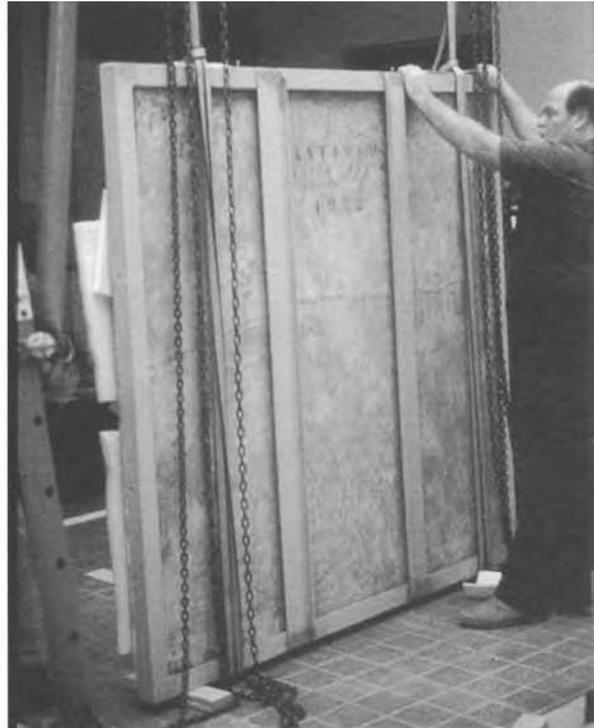
Figure 3. The same mosaic as in Fig. 2., after being framed with a metal frame.

The major intervention to stabilize the mosaics consisted in framing them with custom-made steel or aluminum frames (Fig.3), which were fastened to the mosaics with screws that were anchored into the concrete backing. Crossbars on the back of the frames, padded with high density Ethafoam, provided additional support for cracks.

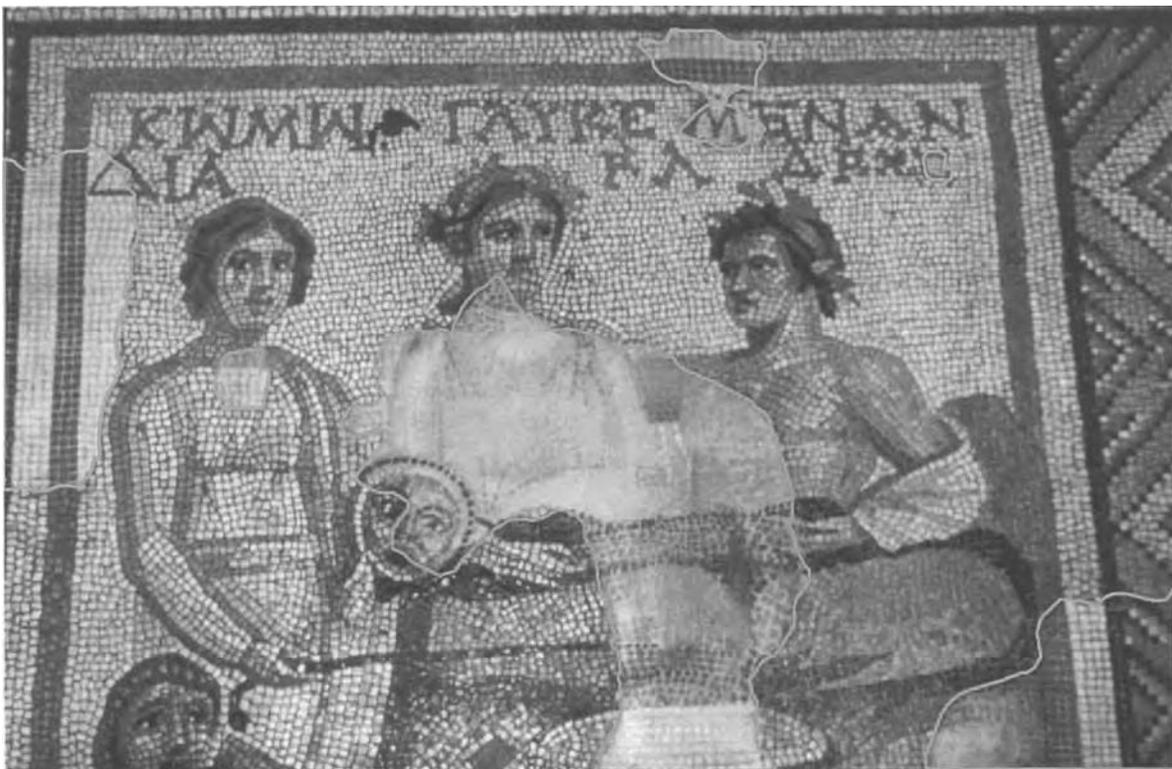
Figure 5. Detail of the *Menander, Glykera and Comedy* mosaic (collection of The Art Museum, Princeton University; c. 250-275 CE). Outlined are painted concrete fills imitating a tesserae pattern with an invented design in the largest fill.

Each institution dealt with these fills differently upon receiving their share of Antioch mosaics. Some did not do anything to these fills (Fig.4). Others painted over them, replicating the pattern of the mosaic by often inventing the design (Fig.5). In other cases the concrete fills were replaced with plaster that was consequently painted, also imitating a mosaic design. At the Worcester Art Museum mosaic artists from Italy restored a number of mosaics in 1936. They removed part of the concrete, and filled the losses with stone tesserae (Figs.14, 16). Besides using new tesserae, unfortunately ancient tesserae were also used during these restoration efforts. These tesserae came from mosaic fragments thought not worthy of exhibit at the time. The numerous photographs taken during excavation proved to be invaluable to the Worcester conservators during the treatment of the mosaics because they allowed them to clearly distinguish original parts from restorations.

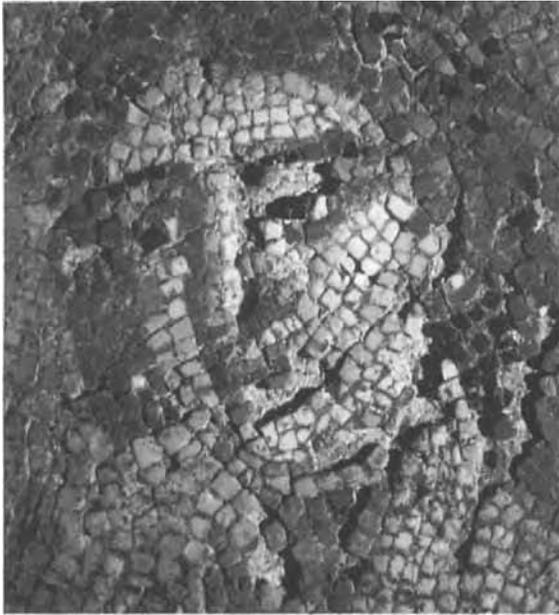
Figure 6. Detail of a head of the mosaic representing a *Funerary Symposium*, after removing concrete fills (collection of the Worcester Art Museum; late 4th century CE).

In some cases where individual tesserae were missing in central parts of a mosaic it was thought necessary to use a different compensation approach. This was the case in the *Funerary Symposium* mosaic for example, specifically in the area of the head of one of the women. The absence of individual tesserae was visually disruptive making it impossible to appreciate the 2-dimensional illusion of a 3-dimensional work of art. Each little hole created by a missing tessera appeared as a dark shadow distorting the design immensely. If these multiple losses were filled with the restoration mortar, their appearance would not be very different to the image in Fig. 6. It was thought that it would be appropriate to fill these losses with newly fabricated restoration tesserae.

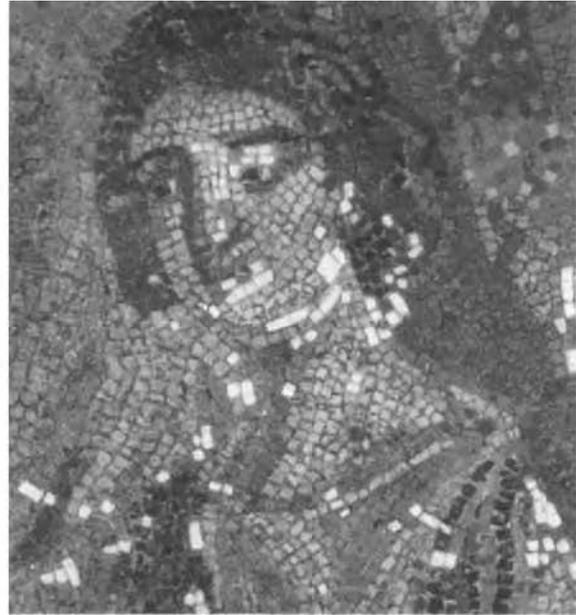
Figure 7. Same detail as Fig. 6, after filling losses with restoration tesserae.

Two approaches were used to make new tesserae during the Worcester conservation campaign. One was to cast them in plasticine using Whatman's paper pulp mixed with Sigma methyl-cellulose; the other one was done by casting them in President-Coltene silicone-based impression material using plaster. The plaster was consolidated with Paraloid B-72 after curing. Windsor & Newton watercolors or Golden acrylics were used to paint them. Figs. 7 and 9 show the detail of the head in Fig. 6 after filling with paper pulp restoration tesserae, and after in-painting with water colors. This filling approach was taken only where the shape and color of the tesserae were predictable since no invention of the design was acceptable.

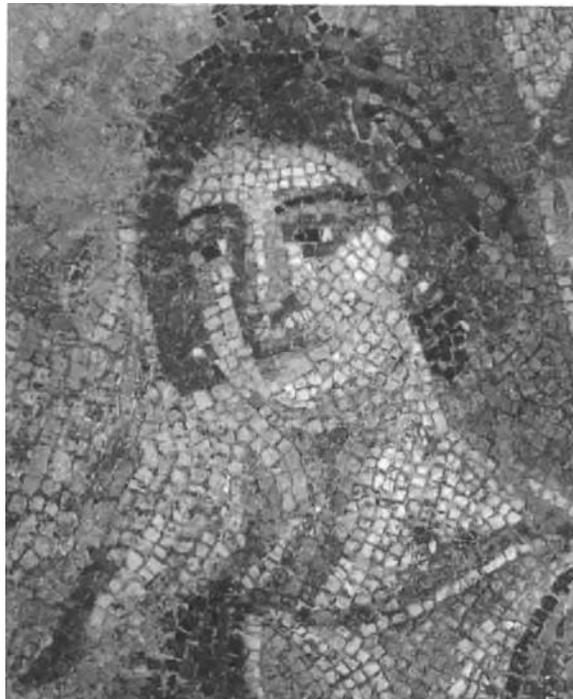
Figure 8. Same detail as in Fig. 6, after inpainting the restoration tesserae.

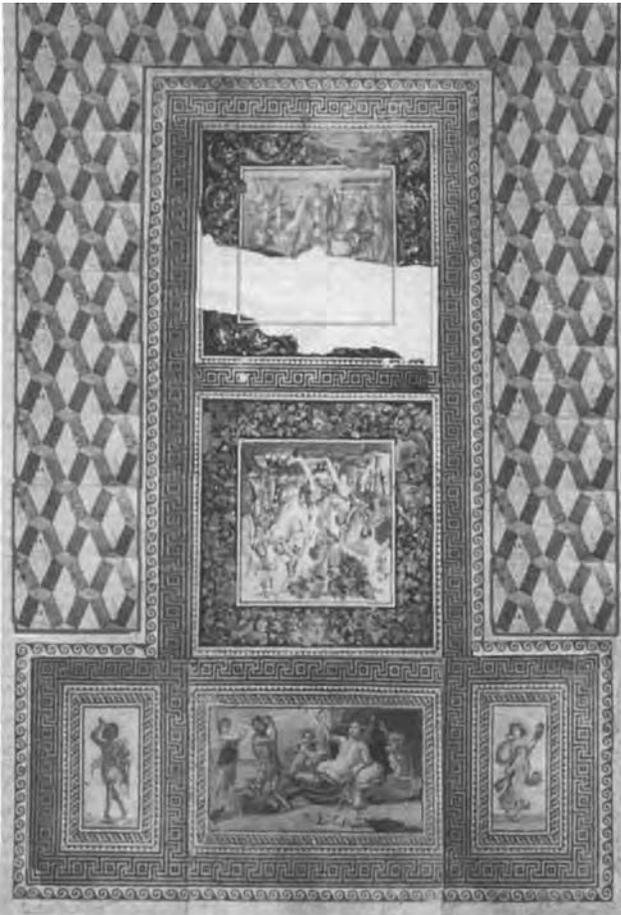
Figure 9. Atrium House dining room floor. Computer-generated photo composite showing all the panels that were separated after excavation and distributed to several institutions. They were reunited during the Worcester exhibition. The loss in the center of the floor was caused by the low wall-like structure visible in Fig. 10.

Another exception to the filling rule was the compensation of a large loss in the center of the dining room floor. In a computer model of it in Fig. 9 all the mosaic segments now belonging to six different museums can be seen side by side as they were found and as they were exhibited in the Antioch exhibition. In Fig. 10 is a field photograph before the floor was lifted. The damage in the center of the floor occurred before the mosaic was discovered, when a trench was dug to built a wall. In this particular case the conservators and the curator decided to continue parts of the repetitive geometric border with plaster restoration tesserae cast in entire sections in order to better integrate these two fragments into the floor (Figs. 11, 12). The remainder of the loss was to be filled with Edison mortar.

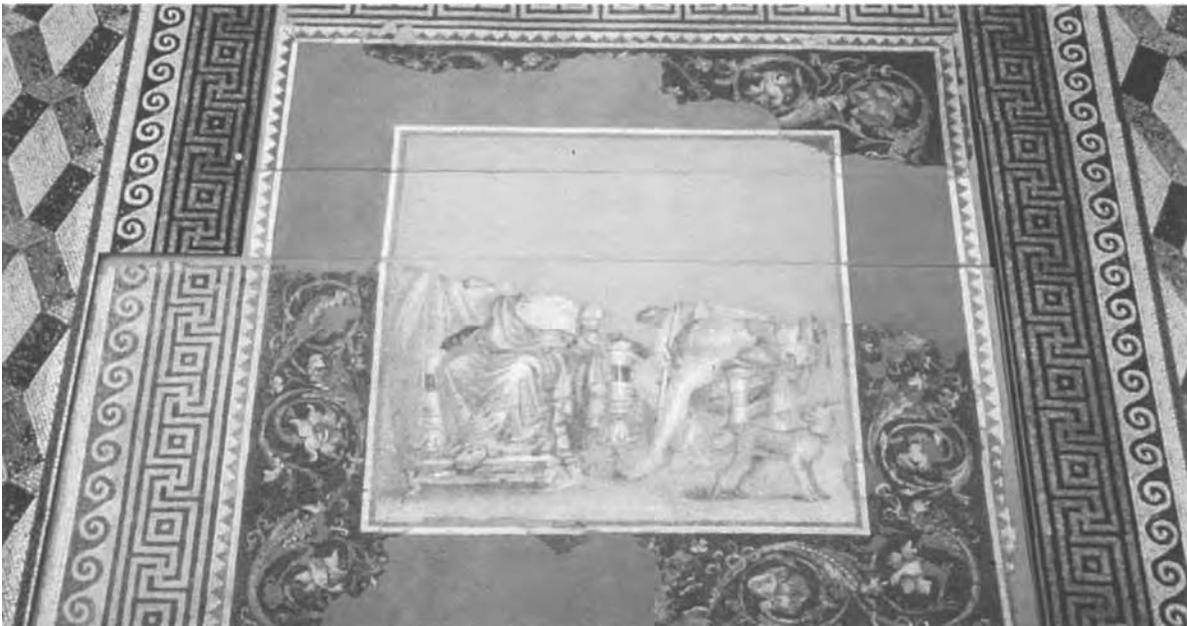
Figure 13. Panel representing Aphrodite and Adonis (collection of The Art Museum, Princeton University), from the Atrium House dining room. After conservation, in the Worcester exhibit. The upper border is the Wellesley fragment in Fig. 11. The border areas, except for the sections along the top and lower left, are a black and white photographic image of fragments which are in the collection of the Antakya Museum.

In Fig. 13 the panels can be seen *after treatment* incorporated into the dining room floor at the exhibition venue in Worcester. The plaster restorations were painted using an airbrush in a slightly lighter color than the original border to make the restorations obvious. To compensate for the missing mosaic pavement between these two fragments an entire separate fill panel was

fabricated, using a wooden board for the substrate.

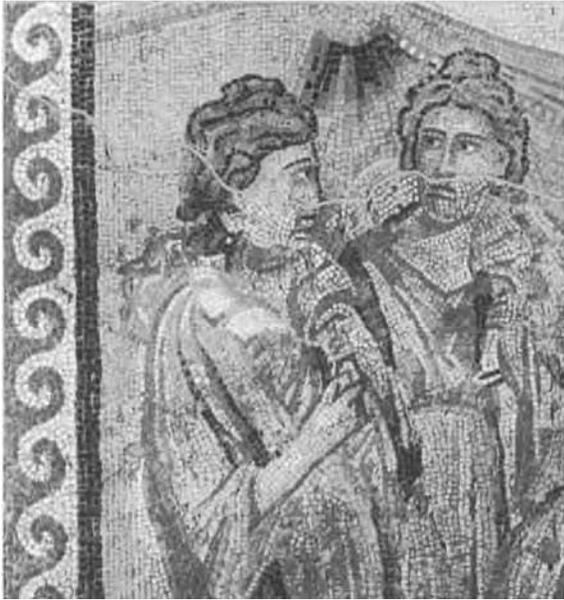
Figure 14. Detail of *Funerary Symposium* mosaic after the 1930's restoration with stone tesserae (the outlined areas is to be covered with tissue paper).

In the case of the Funerary Symposium mosaic it was decided to cover areas of the 1930's tesserae restorations with tinted tissue paper instead of removing the restoration tesserae (Figs. 14-16). It was felt that these skillful restorations are now part of the history of the mosaic. Besides being incorrect, the modern faces, for example, which were in perfect condition, made the ancient, eroded faces look secondary.

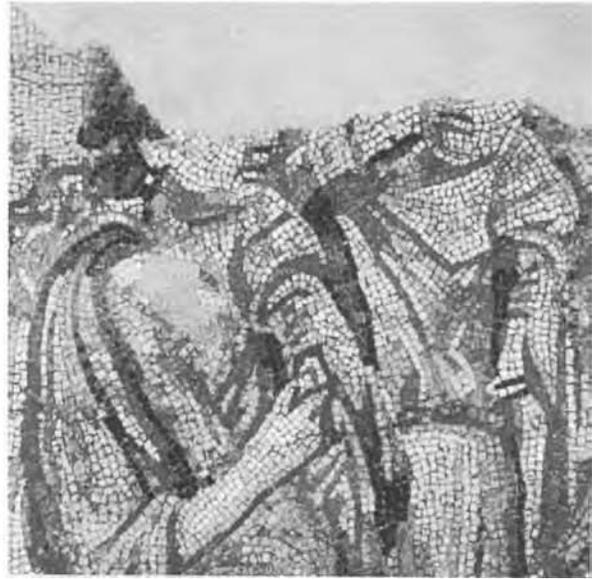
Figure 15. Detail of Fig. 14 after covering the 1930's restoration of the faces with tinted tissue paper.

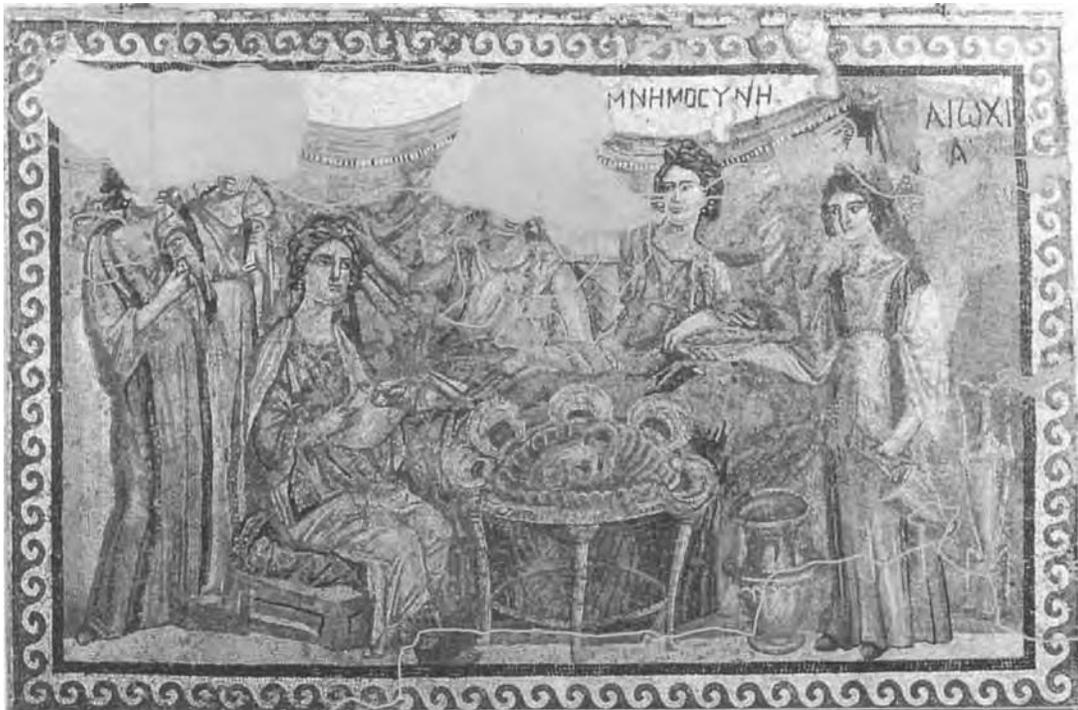
Figure 16. *Funerary Symposium* mosaic, after treatment. Outlined are all loss areas, most of which were filled with stone tesserae in the 1930's.

But not all the restorations were covered. It was decided that the restorations of the geometric border sections and the background curtains would be left uncovered because they don't seem to be invented shapes but rather a continuation of existing patterns. Also, the curtains help to establish the physical space in which the banquet is taking place.
