Article: Managing Construction-Induced Vibration in the Museum Environment

Author(s): Anna Serotta, Andrew Smyth

Source: *Objects Specialty Group Postprints, Volume Twenty-One, 2014*

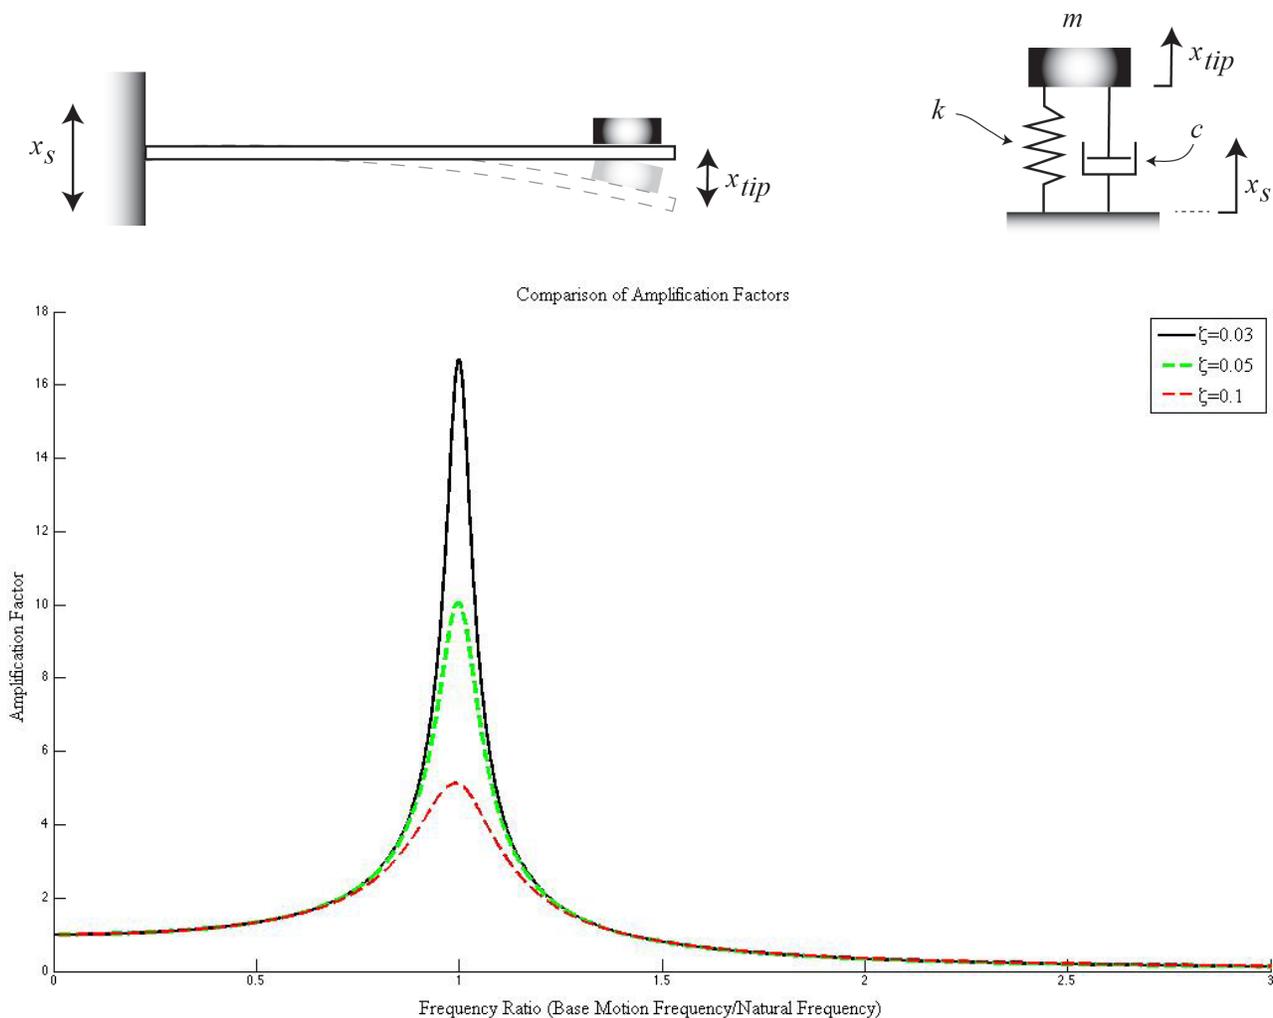
Fig. 1 (a) Schematic of simple cantilevered shelf system with vertical wall excitation, (b) The amplification of a simple “single degree of freedom” dynamic system due to harmonic excitation. The horizontal axis in the graph is a ratio of the harmonic excitation frequency to the natural frequency of the system. (Courtesy of Andrew Smyth)

The surprising thing to the uninitiated is that the shelf vibrations may be much larger than the exciting wall vibrations. This is due to the well-known resonance condition that occurs when the exciting frequency is near the natural frequency of the shelf. This is shown in the amplification plot (fig. 1b) for

the same shelf with different values of inherent energy dissipation (or damping). Notice that even for a relatively large damping value of 0.1, the response can be five times as large as the excitation displacement. As the frequency of excitation goes higher above the natural frequency of the shelf system, the response starts to drop significantly. This idea will be used later.

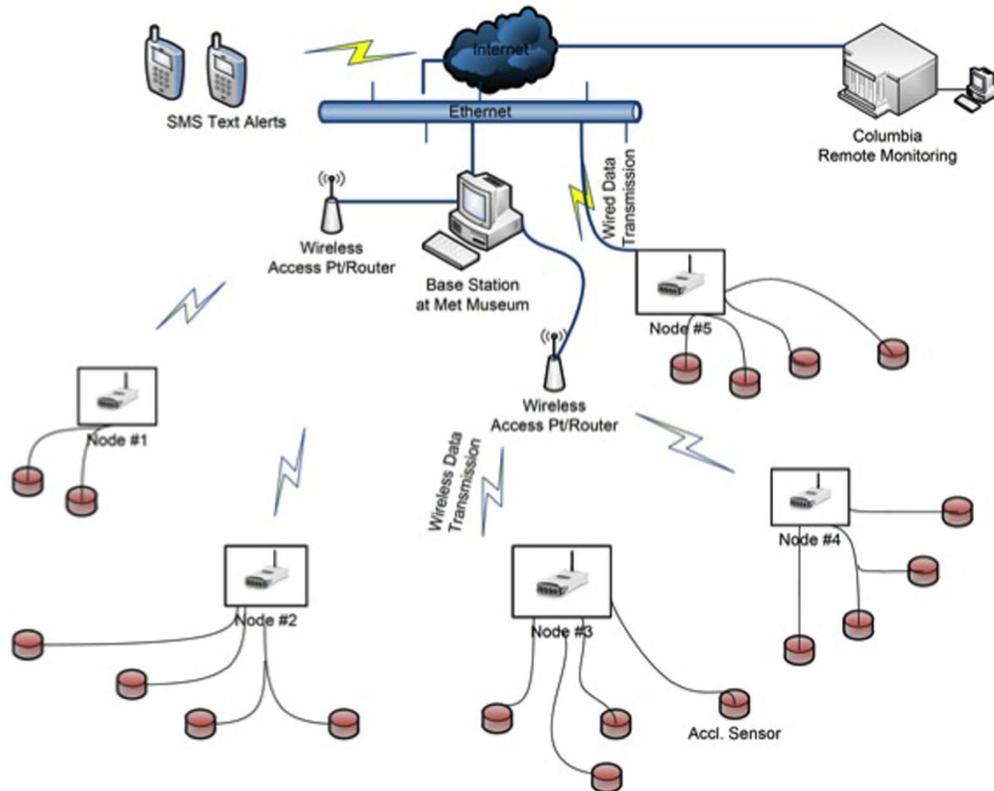
Fig. 2. Schematic of wireless monitoring network developed by Columbia University team (Courtesy of Andrew Smyth)

Figure 2 illustrates a schematic of the monitoring network. Accelerometer sensors were connected to wireless data acquisition nodes, as seen in figure 3, which would communicate with a central processing server over the museum's own wireless network. Data were analyzed in real-time and when thresholds, which had been established from the pilot testing phase, were exceeded, automatic warnings were sent via e-mail and text message to key individuals on the engineering, construction, and conservation staffs. Typical alert thresholds were in the 1 or $3 \text{ mm} \cdot \text{s}^{-1}$ range. Note that these were not necessarily thresholds that would cause work stoppage, but were used as levels that would trigger alert messages that were reviewed in the appropriate context, and which, in turn, led to different actions being taken. Alert thresholds were often programmed for different sensors depending on their location (e.g., floor or shelf) and the perceived fragility of nearby objects. Wireless nodes were installed throughout the

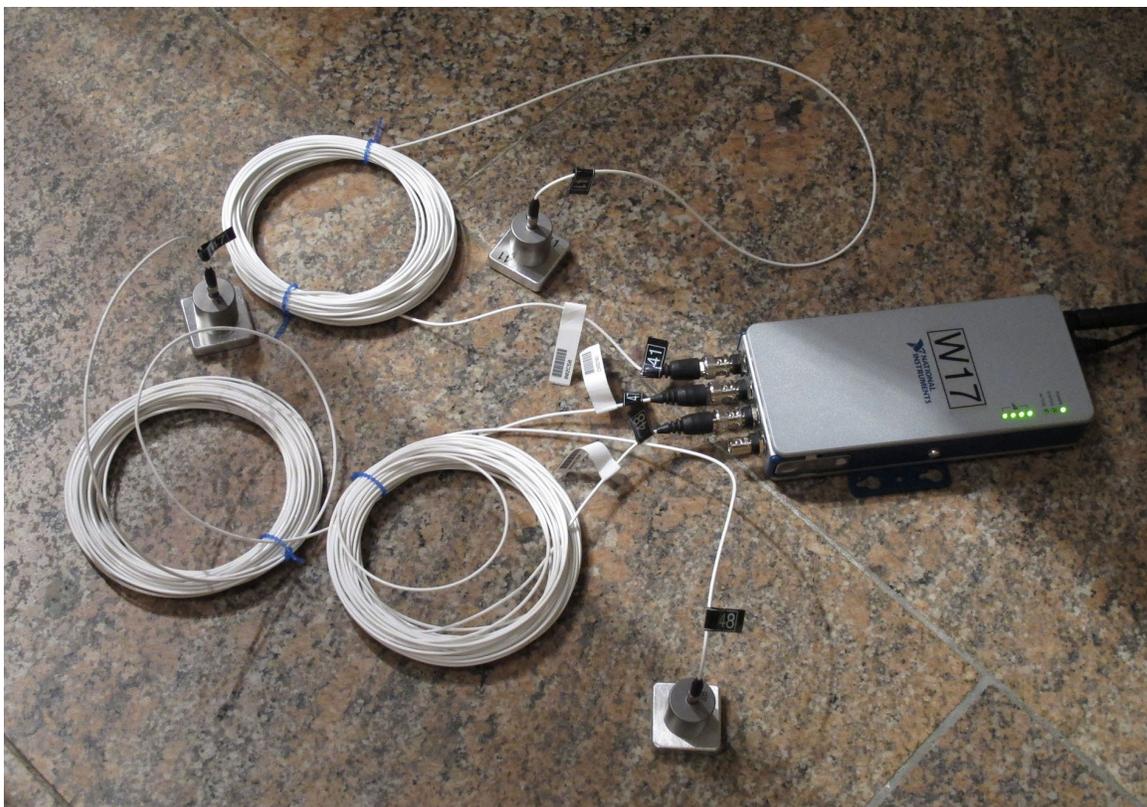
Fig. 3. Wireless data acquisition unit with sensors attached (Courtesy of Andrew Smyth)

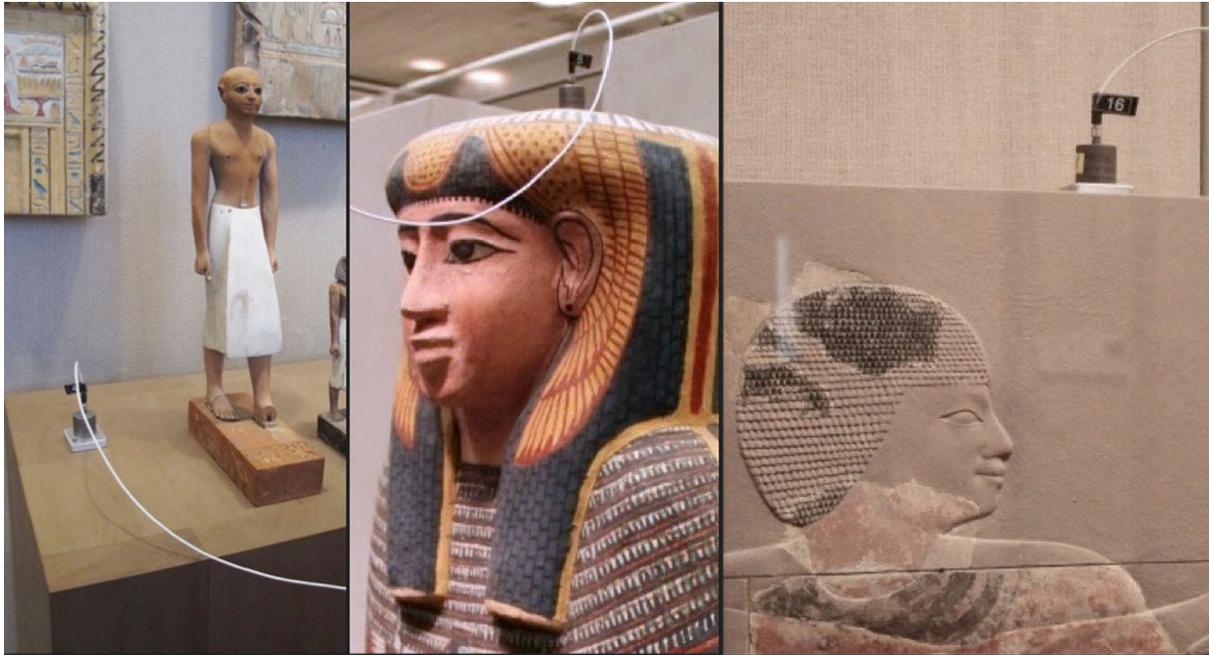
Fig. 4. Sensor placement during pilot testing (Courtesy of Andrew Smyth)

During the pilot testing, sensors were placed on the floor, on pedestals and shelves, and on the objects themselves with Mylar barriers (fig. 4).

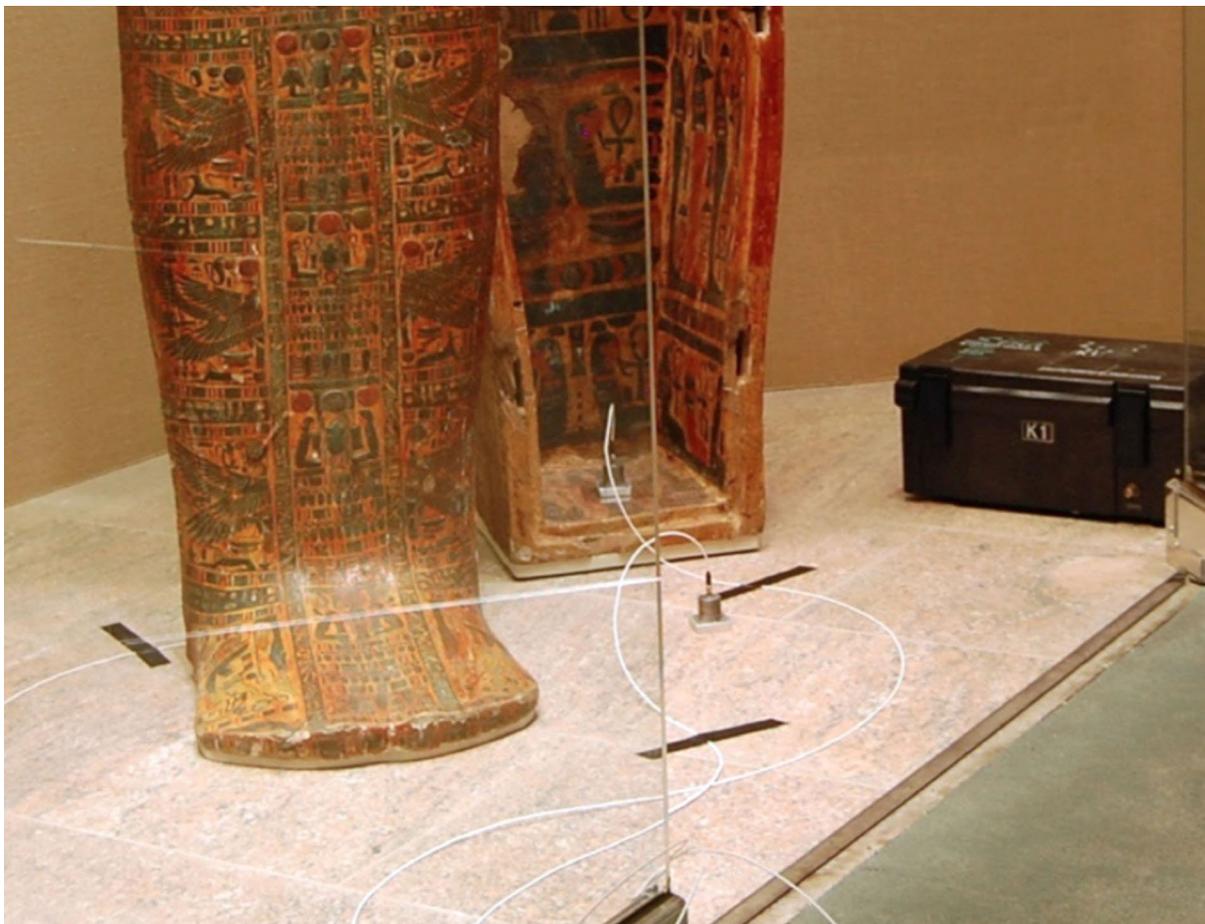
Fig. 5. Testing Sorbothane isolation during pilot tests. Sorbothane pads are installed under the coffin bottom but not under the lid. Vibration responses were measured in both the coffin bottom and lid, and also in the floor. (Courtesy of Andrew Smyth)

Figure 5 demonstrates the use of Sorbothane to decrease the response vibrations in a standing coffin base when excited by a 30 lb. chipping gun removing concrete fireproofing on a beam just beneath the floor.

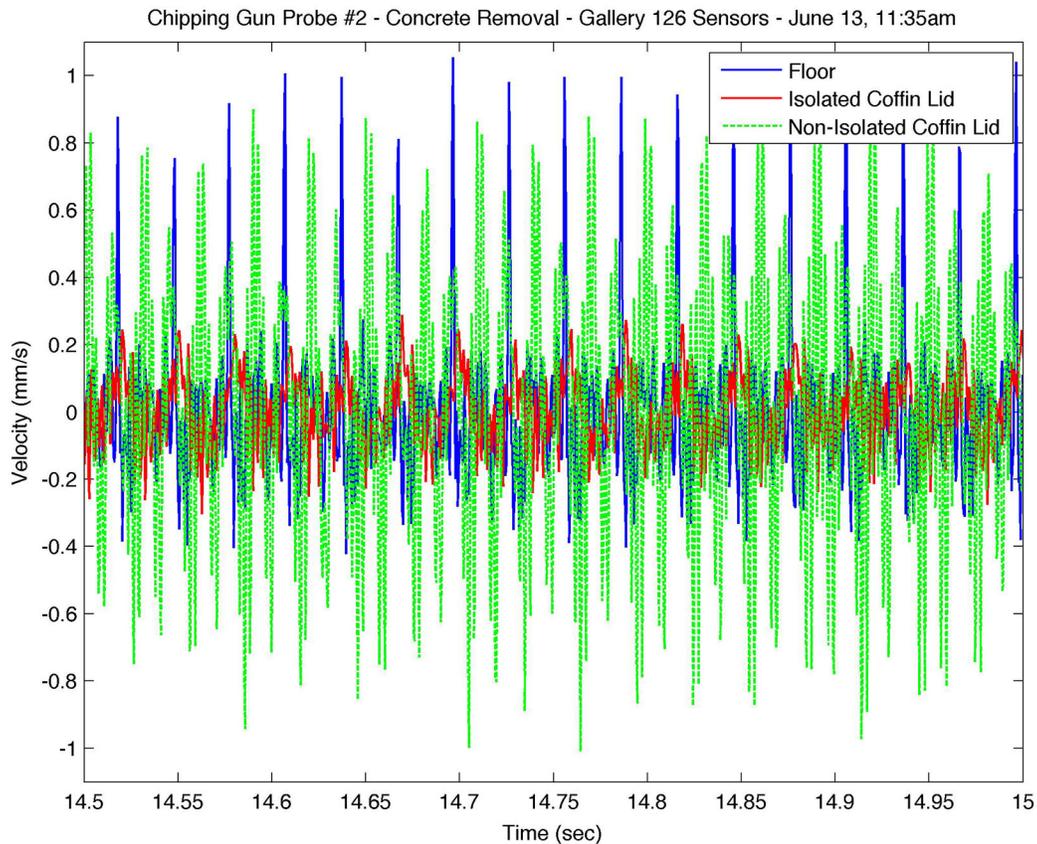
Fig. 6. A comparison of the response of the floor, with a nonisolated coffin lid and a similar neighboring coffin (Courtesy of Andrew Smyth)

The response of this coffin was compared with vibration levels in the adjacent floor and in the lid of the coffin, which had not been isolated with Sorbothane (fig. 6).

The objects were exposed to vibration from the chipping gun for a short duration, and the response vibrations were recorded. In this instance, Sorbothane was a decidedly effective isolator: the velocity reduction between the floor and the isolated coffin base was approximately 75–80%. Other objects isolated with Sorbothane also performed well during the probes, showing vibration reduction factors of 3, 4, and 5 with the appropriately designed Sorbothane pads, and these results encouraged wider use of the material.

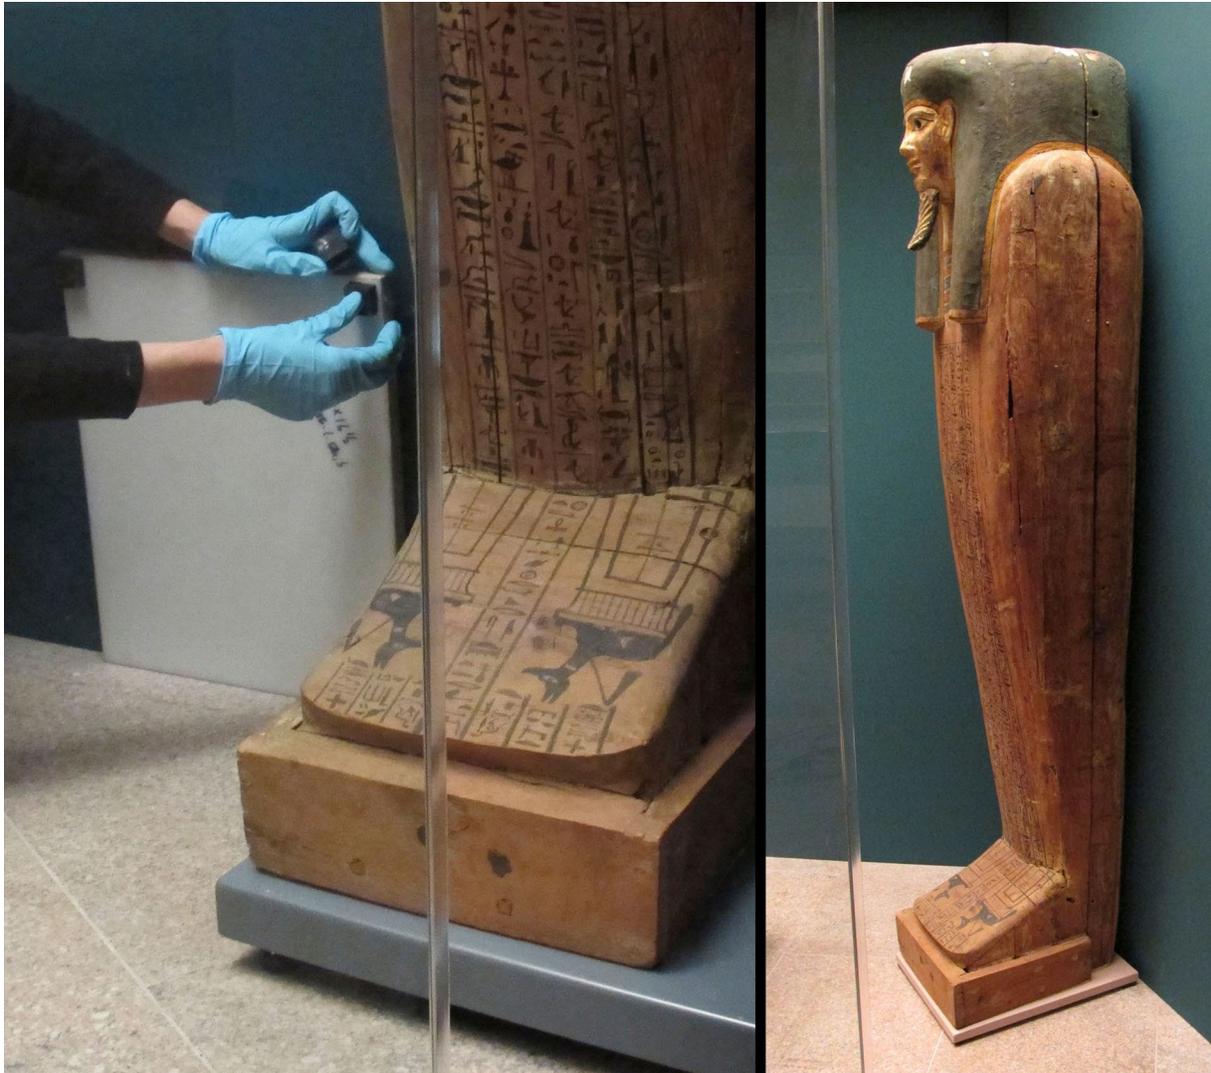
Fig. 7. (a) Sorbothane pads were installed in each corner of the HDP board and (b) the object was placed on top of the HDP board (Courtesy of Anna Serotta)

The project team installed Sorbothane under a variety of objects and pedestals, particularly in galleries above areas slated for structural demolition. One pad was typically placed in each corner of the base of the object or pedestal, although rectangular bases often required additional pads below their longer edges. To ensure good performance, it was important to achieve an even distribution of weight on all pads. If an even distribution of weight was not possible because the bottom surface of the object was uneven and the object had no pre-existing base, boards of high density polyethylene (HDP) were inserted between the object and the Sorbothane pads (figs. 7a, 7b).

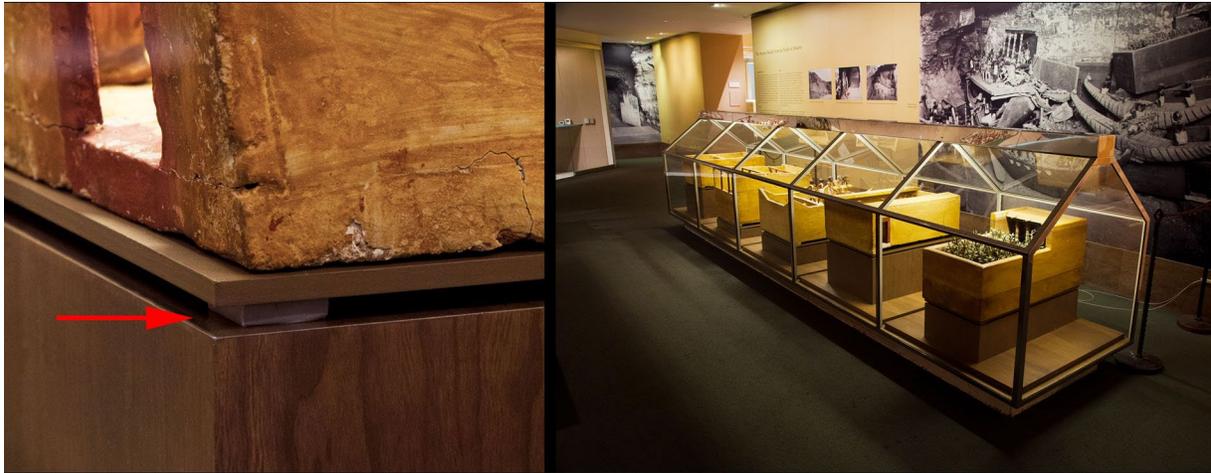
Fig. 8. (a) Sorbothane pads installed under steel plates (Courtesy of Andrew Smyth); (b) the Meketre models isolated on their new pedestals (Courtesy of Gustavo Camps)

Pedestals, rather than individual objects, were isolated when the objects themselves were particularly fragile or when the objects themselves were not heavy enough to properly compress the Sorbothane pads. (Recall that because one is trying to create low natural frequency systems when performing isolation, it is important to have a relatively large mass to stiffness ratio.) One group of fragile, lightweight objects was effectively isolated by increasing the weight of each object with a steel

plate base. These objects, painted wooden models from the tomb of Meketre (MMA 20.3.9-13), were previously installed on pedestals whose mushroom-shaped structure precluded effective isolation; the bases of these pedestals were relatively narrow and the additional height of the Sorbothane pads would have positioned the objects too close to the top of their case. New, shorter pedestals were designed and the objects were reinstalled on Sorbothane pads on top of these pedestals, with a steel plate positioned between each object and its Sorbothane pads. This new configuration, shown in figure 8, enabled the effective isolation of the models and allowed these highly popular objects to remain on view for the duration of the project.

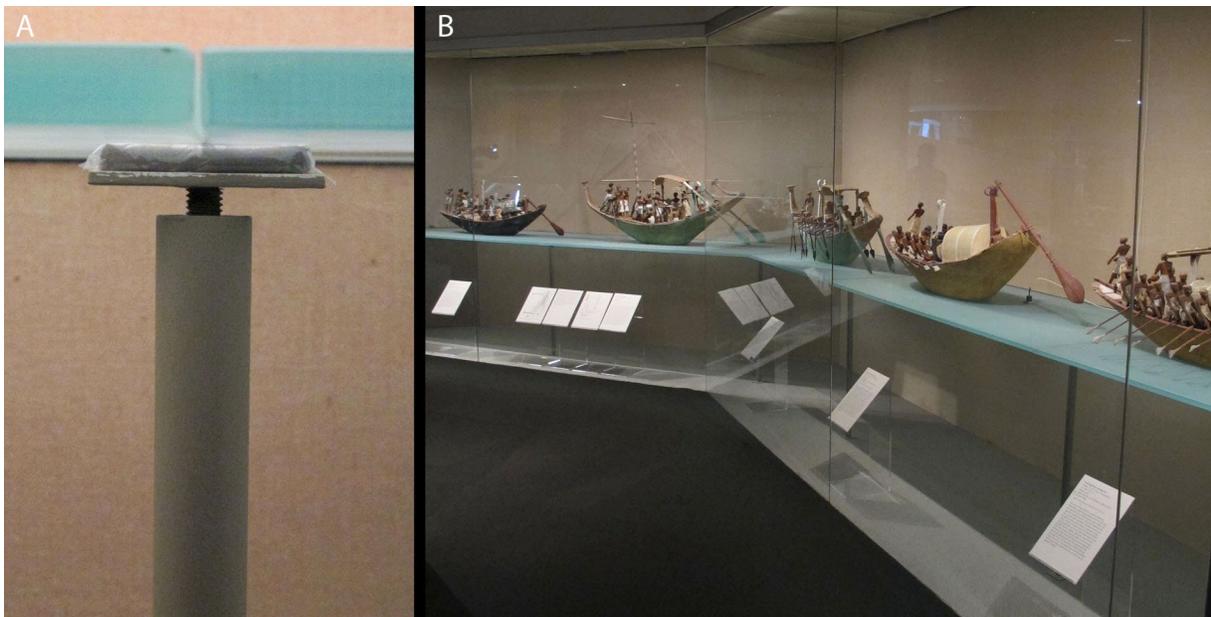
Fig. 9. (a) Sorbothane pads inserted between support leg and glass shelf; (b) Support legs with Sorbothane pads at their top ends were installed under cantilevered glass shelf with Meketre boats (Courtesy of Andrew Smyth)

This mitigation method had to be further modified for another group of objects in the same gallery, the Meketre boats (MMA 20.3.1-6), which sit on glass cantilevered shelves. As with the Meketre models, deinstallation of these objects was seen as a last resort because of their importance, popularity, and fragility. Sorbothane pads were tested under one of the Meketre boat models during the pilot tests, and the vibration responses of the isolated boat and shelf were measured. The cantilevered shelves acted as

a low-pass filter for the input vibrations, effectively filtering out much of the high-frequency component. Not surprisingly, those low frequency input vibrations were amplified, rather than dampened by the Sorbothane pads, where the response of the isolated boat is significantly greater than that of a nonisolated boat. In this case, where low-frequency vibrations were expected, alternative steps had to be taken to reduce the magnitude of the response vibrations. The solution developed by the project team was to install a support leg in the front corner of each shelf, as seen in figure 9. The legs helped elevate the natural frequency of the shelf support system and thus reduced shelf movement and, in addition, the Sorbothane pads installed between each leg and the shelf served to further dampen vibration. This system was tested and found to satisfactorily reduce the vibration experienced by the fragile boats.

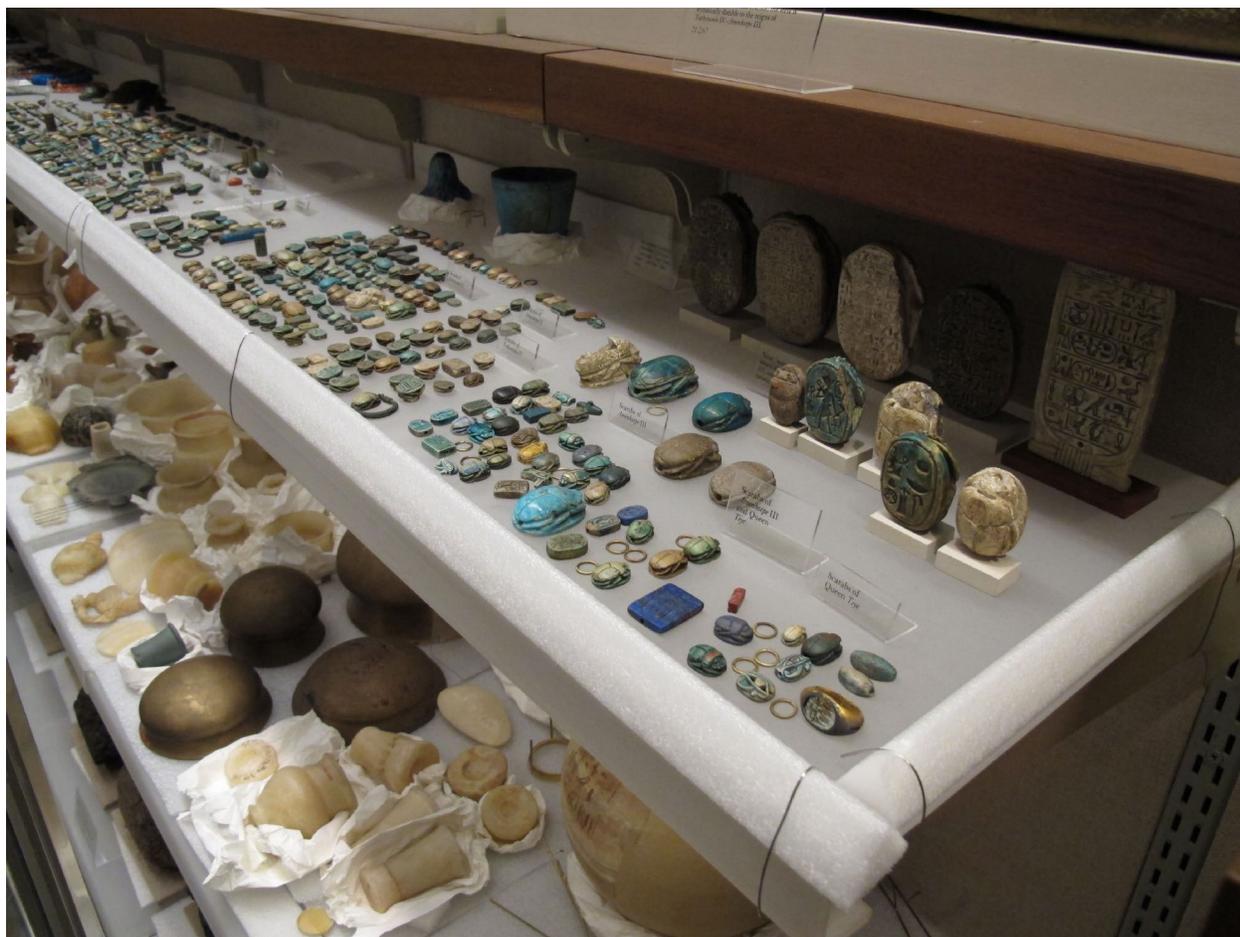
Fig. 10. Small objects reinstalled on foam trays (Courtesy of Anna Serotta)

Another solution for protecting small, light objects was to reinstall entire shelves on trays made from thick archival blueboard and thin polyethylene foam, as shown in figure 10. These trays were given

additional foam rims, which prevented vibration from causing especially light objects from walking off of shelves.

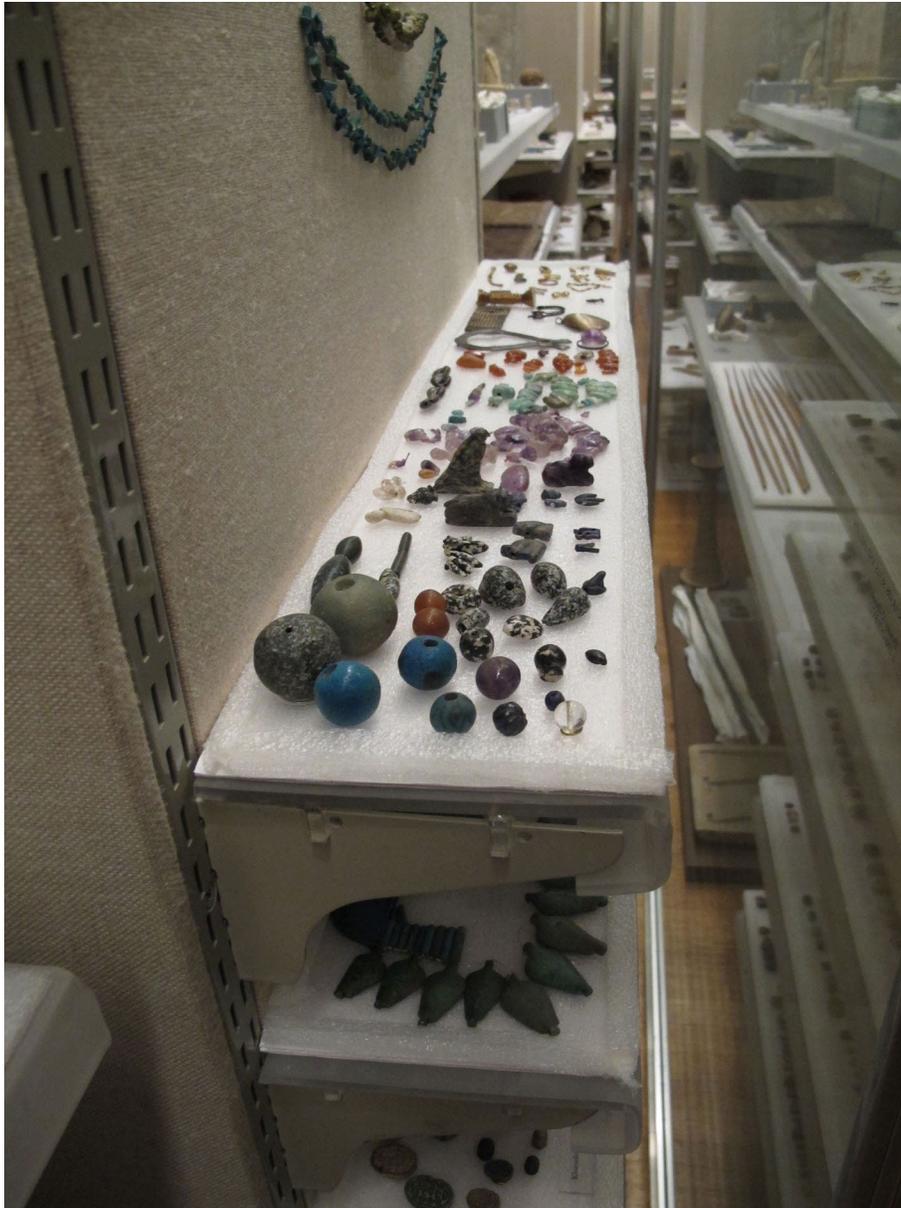
Fig. 11. Bumpers installed in a closed study gallery to prevent objects from walking off of shelves (Courtesy of Anna Serotta)

Because making and installing thousands of tiny objects on to the foam trays was time consuming, in closed galleries, bumpers made of Ethafoam tri-rod were often substituted (fig. 11). Bumpers were used only in cases where the objects were not particularly fragile and where the major concern was the objects walking off of their shelves.
