Article: Conservation Realities and Challenges at Archaeological and Historical Sites in Colombia: Seeking Success by Considering the Context

Author(s): María Paula Álvarez

Source: *Objects Specialty Group Postprints, Volume Twenty-One, 2014*

CONSERVATION REALITIES AND CHALLENGES AT ARCHAEOLOGICAL AND HISTORICAL SITES IN COLOMBIA: SEEKING SUCCESS BY CONSIDERING THE CONTEXT

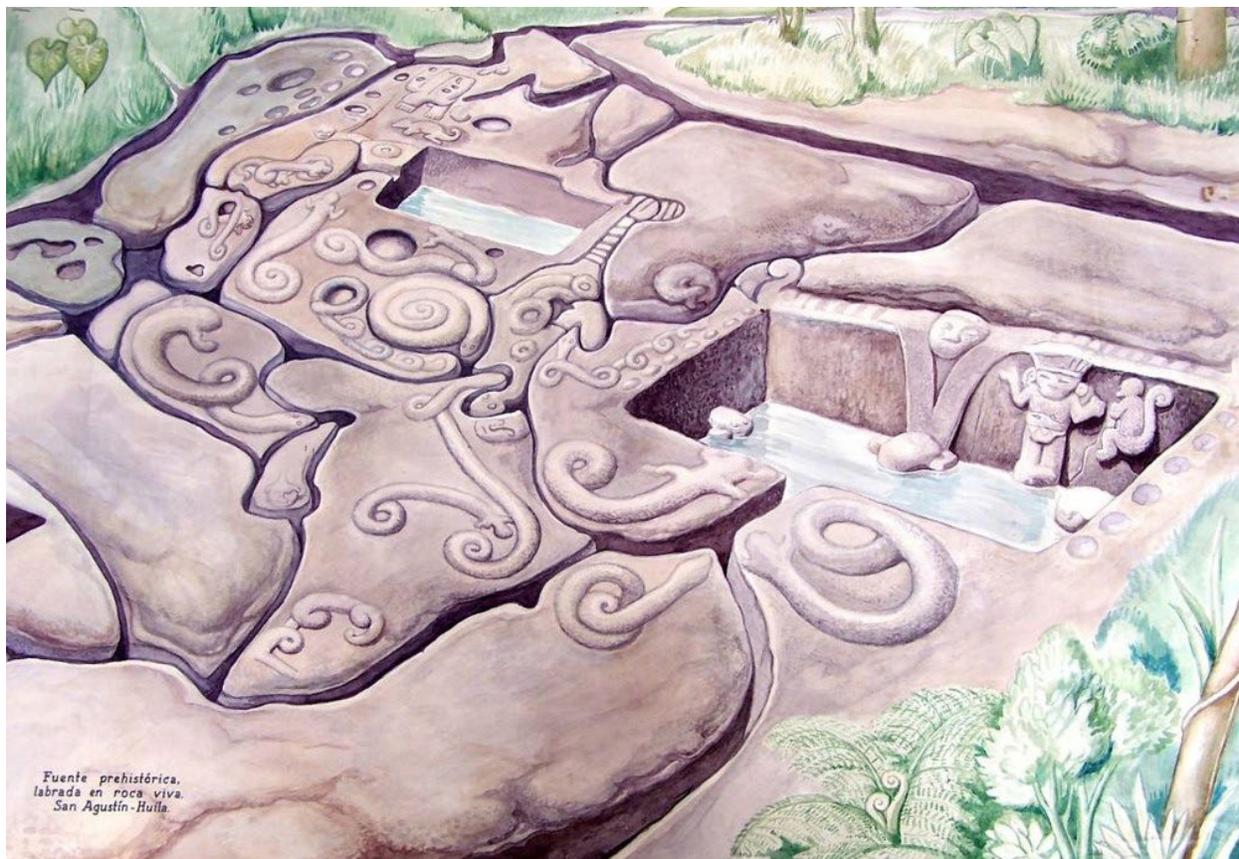
Fig. 2. *Fuente de Lavapatas* drawing by Luis Alfonso Sánchez from the archaeological commission headed by José Pérez de Barradas (7/10/1937) (Courtesy of ICANH)

The *Lavapatas* fountain was built by pre-Columbian sculptors of the Upper Magdalena region, sometime between the ninth century BC and the ninth century AD, in the sloping bed of the Lavapatas creek. The fountain is formed by a series of complex channels and wells that determine the direction of the water flow. As seen in figures 2 and 3, these channels define, mark, and highlight human and animal sculptures such as lizards and snakes.

The predominant forms are located in the north and central sections and are protected by a shelter covering an area of 20.2×21.7 m. Other carved forms and channels, which are less significant, are located outside of this covered area.

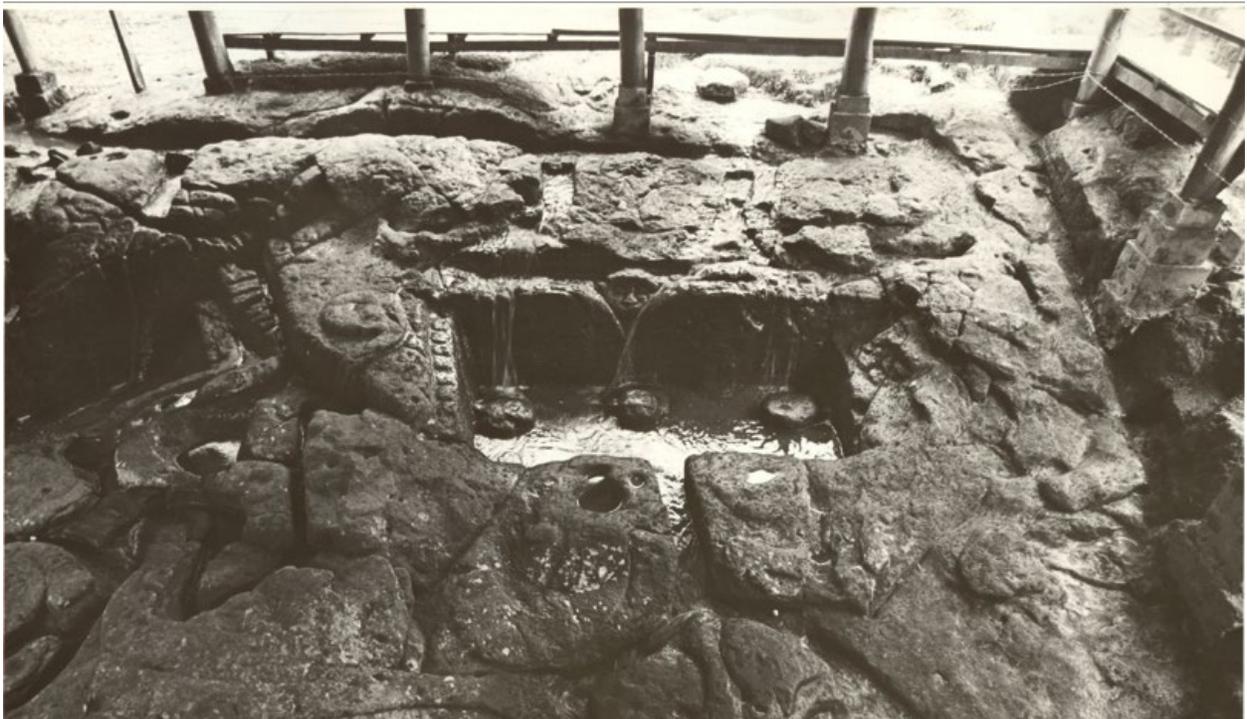
Fig. 4. First shelter with structure directly attached to the *Lavapatas* (Courtesy of Duque, ICANH Archive 95ii 0191)

As seen in figure 4, the first shelter over the *Lavapatas* was directly attached to the site causing some damage to the stone. The current shelter (fig. 5), a metallic structure covered with acrylic, was installed in the eighties.

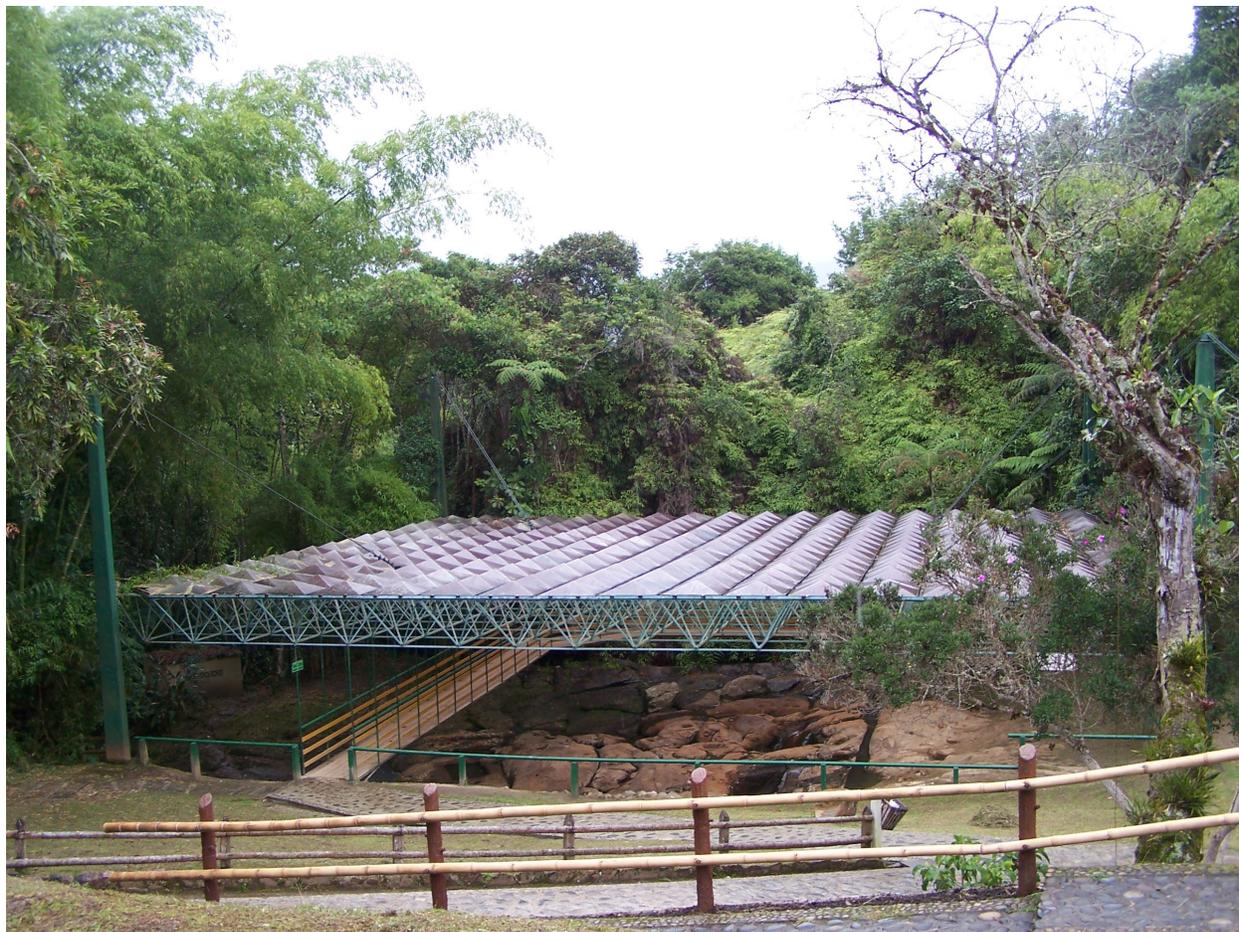
Fig. 5. Shelter installed in 1984 and present at the site currently (Courtesy of C. Bateman)

Those measurements allowed us to understand that the current shelter mitigates the impact of environmental conditions such as solar radiation, relative humidity, and temperature on the rock of the *Fuente*. However, the current shelter is inadequate because it leaks and has structural damage. The shelter conditions should be monitored and in the future it should be repaired.

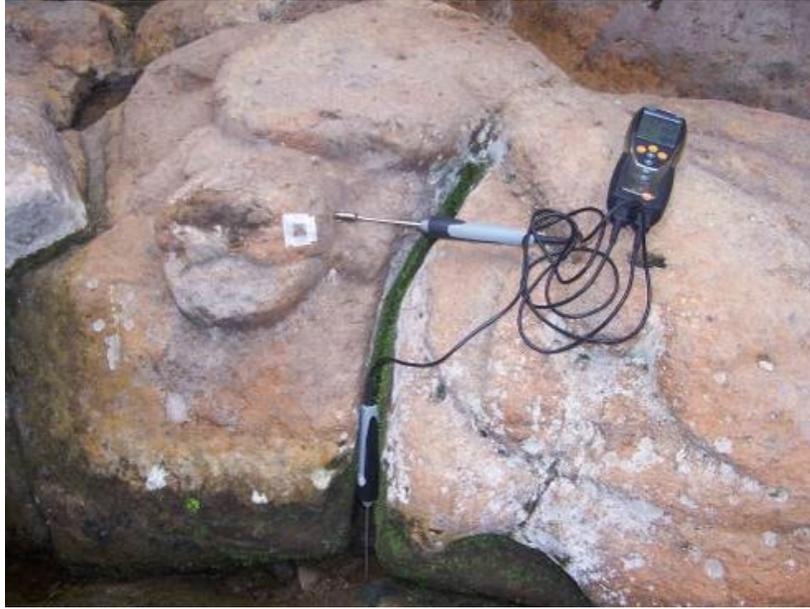
Fig. 6. Surface temperature measurements as part of the weather conditions study (Courtesy of A. Miro)

During a period of more than 6 months, local weather conditions were studied, measuring relative humidity and temperature inside and outside the shelter, and taking surface temperature measurements of the rock (fig. 6).

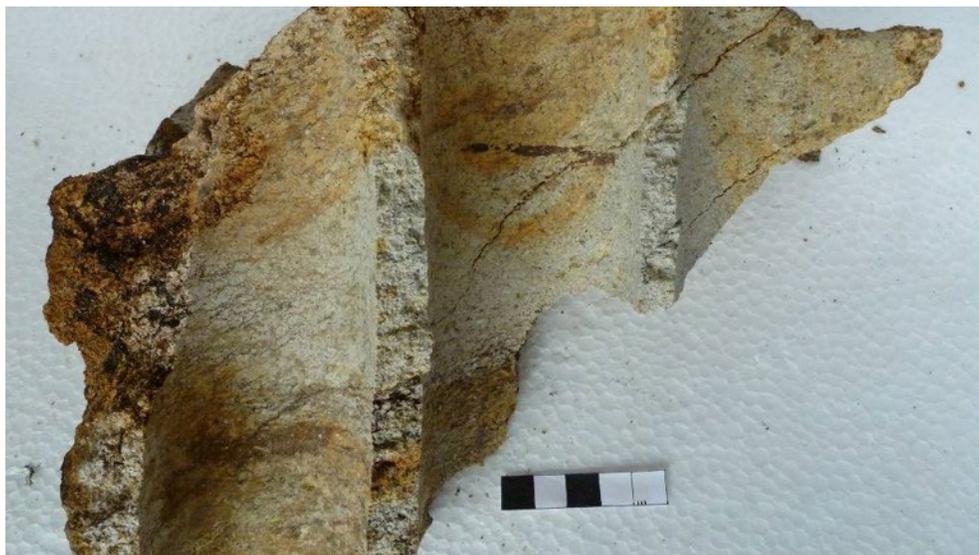
Fig. 7. Discontinuous and heterogeneous nature of the *Lavapatas* volcanic tuff (Courtesy of H. Jacobsen)

The geological study was done in situ through the macro-description of the rock, the evaluation of capillary absorption, the documentation of fractures, and hardness of the surface, and in the laboratory through the study of samples taken from different areas of the fountain illustrating different states of conservation. Petrographic, microprobe SEM, infrared spectroscopy, and x-ray diffraction analyses were carried out allowing the understanding of the discontinuous and heterogeneous nature of the *Lavapatas* volcanic tuff, illustrated in figure 7.²

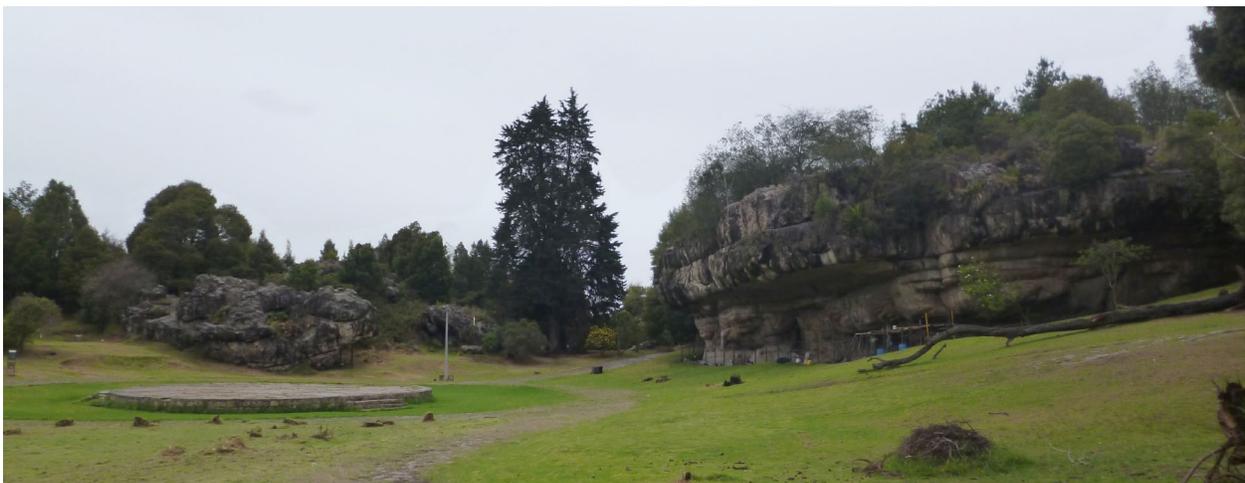
Fig. 8. Panoramic view of the park's central area with the rock shelter of Los Presidentes and rock shelter 18 (Courtesy of M. P. Álvarez)

The Facatativá nature reserve, which was declared a national archaeological park in 1946, is a very beautiful and heavily visited place located 36 km from Bogotá. It is known for having more than 20 rock shelters as seen in figures 8 and 9, with approximately 60 pre-Hispanic pictographic panels and 5 painted portraits of prominent citizens done in 1915. The area was used as a recreational park for years, during which time the pictographs were not protected in any way. The pre-Columbian heritage values were never appreciated or presented to the visitors.

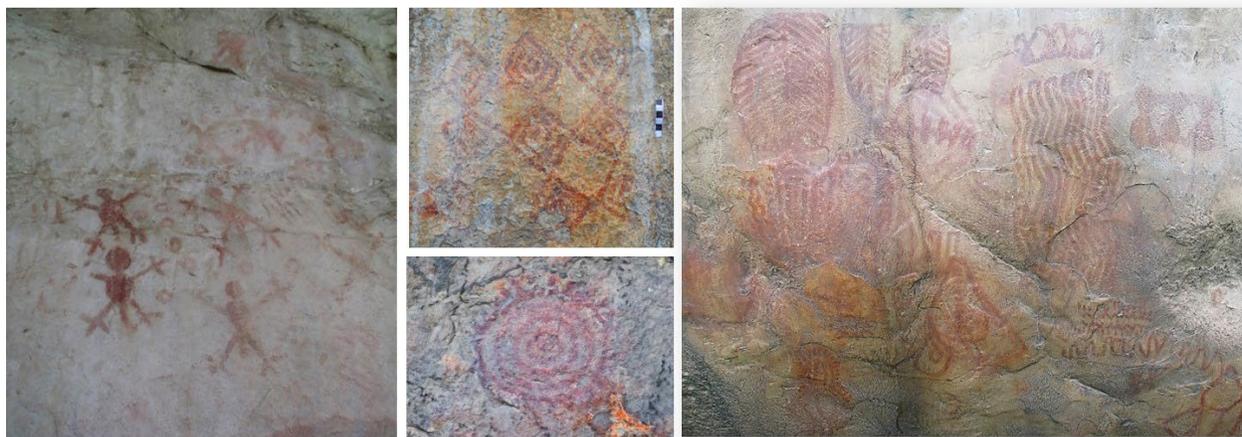
Fig. 9. Pictographs from Facatativá Archaeological Park (Courtesy of M. P. Álvarez and L. Castillo)

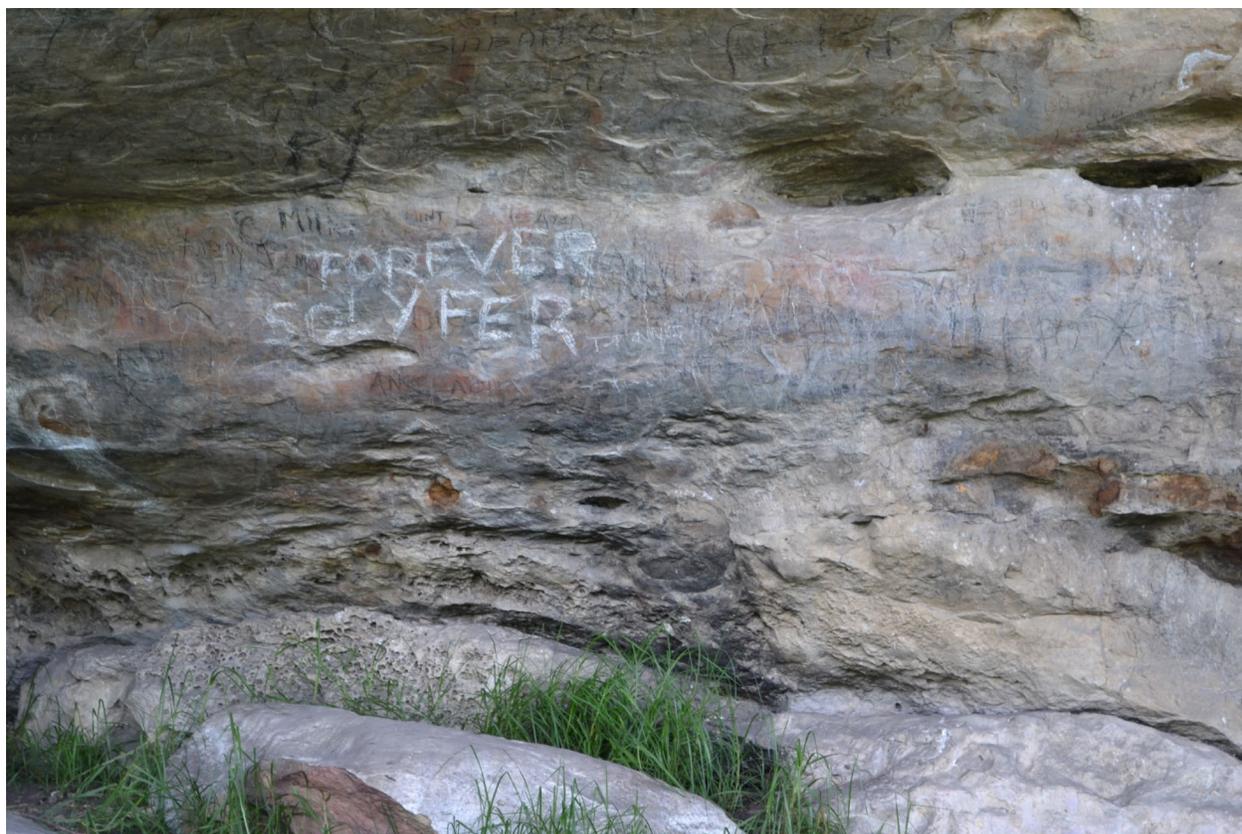
Fig. 10. Bonfire stains, salts, dirt, inscriptions, and graffiti on panel 20E in 2013 (Courtesy of L. Castillo)

The use as a recreational park allowed several practices that directly led to deterioration of the pictographs. A great number of the pictographic panels were covered with graffiti, inscriptions, and scratches, and, occasionally, bonfires were lit under the rocky shelters. Some examples of this deterioration can be seen in figure 10.

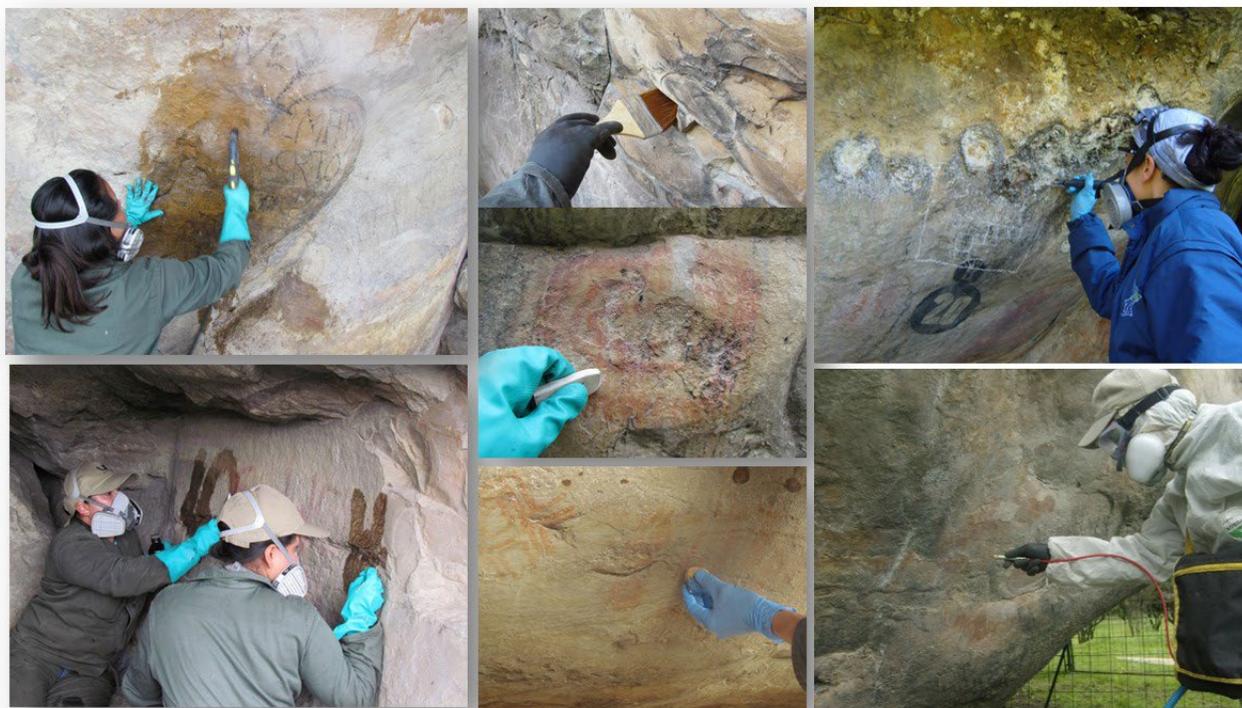
Fig. 11. Conservation activities carried out on different pictographic panels during 2014 (Courtesy of G. McCormick and M. P. Álvarez)

- Photographic documentation
- Compilation of previous documentation
- Description and graphic documentation of pictographs
- Documentation and identification of damage. This is supported by laboratory analysis of salts, stains, and biodeterioration.
- Assessment of the condition of the pictographs
- Treatment proposal supported by cleaning tests approved by ICANH
- Conservation treatments
 - Cleaning: As seen in figure 11, steam, brushes, erasers, sponges, and solvents were used. In some special cases a motor-tool and microsand blasting was required.
 - Consolidation of pictograph's paint layers, and ground and paint layers from the 1915 painting (fig. 12).
 - Inscriptions, graffiti, and scratches that could not be eliminated during the cleaning process had to be covered with silicate chalks. For the 1915 paintings, the retouching technique of *acquasporca* was used.

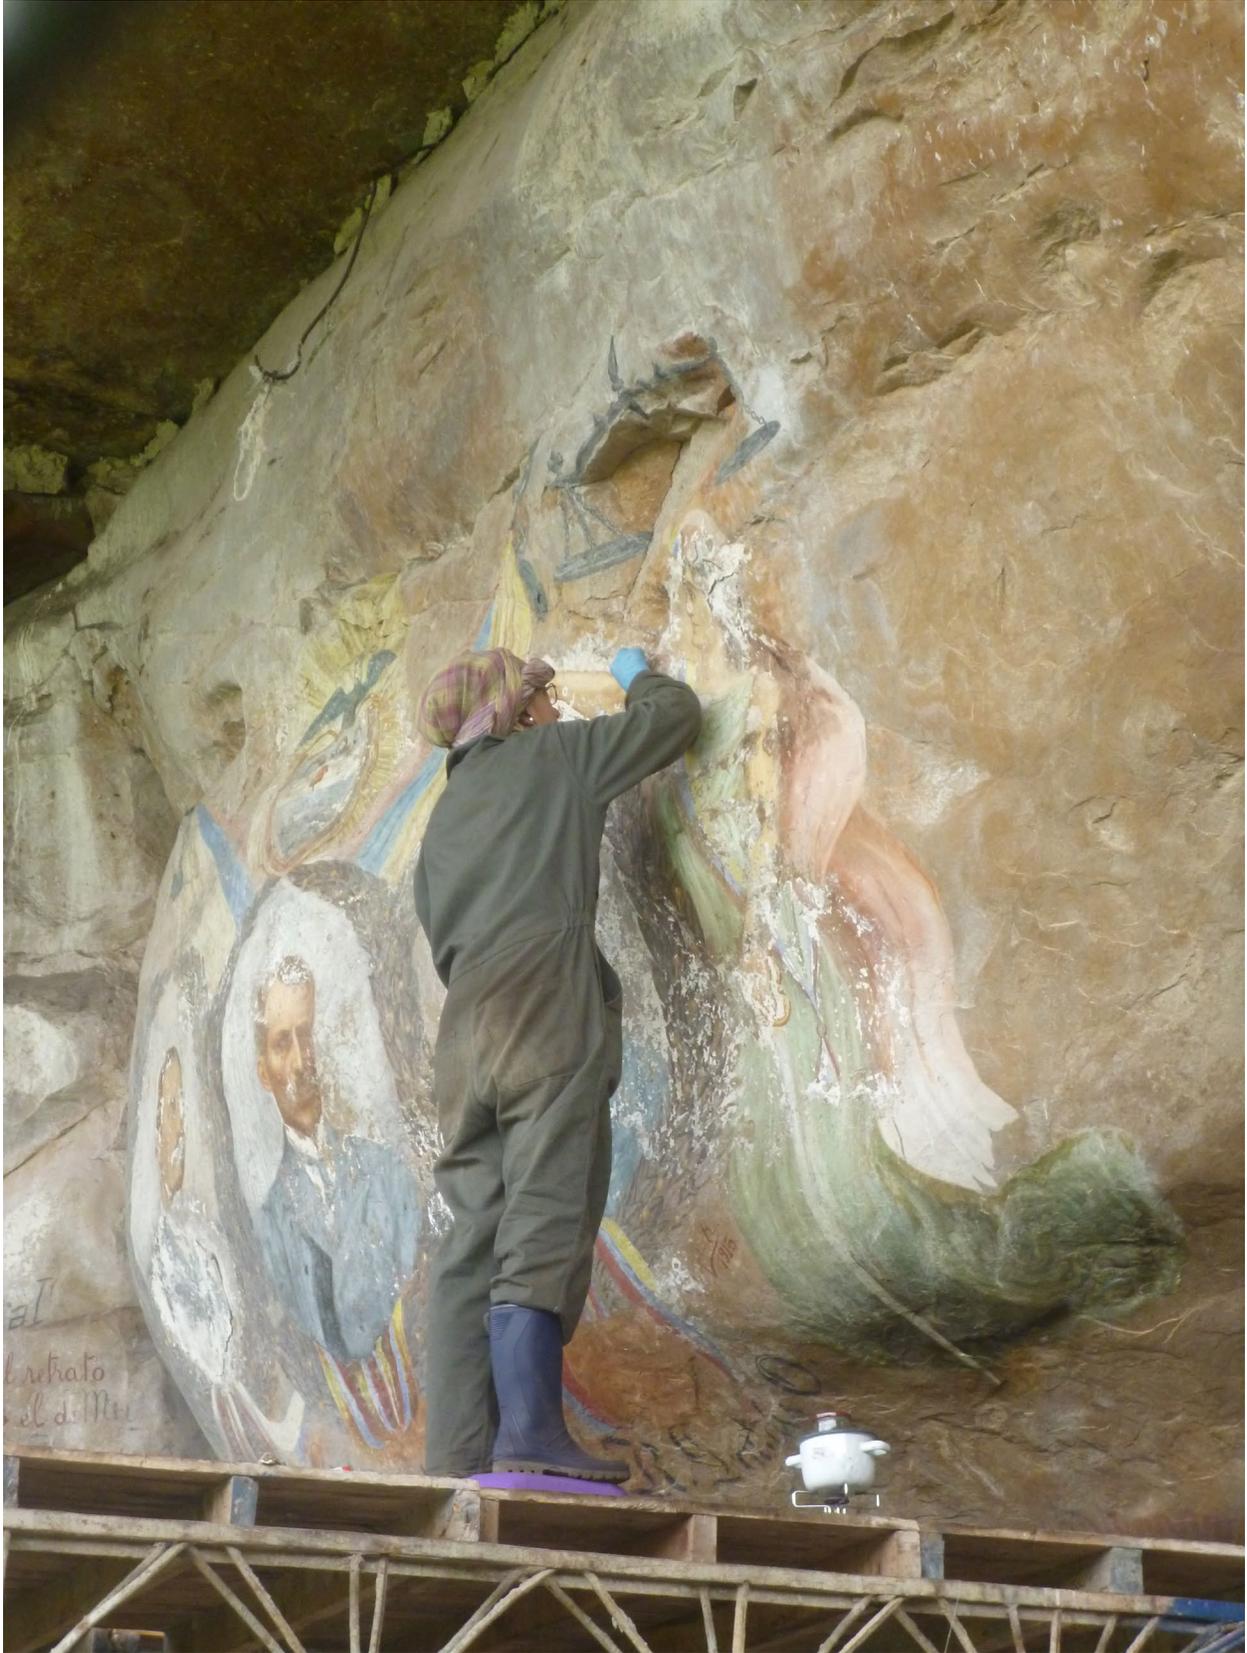
Fig. 12. Consolidation of paint layers on the 1915 painting in 2014 (Courtesy of M. P. Álvarez)

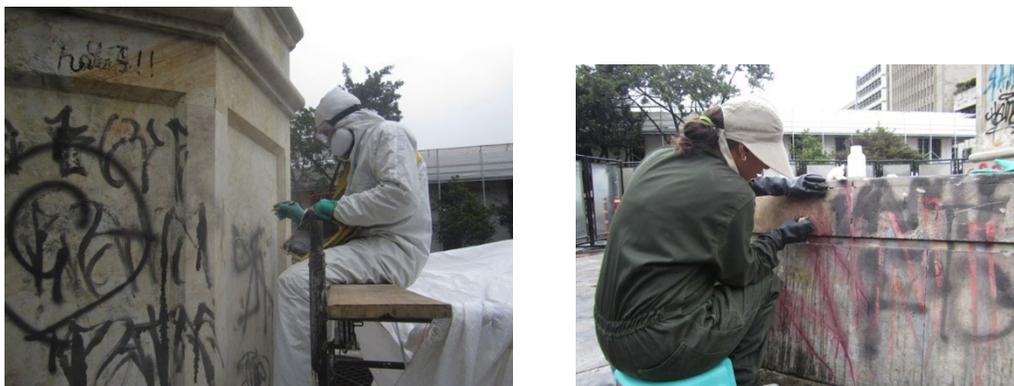
Figs. 15 and 16. Graffiti removal at *Jimenez de Quesada* monument with abrasive sandblasting and other abrasive methods. Restoration process carried out in the second semester of 2013 (Courtesy of A. Logreira)

- Cleaning of stone surfaces
- Removal of graffiti with chemical and mechanical methods

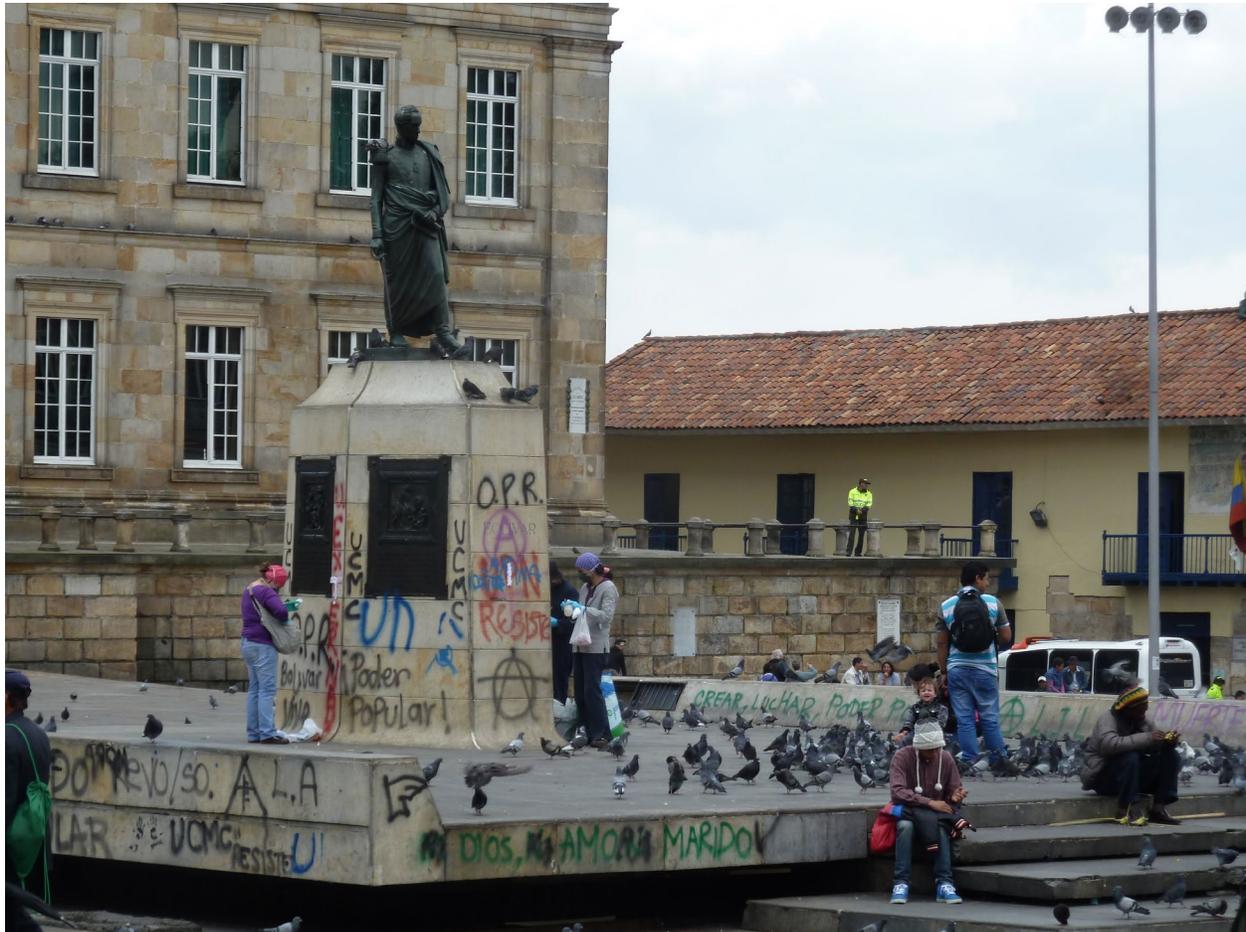
Fig. 17. *Simon Bolivar* monument before the first conservation treatment carried out in 2013 (Courtesy of M. P. Álvarez)

The *Simon Bolivar* and the *Jimenez de Quesada* monuments are two of the monuments to which Recubridor was applied. They are located in the historical heart of the city. The *Simon Bolivar* monument stands in the middle of the Plaza de Bolivar, which is surrounded by the cathedral and other important buildings, such as the National Capitol building, the Supreme Court building, and the Mayor's Office building. This main square and all the buildings surrounding it are made of sandstone and offer multiple surfaces to graffiti artists. It is a place where political and social protests very often take place (fig. 17).

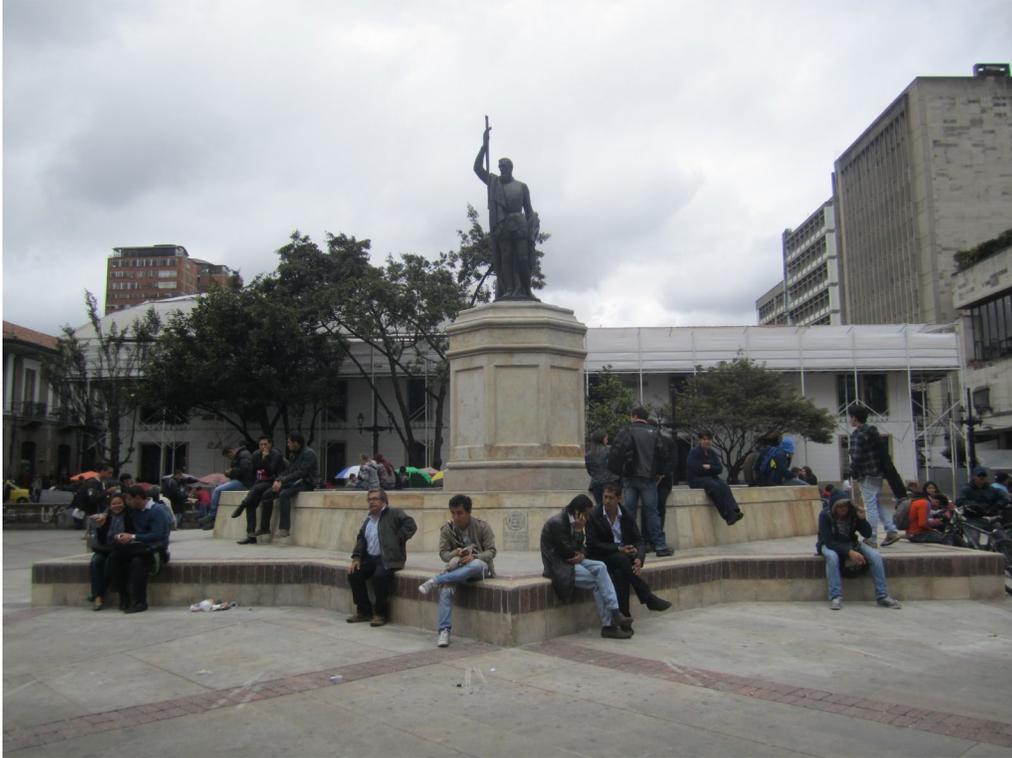
Fig. 18. *Jimenez de Quesada* monument with anti-graffiti coating after its conservation in the second semester of 2013 (Courtesy of A. Logreira)

The anti-graffiti coating was applied to buildings surrounding the Plaza de Bolivar, and to the *Simon Bolivar* and the *Jimenez de Quesada* monuments. Figures 18 and 19 show the *Jimenez de Quesada* and *Simon Bolivar* monuments after their conservation in 2013.

The application of the anti-graffiti coating allowed a more effective second cleaning of the sandstone surfaces in Plaza de Bolivar and the *Jimenez de Quesada* monument, contributing to improved conservation of these stone materials (Álvarez and Logreira 2013).

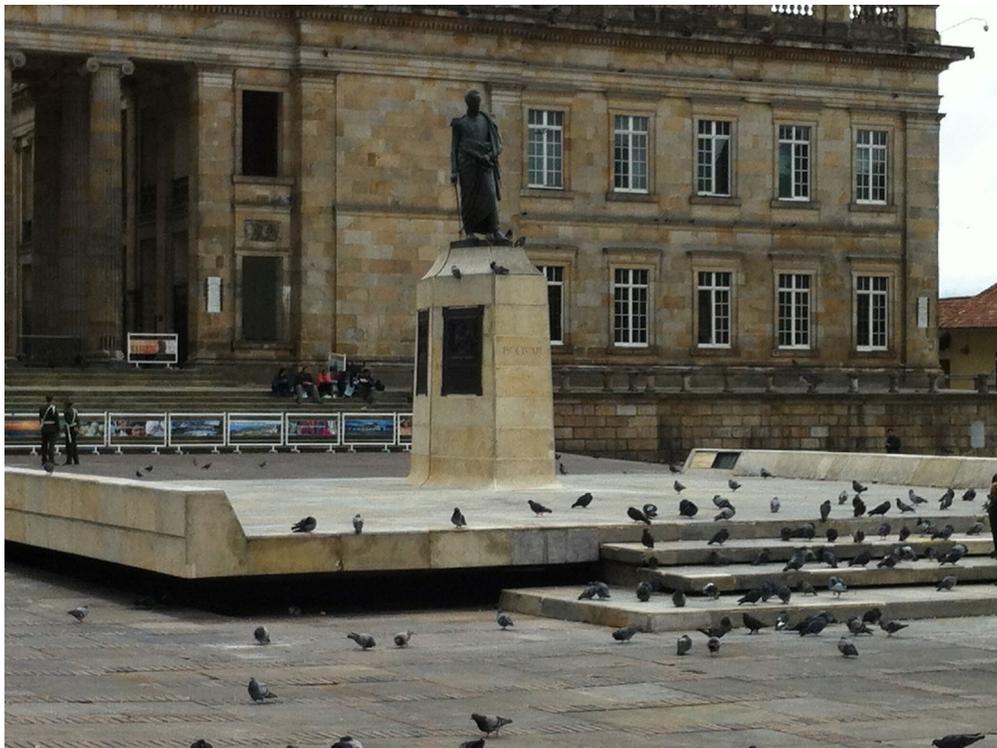
Fig. 19. *Simon Bolivar* monument with anti-graffiti coating after its conservation in the first semester of 2013 (Courtesy of M. P. Álvarez)
