Source: *Objects Specialty Group Postprints, Volume Twenty-One, 2014*

THE DEVELOPMENT OF TREATMENT PROTOCOLS AT THE WATTS TOWERS CONSERVATION PROJECT

FRANK PREUSSER, BLANKA KIELB, SYLVIA SCHWERI-DORSCH, CHRISTINA FISHER, MARIANA RUIZ, ISRAEL CAMPOS

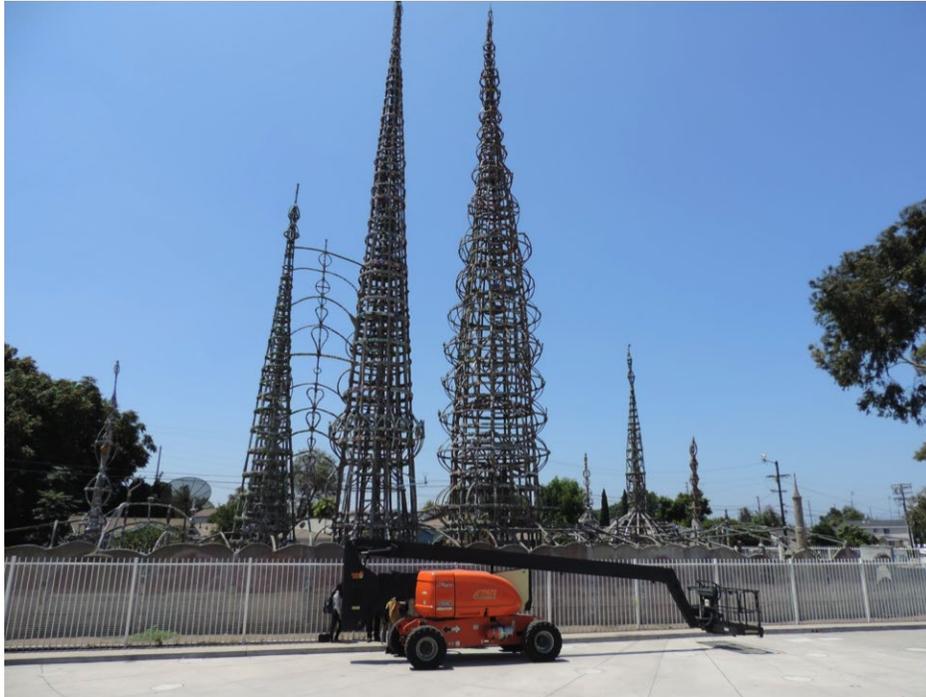
The Watts Towers (fig. 1) were built by the Italian Immigrant Sabato (Simon) Rodia in the backyard of his house in the years from 1921 to 1954. They consist of 17 interconnected structures, with the tallest reaching a height of 99.5 ft (30 m). They are owned by the State of California and are currently administered and operated by the Department of Cultural Affairs of the City of Los Angeles. They are located in the Watts district of Los Angeles County.

Fig. 1. *Watts Towers*, Sabato (Simon) Rodia, steel, cement, and embedded ornament, 30 m, City of Los Angeles Department of Cultural Affairs; view from the North side (Courtesy of Frank Preusser)

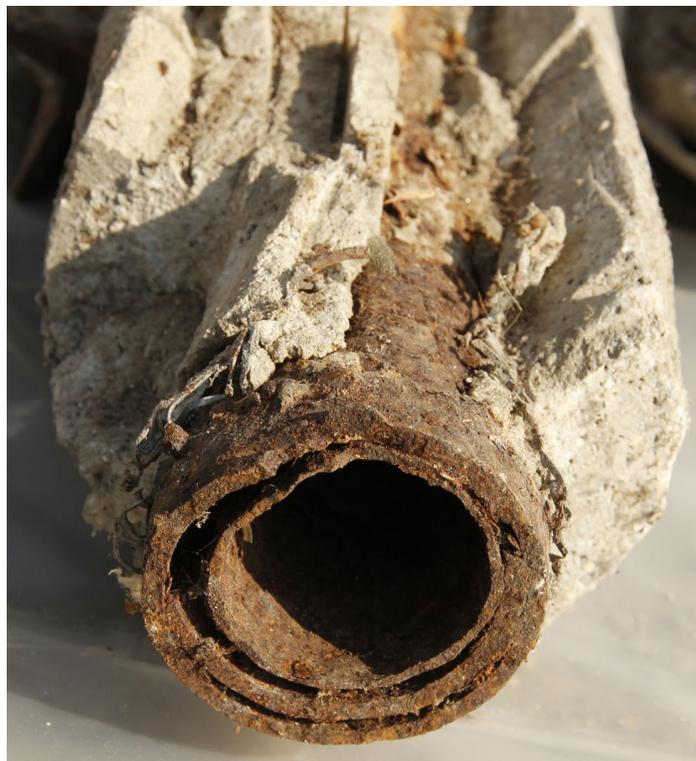
Each segment of the Towers consists of a central steel element covered by wire mesh. Rodia then applied a cement plaster (figs. 2, 3) and embedded decorative ornaments while the plaster was still wet (fig. 4).

Fig. 2. Cross section of element from the Towers (Courtesy of Kimberly Blanks)

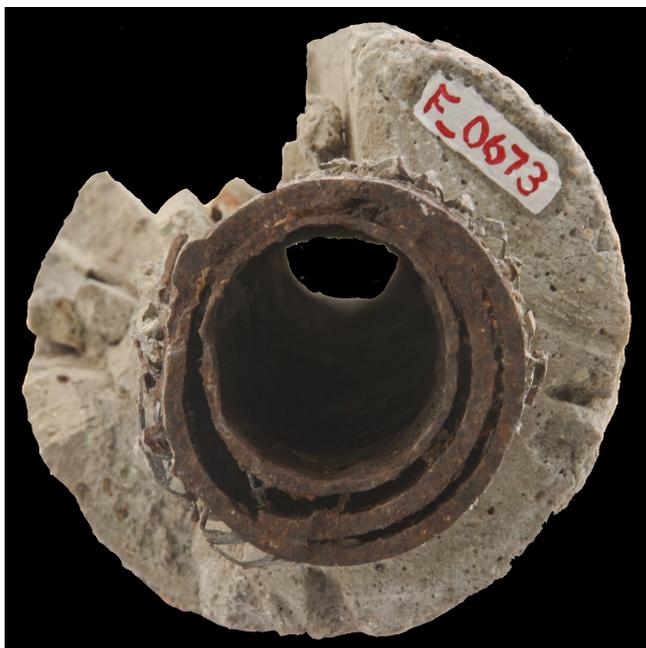
Fig. 3. Cross section of element from the Towers (Courtesy of Blanka Kielb)

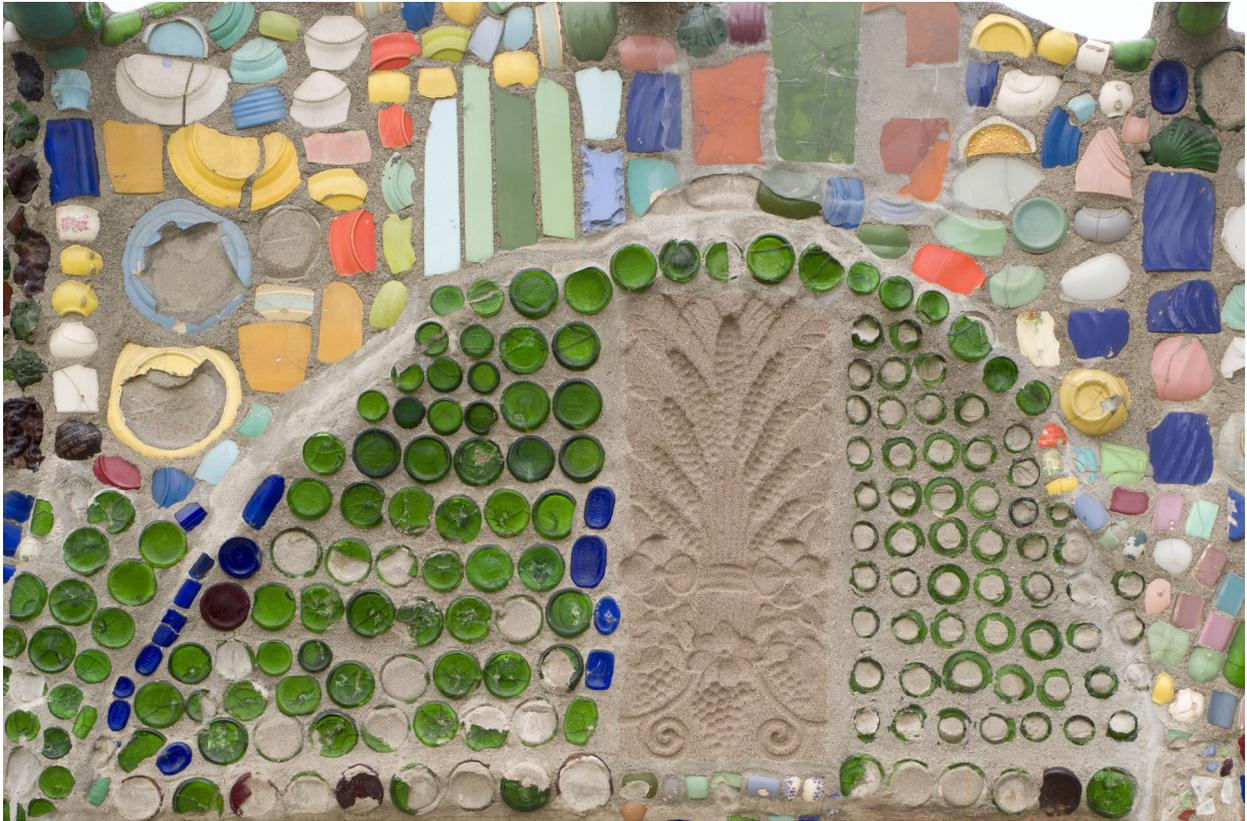
Fig. 4. Embedded decorative ornaments (Courtesy of Frank Preusser)

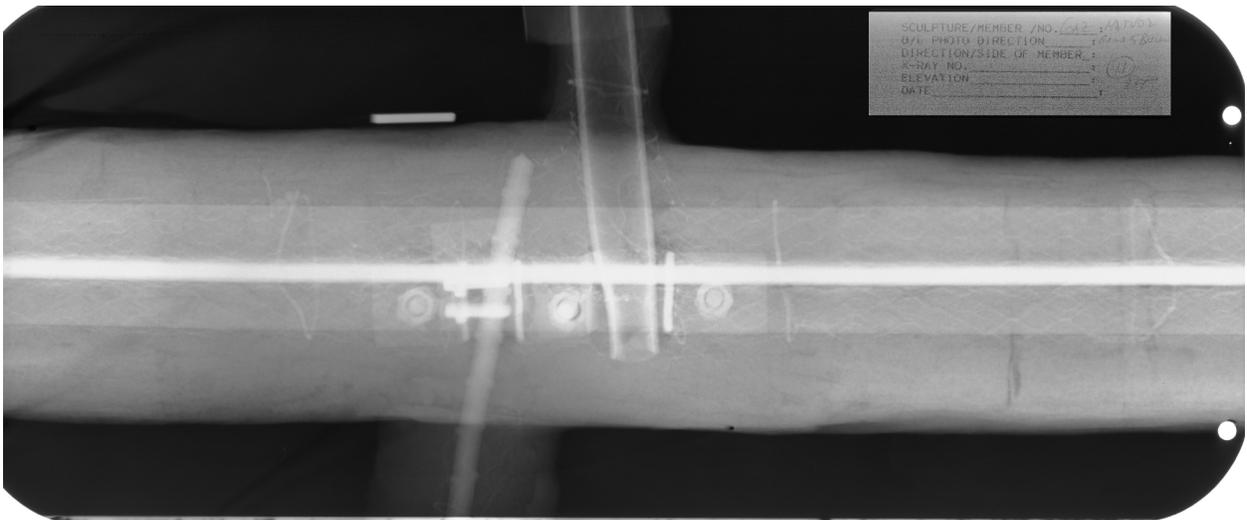
The steel elements were tied together with wires; Rodia did not bolt or weld them together. In later restorations bolting and welding became common, making the structure stiffer (fig. 5).

Fig. 5. X-radiograph of bolting (Courtesy of Los Angeles Department of Cultural Affairs)

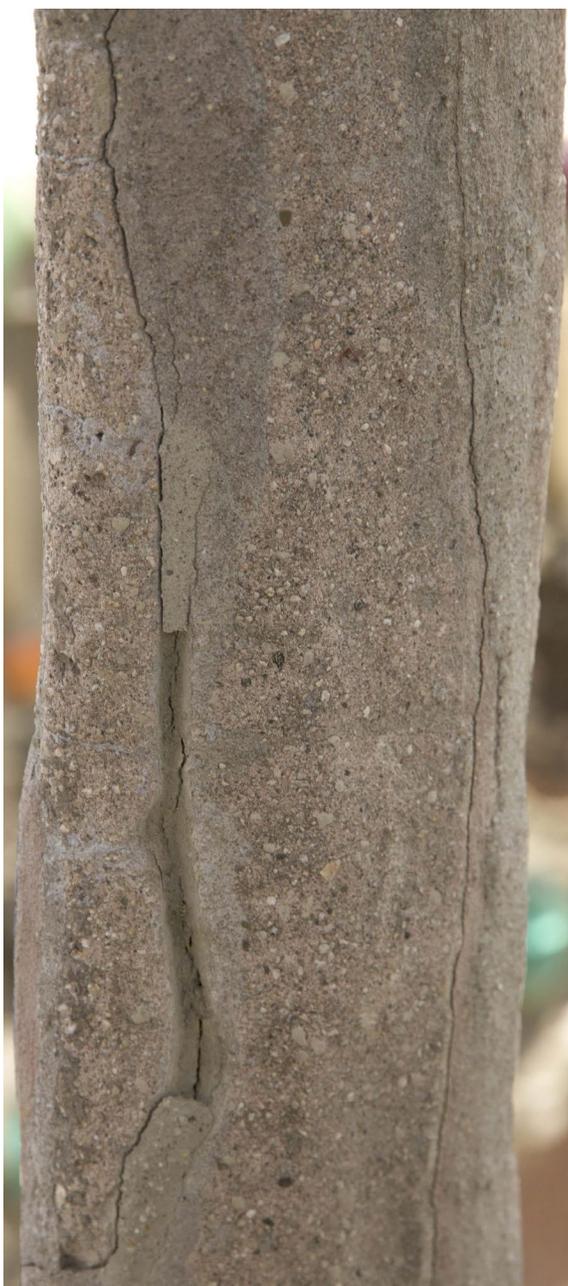
Fig. 6. Adhesive failure of repairs (Courtesy of Blanka Kielb)

occurred in traditional repair materials such as portland cement, which often failed at the bond-line, and in repairs consisting of a thin cement fill applied over an architectural epoxy paste, which failed adhesively at the cement/epoxy interface. Cohesive failure, which consists of cracks within the repair material, can be found in both epoxy and traditional cement repairs because they are too rigid to accommodate the movement of the sculptures.

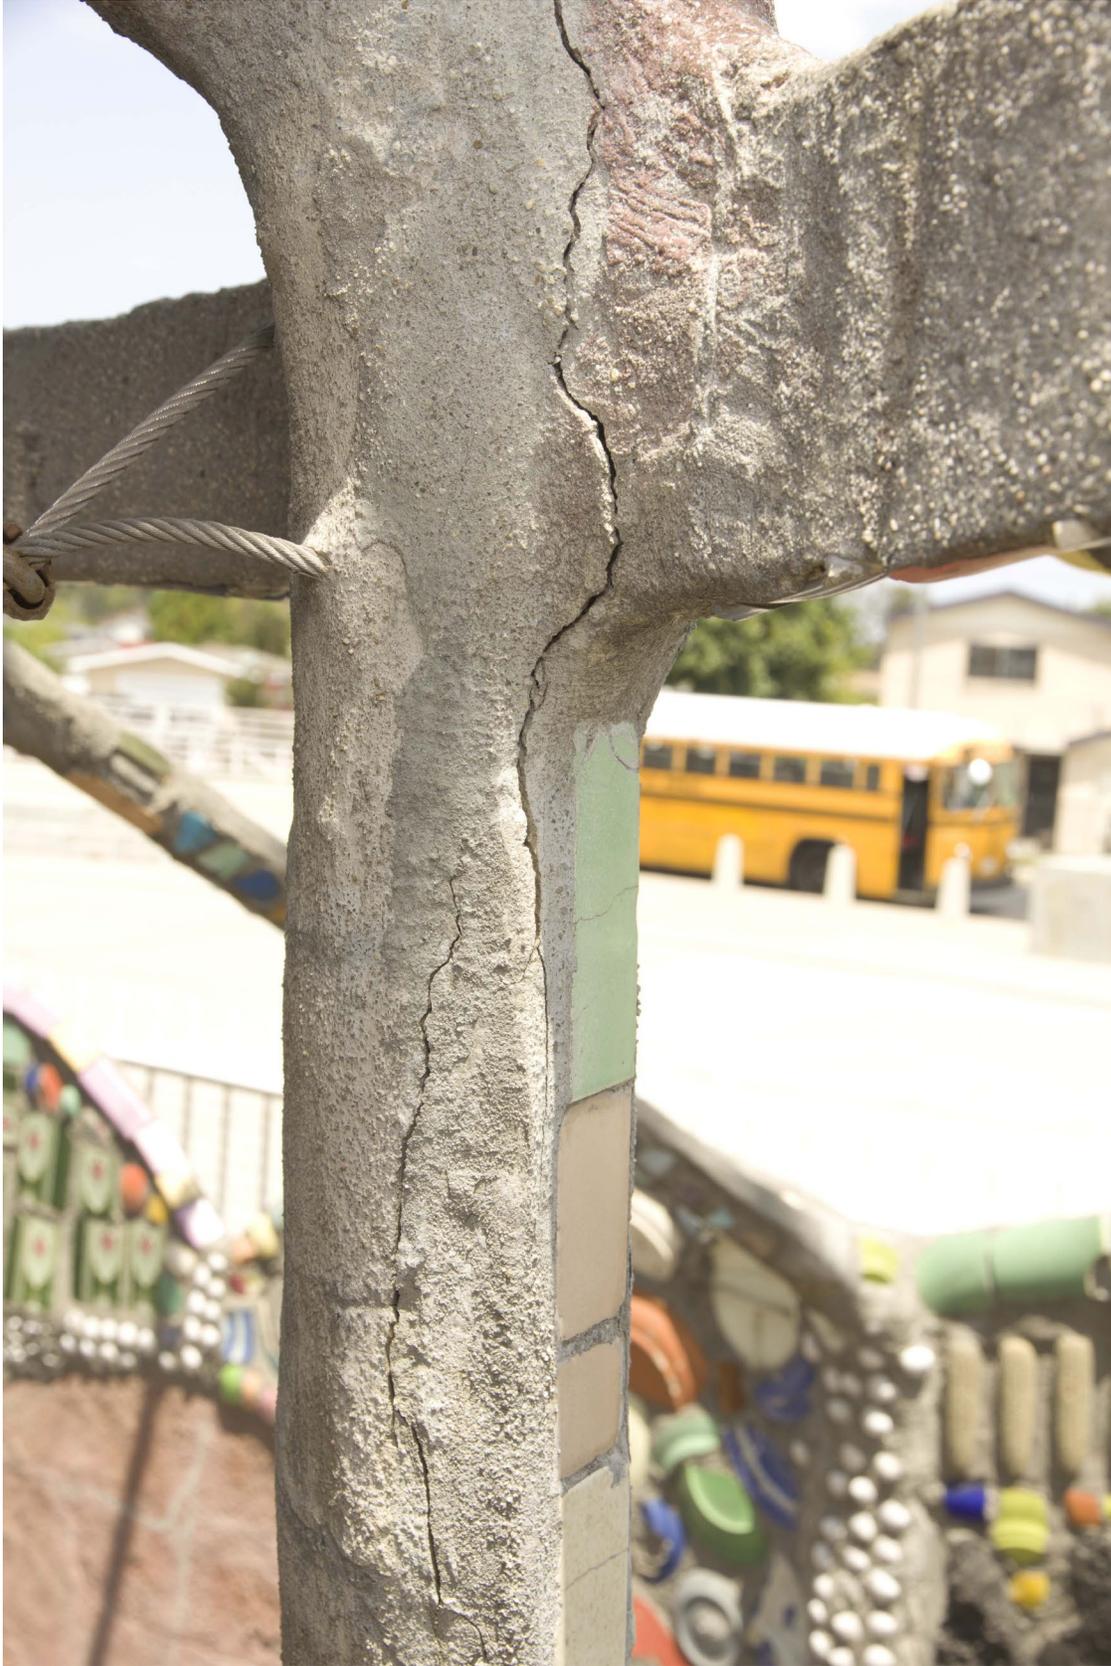
Fig. 7. Adhesive and cohesive failure of repairs (Courtesy of Blanka Kielb)

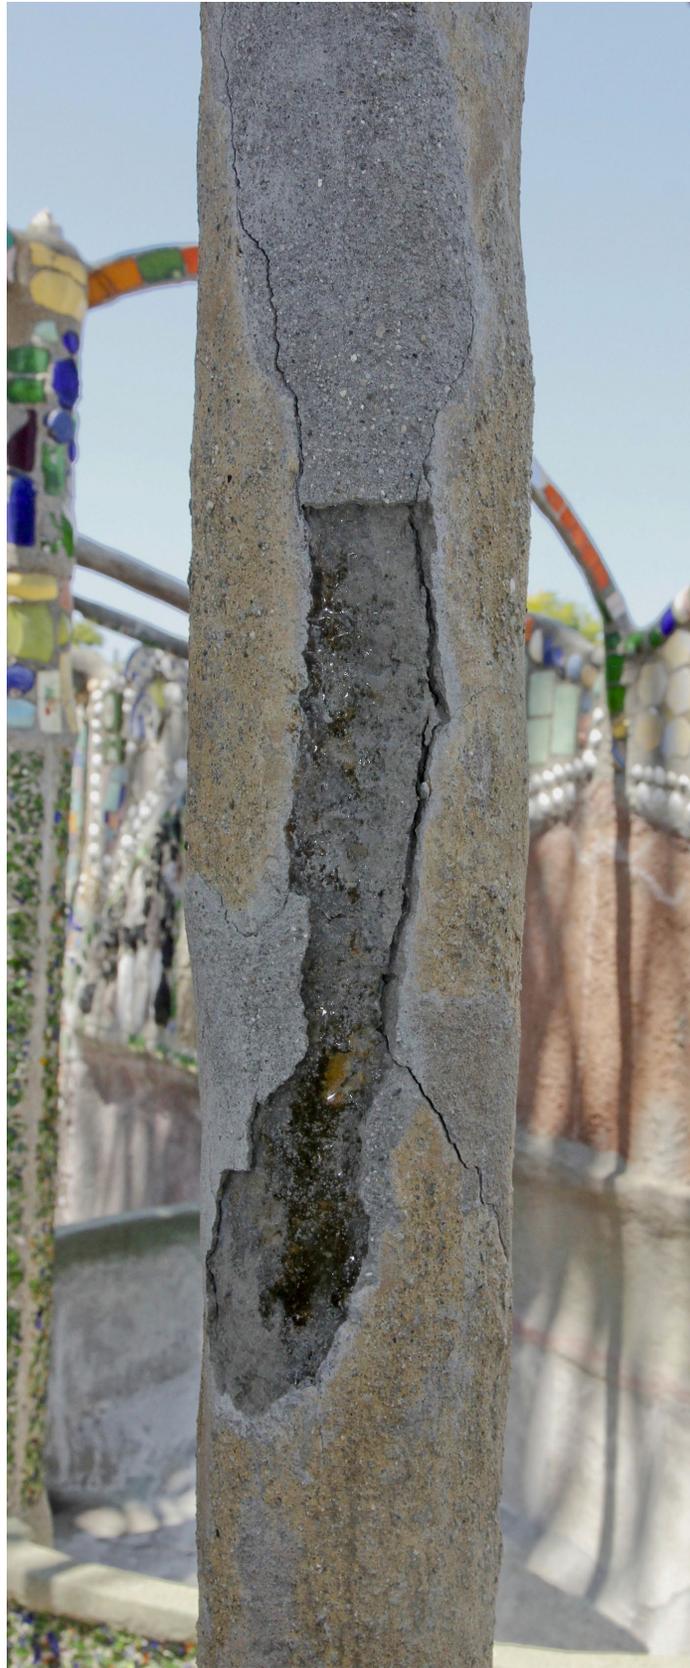
Fig. 8. Loss of cement cover over epoxy repair, adhesive failure of repair (Courtesy of Frank Preusser)

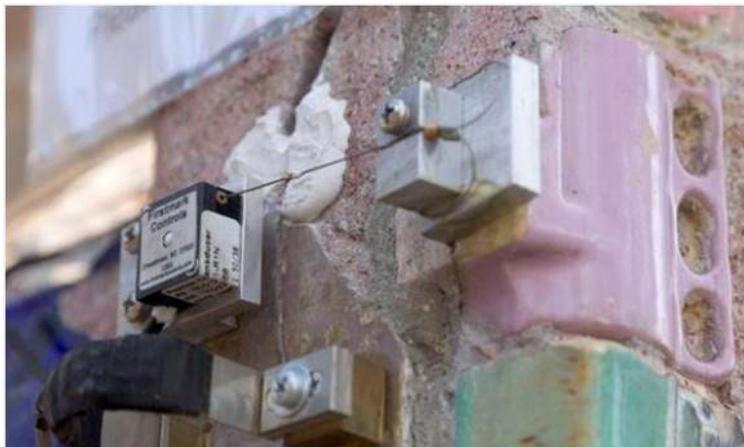
- Many of the existing cracks are moving (some plaster bridges broke within less than two weeks) (fig. 9). The cracks vary in width from less than 1 mm to 3 or 4 mm.
- Strong winds create g-forces on the Towers comparable to moderate earthquakes
- Temperature differences between the cement plaster and the decorative elements are substantial

- Electronic displacement transducers with data-loggers (fig. 9).
- Thermal imaging using a FLIR E60bx camera.

Fig. 9. Plaster bridge and two different types of displacement transducers (Courtesy of Blanka Kielb)

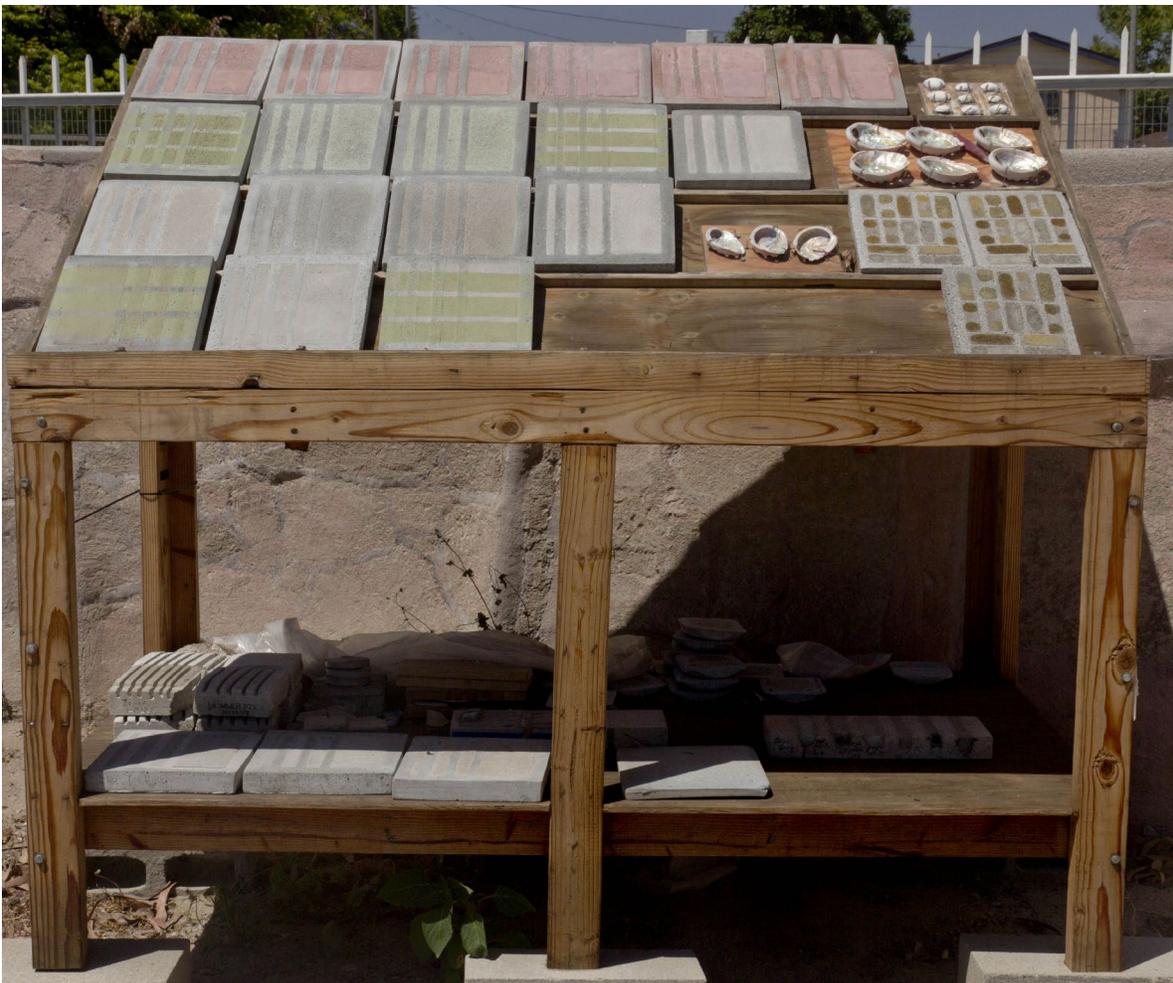
There is a great selection of ECFs, PMMs, water repellents, and architectural adhesives on the market. We made our initial selection based on published data and communication with manufacturers and colleagues. We then obtained samples which we applied to concrete plates that we cast and to commercial concrete tiles and blocks. These samples were then exposed in the laboratory to temperature and humidity cycles, and UV radiation. A similar set was exposed on-site on an exposure rack (fig. 10).

Fig. 10. Exposure rack (Courtesy of Blanka Kielb)
