Article: The rescue and conservation of the Lost Shul Mural

Authors: Richard L. Kerschner and Constance S. Silver

Source: *Objects Specialty Group Postprints, Volume Twenty-Three, 2016*

This article describes how an interdisciplinary team worked together over two years to stabilize, protect, and move a 105-year-old triptych mural from the former Chai Adam Synagogue to the Ohavi Zedek Synagogue in Burlington, Vermont. The mural is a rare surviving example of traditional Eastern European painted synagogue art following the destruction of nearly every synagogue in Eastern Europe during the Holocaust. Flaking paint was consolidated and secured to the plaster, and layers of darkened varnish and dirt were partially removed from the mural. To ensure the mural's safety during the relocation process, it was faced with Crepline adhered with Paraloid B67 followed by cyclododecane reinforced with fiberglass Micro-mesh. Foam-lined plywood panels were secured against the faced mural to provide uniform, rigid support during the move. A permanent steel framework was built around the roof section of the apse that contained the mural to minimize movement of the plaster-on-lath during extrication

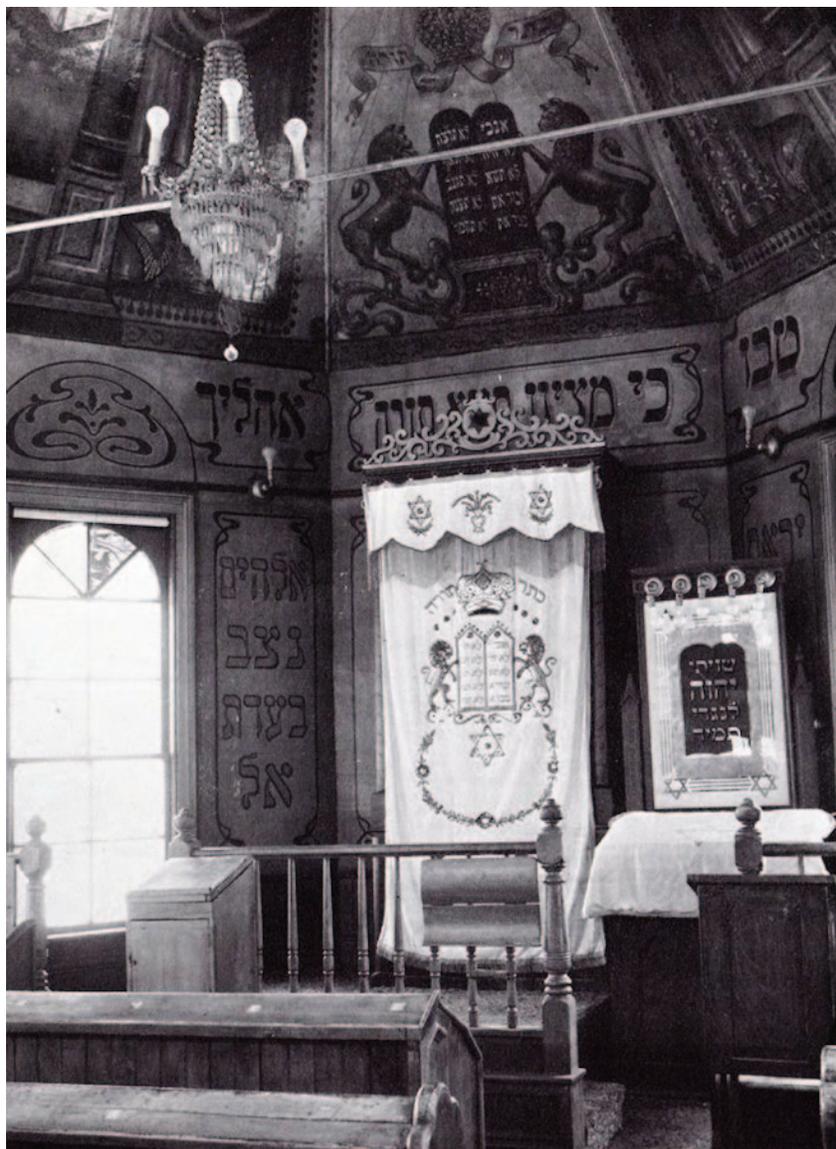
Fig. 1. Historic photo of Chai Adam interior (Courtesy of Lost Shul Mural Project)

In 1910, a young Lithuanian poet, performer, playwright, and artist named Ben Zion Joseph Black was commissioned to paint the interior of the Chai Adam Synagogue in Burlington, Vermont.¹ The only historic photo of Chai Adam's early interior shows the original painted walls and the lower half of the mural (fig. 1). The entire ceiling had also been painted as a blue open sky, complete with birds, musical instruments, and cherubs. Black worked for six months to paint the mural, walls, and ceiling of the synagogue for a fee of \$200.

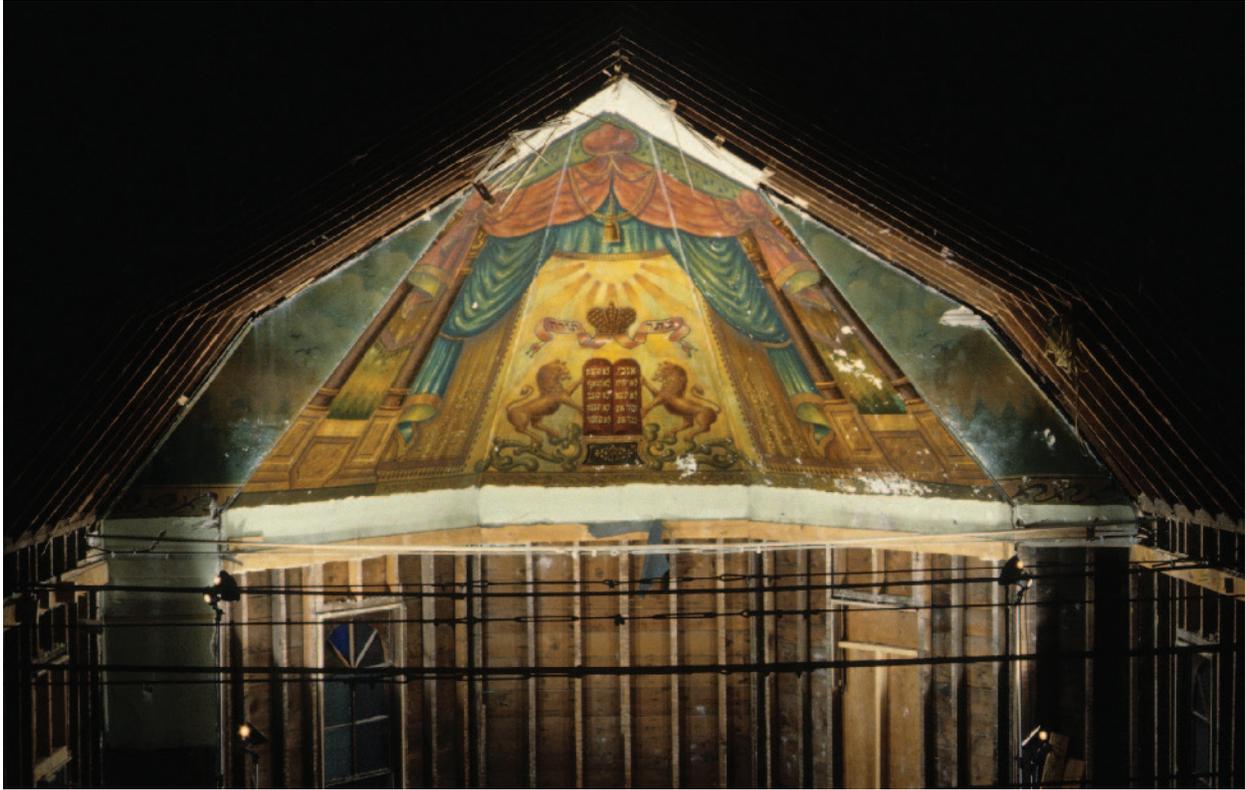
The building had been sold and was in the process of being retrofitted as apartments. The decorated walls and ceiling of the building had been gutted many years before and the owner was ready to destroy the large mural that was in her way. The floor of the upstairs apartment was already in place, allowing easy access to the mural. Goldberg was desperately seeking a plan to save the mural, possibly by arranging for its transfer to another organization that could move it to a safe but accessible location. Although the colors were muted by darkened varnish, the mural was in good structural condition with

Fig. 2. Lost Shul Mural as it appeared in 1986 before being isolated behind a wall, 335 x 640 x 275 cm (11 x 21 x 9 ft.)
(Courtesy of Lost Shul Mural Project)

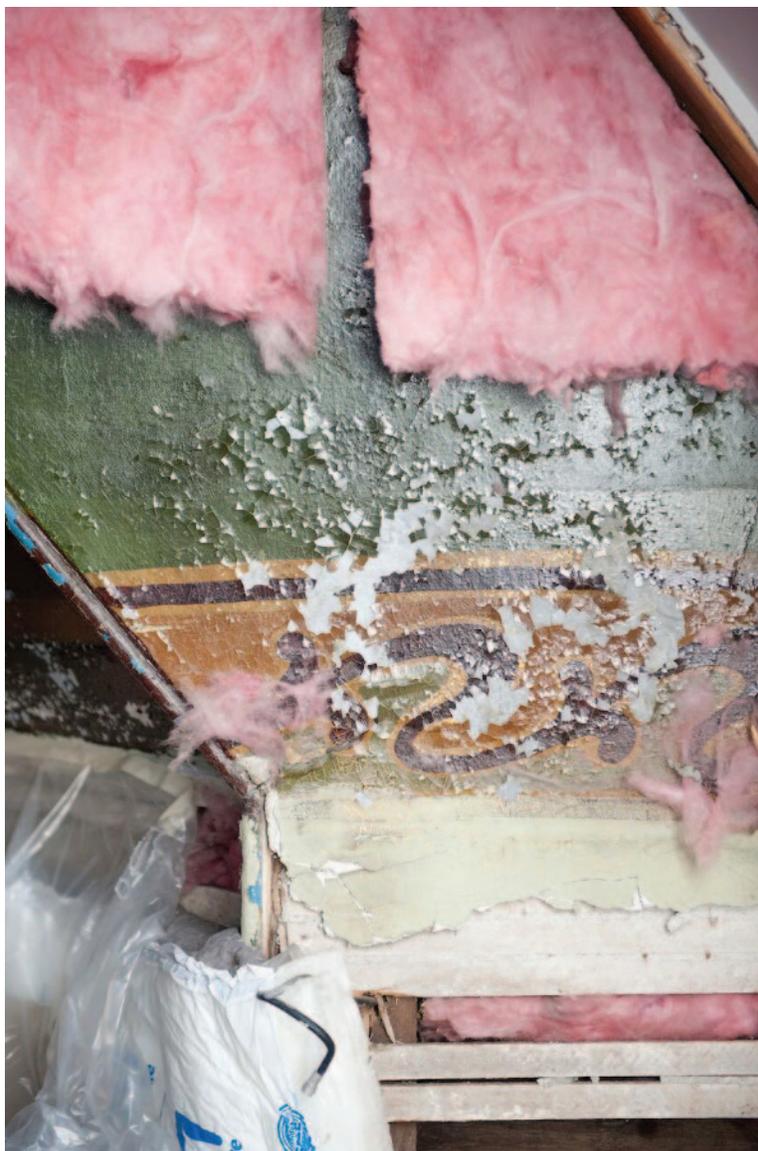
As the insulation was peeled back, it was disturbing to observe the mural's condition (fig. 3). Despite instructions given to the building owner, the mural had not been properly protected when the wall was constructed and fiberglass insulation had been placed directly against the paint in many areas. Large areas of paint were flaking from the plaster. Close comparison to 1986 photos indicated that the areas with the worst flaking had shown cracks and cupping paint even before the mural was isolated behind the wall. However, the widely ranging environmental conditions in the empty wall cavity between the slate roof and the mural aggravated flaking and caused paint to detach.

The surface of the mural had deteriorated more in the 26 years behind a "protective" wall than in the previous 76 years it was open and visible on the ceiling of the synagogue and carpet warehouse. What

Fig. 3. Condition of mural on removal of wall and insulation (Courtesy of Lost Shul Mural Project)

had been estimated as about four square feet of paint loss of the 155-square-foot painting in 1986 had increased to about 15 square feet of loss, with paint actively flaking over the entire mural. Fortunately, 90 percent of the painted mural had survived and could be saved if the flaking could be consolidated.

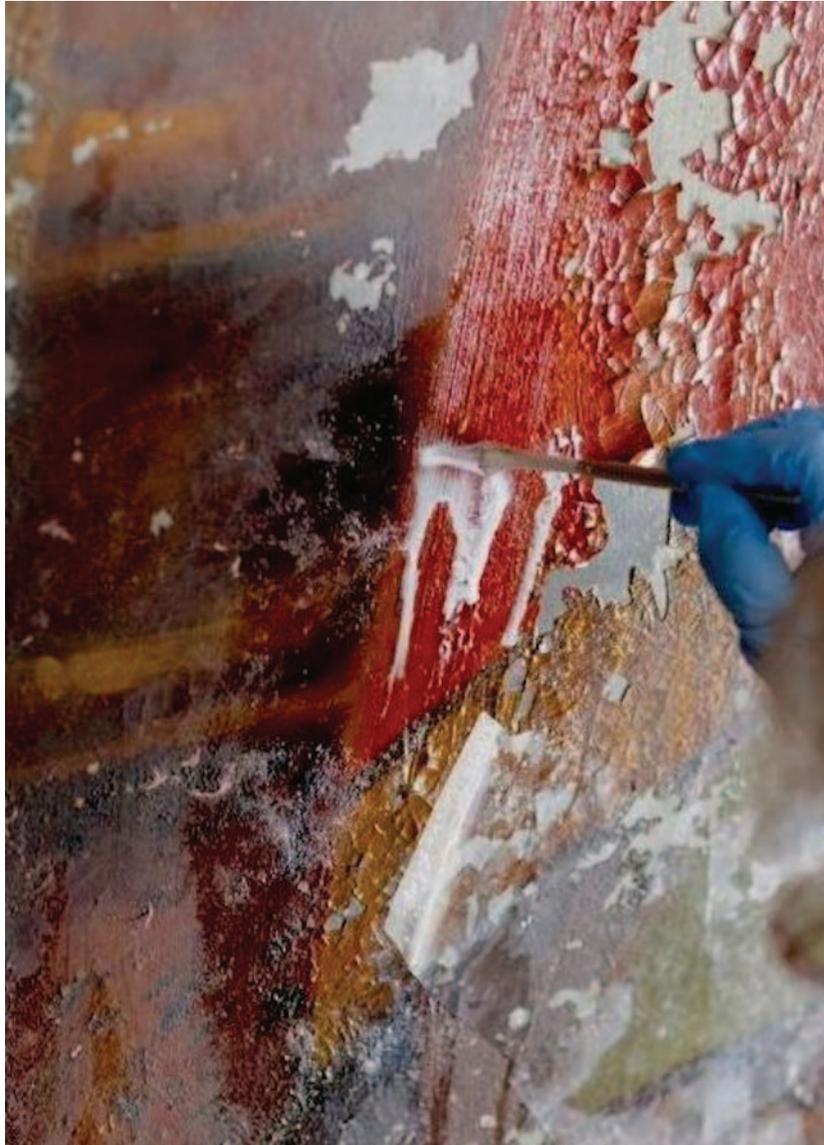
Fig. 4. Applying BEVA D8 to areas of flaking paint (Courtesy of Constance Silver)

mural in similar condition. The chosen consolidant was BEVA D8, an aqueous, non-ionic dispersion of ethylene vinyl acetate diluted 50 percent with distilled water.

The area to be consolidated was misted with distilled water with a drop of Woolite added as a surfactant. The misting wet all the surfaces of the deformed paint, and the wetting of the substrate relaxed the detached and curled paint and eased it back into contact with the plaster through capillary action. BEVA D8 was flowed onto the fragile, wetted surface from an eyedropper or soft brush (fig. 4).

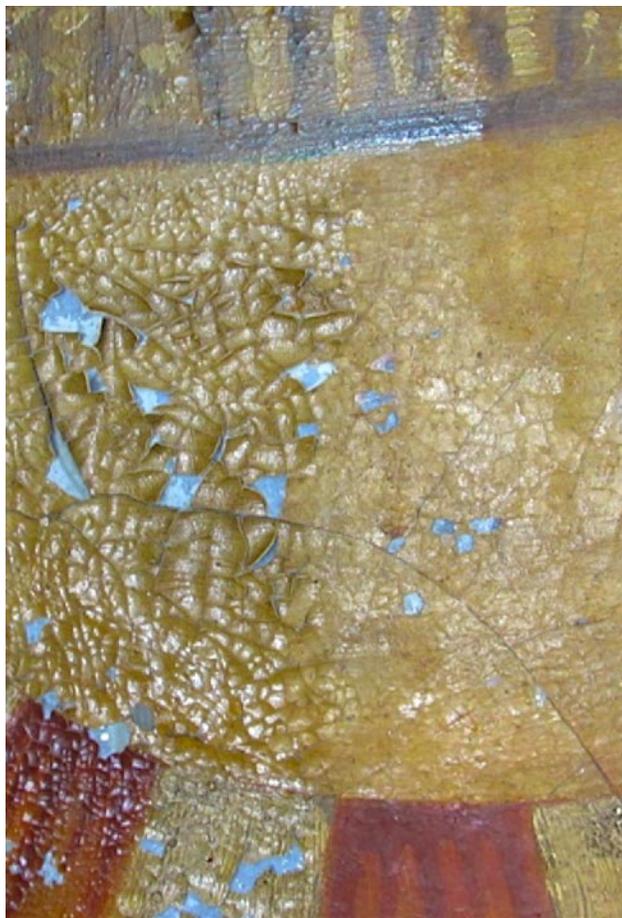
The consolidant followed the path of the wetting agent, penetrating behind each flake. The treated area was allowed to dry slightly. Curled and flaking paint was then gently pressed back into plane using a baby wipe. The soft baby wipe allowed manipulation of the paint without it sticking to the fabric and also absorbed excess BEVA D8. This was an important step, required to avoid “gluing” grime and discolored varnish to the surface of the painting, which would complicate their eventual removal. Firm pressure was applied to the treated area with a flexible rubber bone folder through silicone-release Mylar to coax flakes flat and confirm the bond between the paint and the plaster. The treated area was further

Fig. 5. Detail of the partially consolidated sun (Courtesy of Constance Silver)

pressed into plane and heat-set with a tacking iron. A small travel iron was used to confirm adhesion to the plaster of larger contiguous areas of treated paint. Consolidation proceeded slowly in small areas from the bottom of each panel to the top (fig. 5).

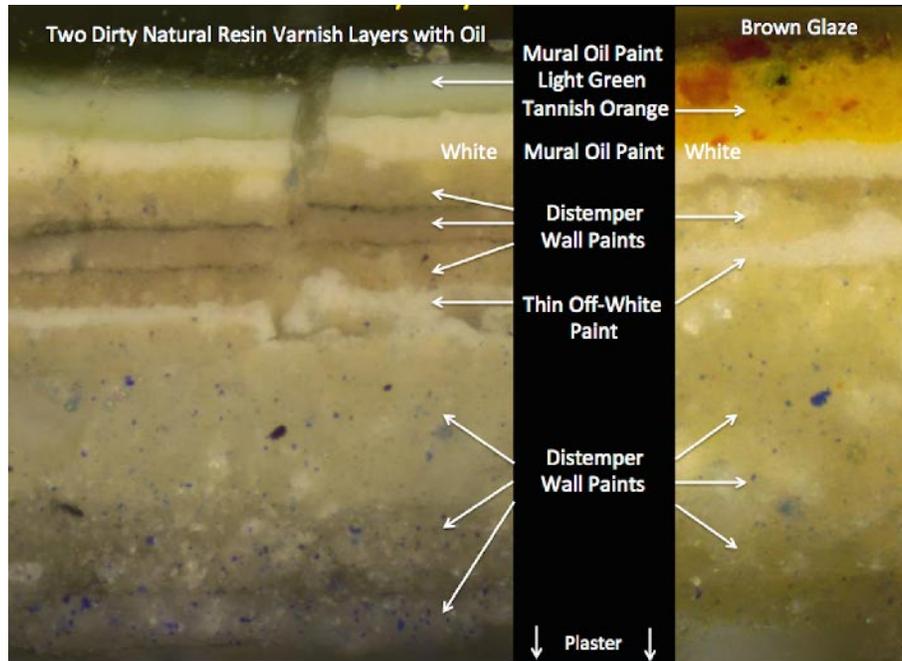
Paint samples were extracted and submitted to conservator Susan Buck for cross section analysis to guide the complicated cleaning process and to identify glazes and over-paint (fig. 6). These two cross sections identified paint stratigraphy as three to four layers of early distemper wall paint directly on top of the plaster, followed by a thin coat of off-white paint and three more coats of a tan distemper paint. The mural oil paint consists of a white base coat followed by design colors, then two layers of varnish. Occasionally, glazes were used to enrich the colors, and the right sample shows a brown glaze directly on top of the orange paint. A total of 18 paint samples were analyzed.

Fig. 6. Two cross sections of mural paint layers (Courtesy of Susan Buck)

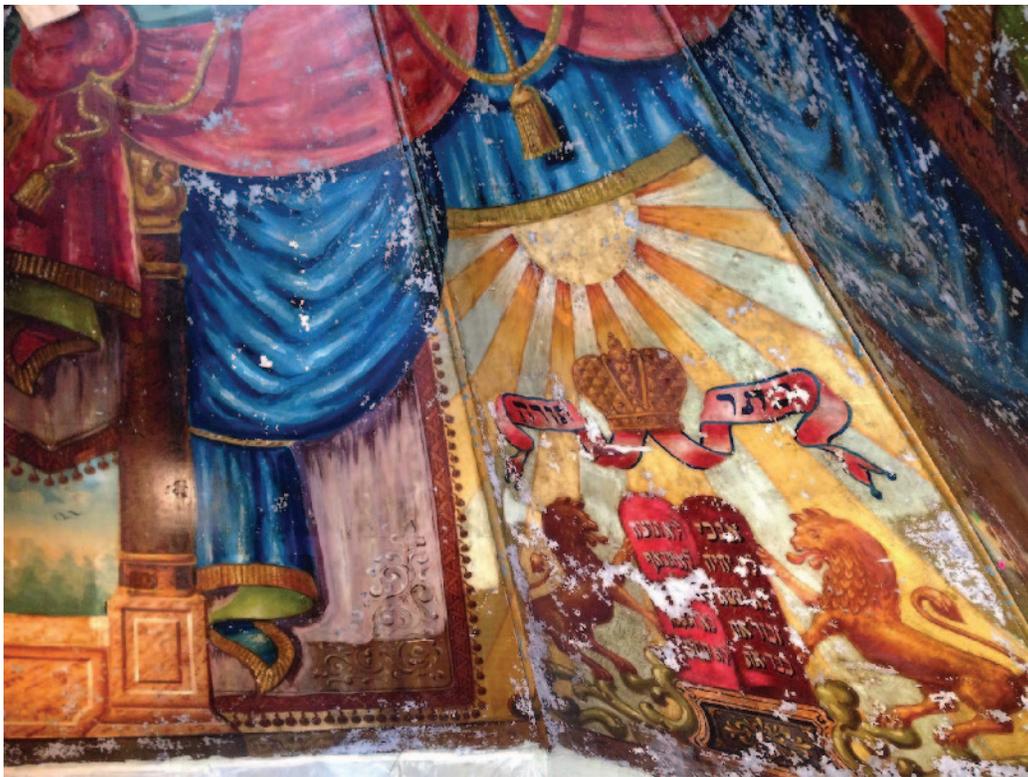
Early cleaning tests revealed several technical issues. A layer of coal soot strongly adhered to the paint by the oil-laden varnish was the most complex cleaning problem. Black, brown, and many red paint areas were sensitive to cleaning agents, as were the brown columns and pediments because they contain multiple layers of thin glazes. All of these areas required slow and careful cleaning. Cleaning tests indicated that the varnish layers were soluble in xylene, isopropanol, and benzyl alcohol or various combinations thereof. Dirt and old varnish were removed by applying a benzyl alcohol-based solvent gel through wet-strength tissue. After the tissue was removed, dissolved varnish and soot were gently dislodged with a brush and cleared from the surface using cotton. Dwell time of the solvent-laden wet-strength tissue varied depending on the thickness of the varnish and the sensitivity of the underlying paint colors and glazes. Consolidation was completed and about 50 percent of the darkened varnish was

removed before the mural was moved (fig. 7). Cleaning was not completed at that time since funds were still being raised to cover the cost of conserving and moving the mural. Cleaned “windows” created by removing discolored and dirty varnish layers helped fuel fundraising efforts as they were tantalizing clues to the vibrant colors hidden beneath the soot and darkened varnishes.

Fig. 7. Consolidated and partially cleaned mural prior to move (Courtesy of Lost Shul Mural Project)

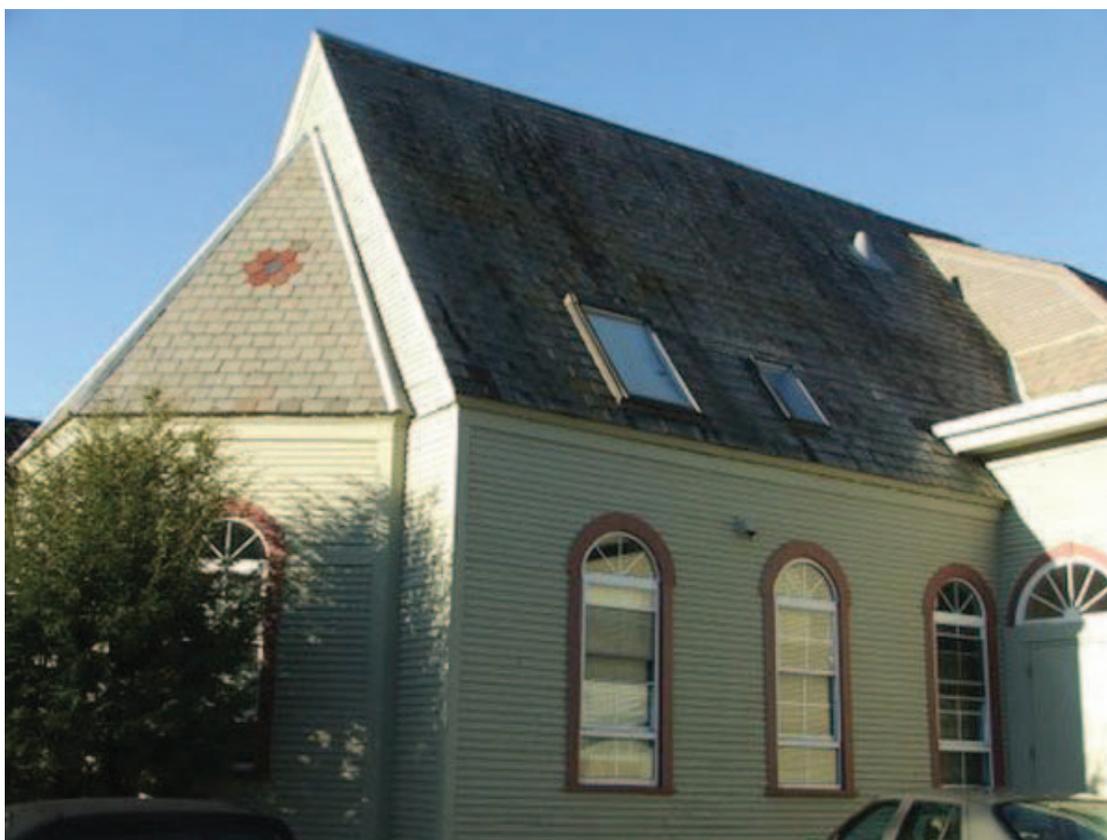
The mural had been painted on the plaster-on-lath ceiling attached to the inside of the rafters that supported the slate roof on the apse of the Chai Adam Synagogue (fig. 8). The two-story protective structure built to enclose the apse of the building (fig. 9) was completed well before one of the coldest and snowiest winters on record. Windows were included in the structure to allow light into the first-floor apartment, and sliding doors on the second floor provided access to load in steel for the framework and other materials. A propane heater was installed on the second floor of the structure to temper environmental conditions in the portion of the building that surrounded the mural.

Fig. 8. The apse of the former Chai Adam Synagogue (Courtesy of Lost Shul Mural Project and Bob Neeld, PE)

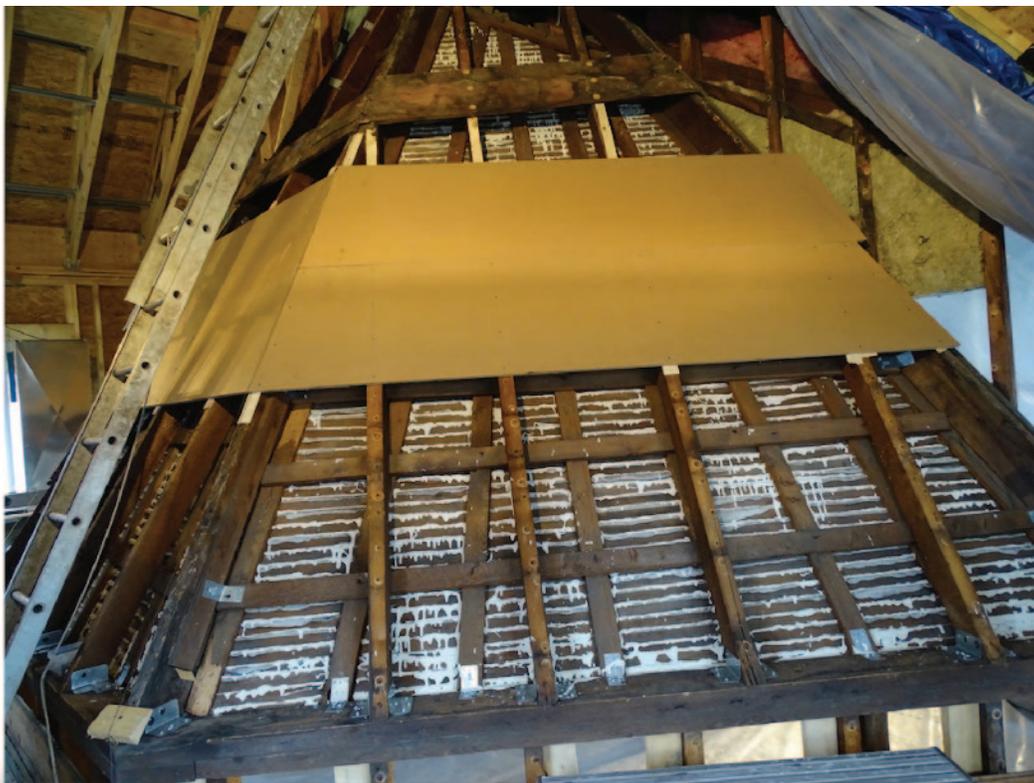
During September, the slates and wood sheathing boards were removed to access the back of the laths that supported the plaster ceiling on which the mural was painted.⁹ The slates were numbered and stored for replacement on the new roof. Great care was taken to cut rather than pull nails so as not to move the rafters and risk breaking the fragile plaster “keys.” As the original sheathing boards were removed, the roof structure was strengthened and made more rigid by reinforcing all the rafter attachments with steel angle brackets.

Attention turned to further evaluation of the plaster substrate and the plaster keys. The historic method of applying plaster to a ceiling or wall was to first nail wooden laths to wall and ceiling joists, allowing spaces of approximately three-eighths of an inch between the laths. Keys are formed when wet plaster fills the spaces between the wooden laths and curls around the back edges of the laths before the plaster sets. Once set, these plaster keys secure the plaster to the laths. If the plaster is weak, the keys can break and the plaster can separate from the wall. Preservation scientist Norman Weiss and conservator Irving Slavid of Monument Conservation Collaborative Materials, Inc., were contracted to analyze the plaster, develop methods to strengthen the plaster keys, and perform the work. Their analysis of samples indicated that the plaster was sandy and quite weak. They recommended strengthening the keys from the back with three applications of Conservare HTC (hydroxylating conversion treatment). After visiting the site and observing the lath and plaster from the back, Weiss also recommended extending the keys over the back of the laths using VoidSpan CG70 Fine Grout (fig. 10). After the keys were strengthened and extended, half-inch MDO plywood was chosen to replace the old sheathing boards to better stabilize the entire structure. Marvelseal 360 was ironed onto the plywood and edges were sealed with aluminum tape to slow humidity changes within the roof/wall structure.

Fig. 10. Reverse of the mural showing plaster keys from the back and the newly created key extensions, metal reinforcing brackets, and new plywood roof sheathing (Courtesy of Bob Neeld, PE)

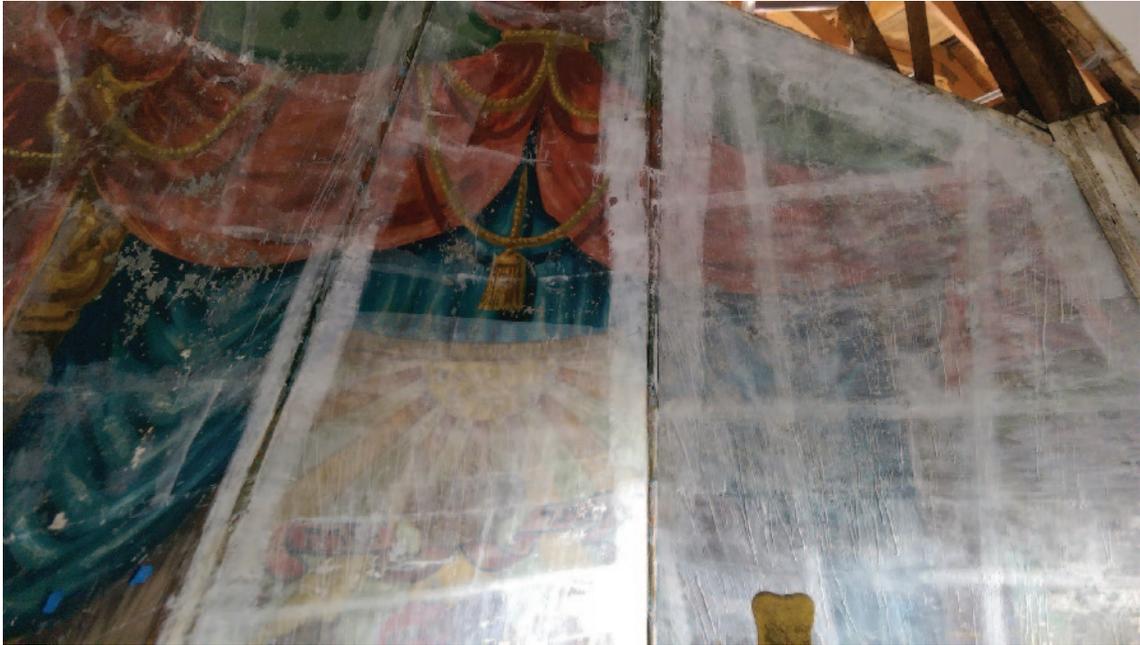
Facings were applied to the front of the mural to protect and secure the paint and plaster during the move. First, the paint was faced with Crepeline adhered with Paraloid B67. However, a stronger facing was required to hold the plaster together in the event that the mural was jarred during movement. A lightly self-adhering fiberglass micro-mesh, designed for repairing drywall, was applied over the Crepeline facing and covered with cyclododecane, a wax-like material that melts at 142°F. (Rowe and Rozeik 2008) The solid cyclododecane was heated in a double boiler and applied as a liquid with large paintbrushes to a thickness of about one-eighth of an inch (fig. 11). Not only is cyclododecane a very

strong adhesive; it sublimates on exposure to air, changing directly from a solid to a gas and simply disappearing over time without the use of solvents or mechanical manipulation.

Fig. 11. The left side of the mural is faced with Crepeline. The right side has cyclododecane applied over fiberglass Micro-mesh on top of the Crepeline facing (Courtesy of Bob Neeld, PE)

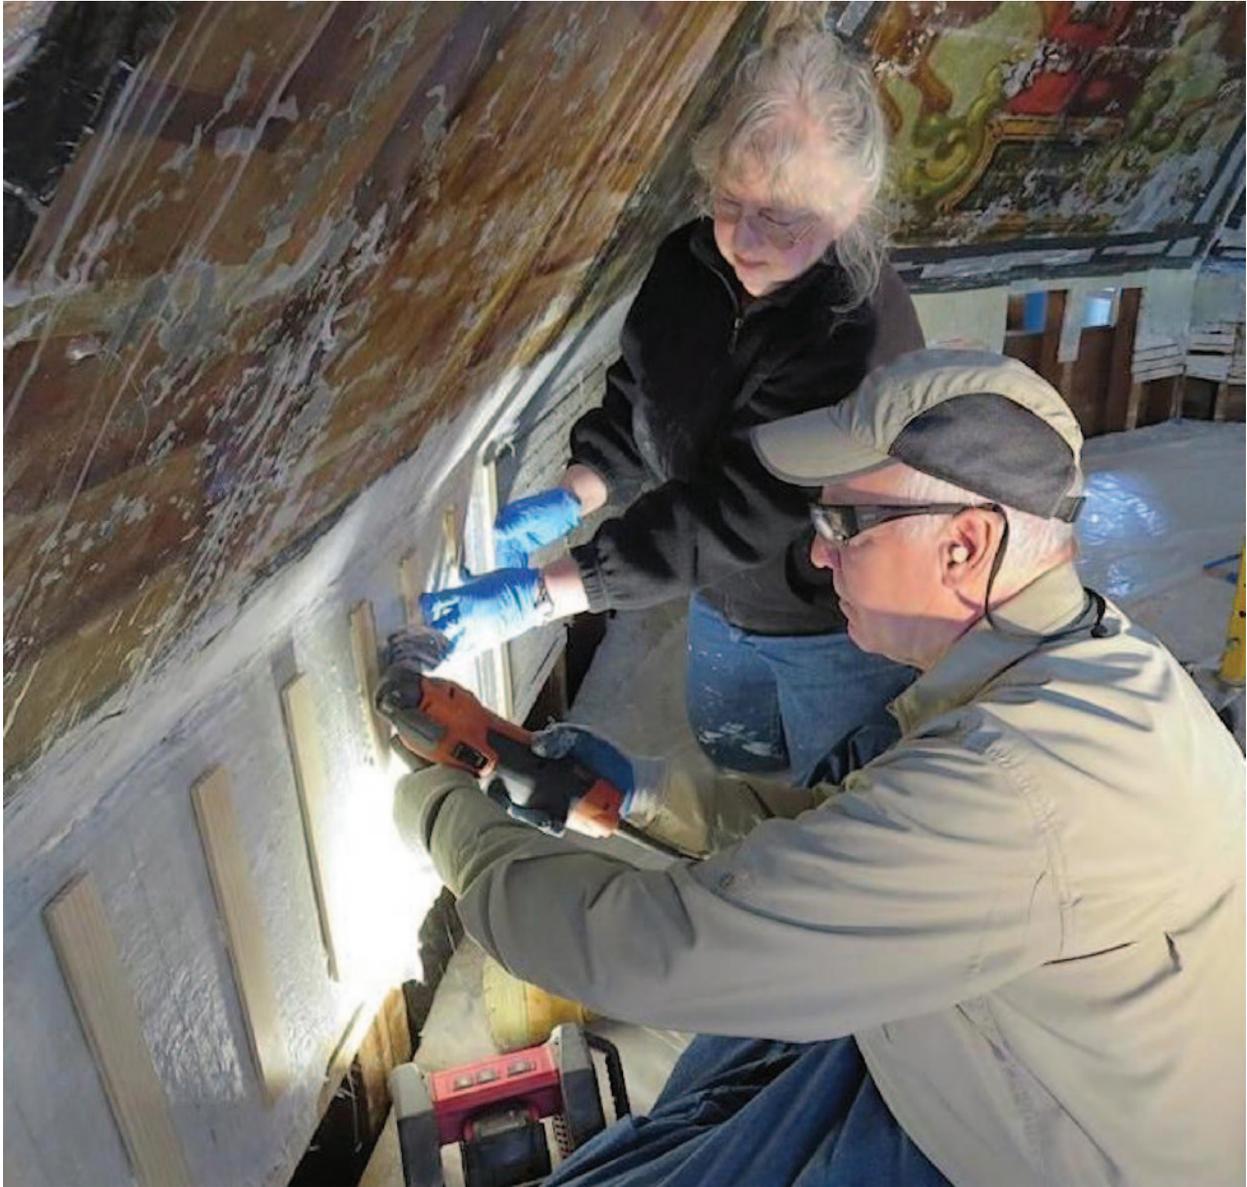
Eighteen inches of plaster bordering the bottom of the mural and two 6-inch-wide vertical strips of plaster bordering the left and right sides of the mural had to be removed so that the three large adjoined triangular sections of the mural could be separated from the rest of the building (fig. 2). In preparation for detachment, a double facing of Crepeline and cyclododecane over fiberglass mesh was applied to the front of the plaster and reinforced with short pieces of wood lath (fig. 12). Master carpenter Ray O'Connor worked with conservator Silver to remove the plaster borders. A hacksaw blade was inserted behind the plaster and used to cut through the plaster keys, freeing the half-inch layer of the faced painted plaster from the lath. After these sections of plaster were removed, it was possible to detach the exposed laths without damaging the plaster at the perimeter of the mural. Removing the laths revealed the apse roof rafters where they joined the end wall of the building and the apse wall joists where they met the base of the roof. It was then possible to saw through the nails connecting the roof rafters and wall joists to the rest of the building and completely separate the apse roof that contained the mural from the structure.

Fig. 12. Removal of painted plaster borders from lath (Courtesy of Lost Shul Mural Project)

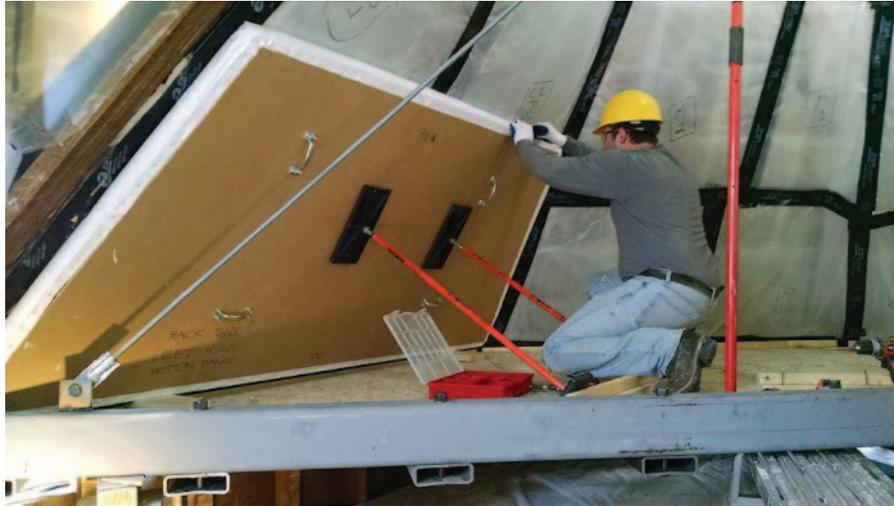
As the framework was being constructed, polyethylene sheet was secured over the mural to prevent the cyclododecane from subliming too quickly, and to provide a barrier between the mural and the foam pads that would protect and secure the plaster during the move. The beam across the front of the mural was required to stabilize the framework during the move and to support a floor in front of the mural to facilitate bracing of the foam pads (fig. 13).

Foam padded panels were built to secure the plaster substrate in place in case sudden jolts broke plaster keys during the move. They were constructed of MDO plywood covered with 1.5-inch urethane open-cell foam wrapped with Tyvek. The panels were pressed firmly against the mural and temporarily braced while a wooden frame was built to secure them in place. The wooden frame allowed pressure to be applied evenly to compress the foam against the plaster. The panels were hinged so that they could be carefully tilted back from the top down to check for loose plaster after the move.

Fig. 13. Plywood and foam pad being positioned on the front of the mural over top of a polyethylene protective covering (Courtesy of Lost Shul Mural Project)

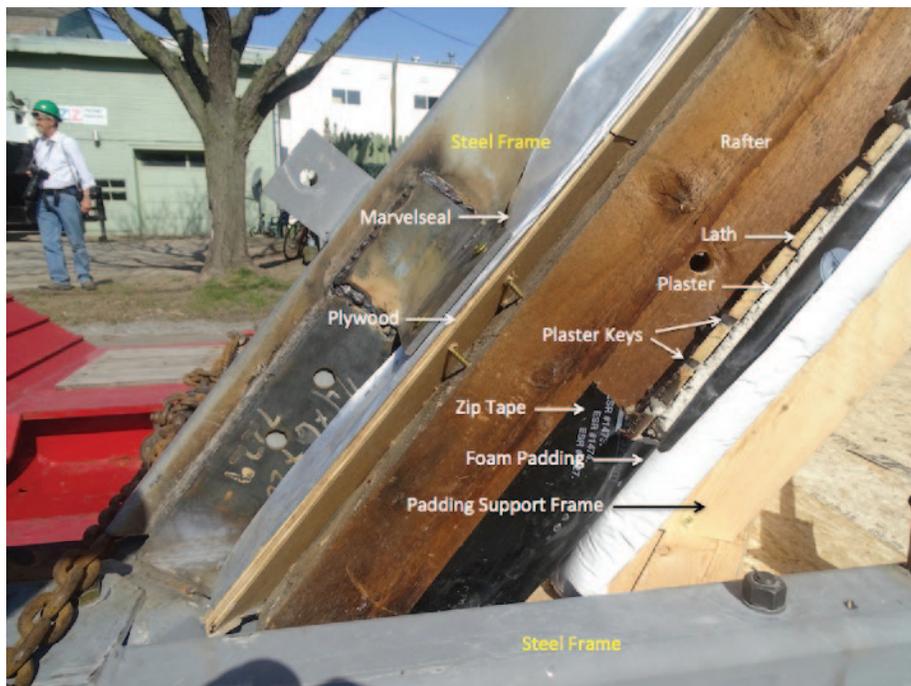
A cross-section of the mural assembly after detachment from the building is shown in figure 14. The steel frame is labeled in yellow. Marvelseal covers the back of the plywood roof sheathing to mitigate

humidity changes within the roof cavity. The ends of the laths nailed to the front of the rafters are visible. The layer of plaster on which the mural is painted covers the laths, and it is possible to view the keys that were formed when the wet plaster was forced into the spaces between the laths. Black ZIP Tape covers and seals the edge of the plaster and lath. The foam padding is pressed and secured against the face of the mural by the wooden frame.

Fig. 14. Cross-section of roof structure and mural (Courtesy of Bob Neeld, PE)

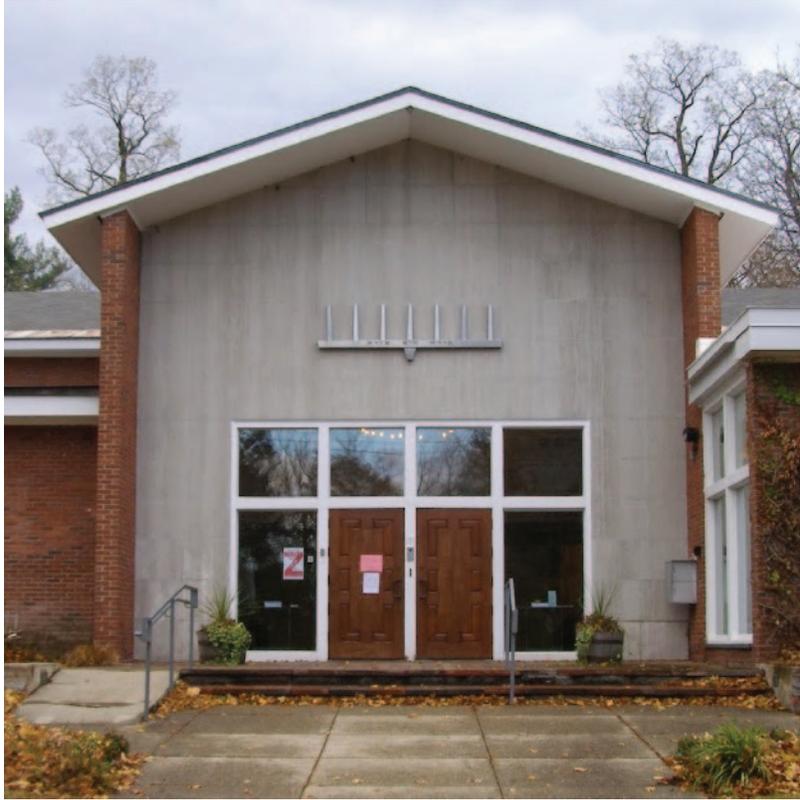
Fig. 15. Entrance to Ohavi Zedek, the new home for the Lost Shul Mural (Courtesy of Lost Shul Mural Project)

While the mural was being prepared to move, the lobby of the Ohavi Zedek Synagogue was being prepared to receive it. The synagogue was built in 1952 and is an exemplar mid-century modern design. Although not designed to house the mural, the lobby is a perfect height and width. A steel-beam superstructure was fabricated and installed in the lobby to support the suspended three-ton mural assembly. A sturdy platform was built in front of the entrance to receive the mural and the glass wall had to be removed for the mural to enter the lobby, and then be rebuilt (fig. 15).

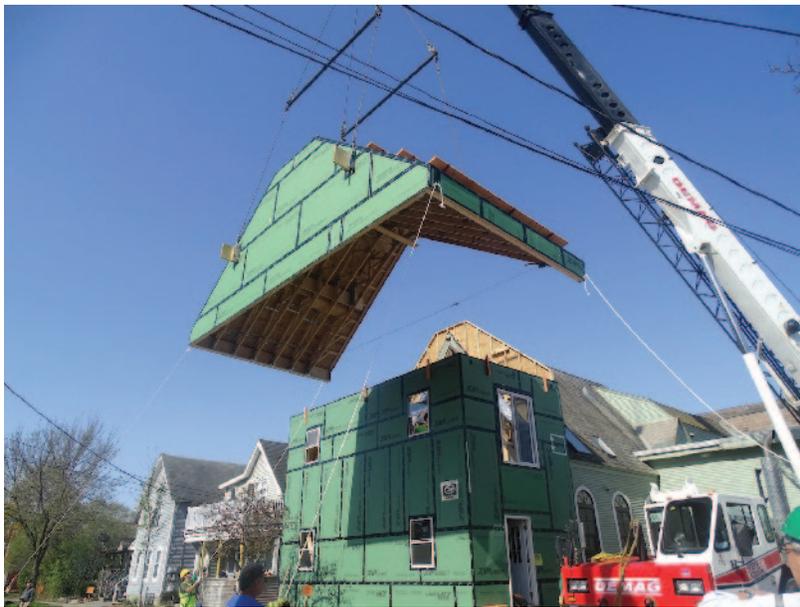
After nine months of preparation, move day (May 6, 2015) dawned bright, warm, and sunny. The first action was to remove the roof to provide access to the mural. A crane lifted the roof and lowered it to the ground, where it was settled on rollers and pushed down the street and out of the way (fig. 16). Lifting straps and chains were attached to lifting points on the steel framework that surrounded the mural. The entire apse roof section had been jacked up a few inches the day before to insure that it was detached from the building. Once the steel-enclosed apse roof was completely supported by the crane, it separated easily from the building.

Fig. 16. Crane removing roof (Courtesy of Lost Shul Mural Project)

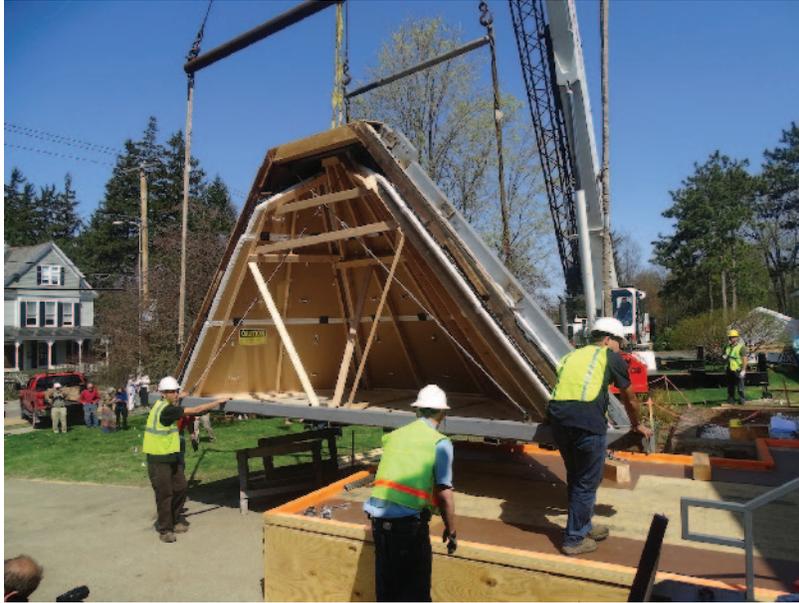
Fig. 17. Mural being moved to platform (Courtesy of Bob Neeld, PE)

The crane lifted the mural from the truck and moved it to a custom-built platform (fig. 17). Several methods of moving the mural from the truck into the building had been discussed including using forklifts to lift the mural, drive it into the lobby and raise it into position. After much discussion, all agreed that the safest method was to attach temporary wheels to the bottom of the steel support structure, then use manpower to roll the 7,500-pound structure into the lobby and carefully maneuver it into position. The mural rolled into the opening with 1 inch of clearance at the top (fig. 18).

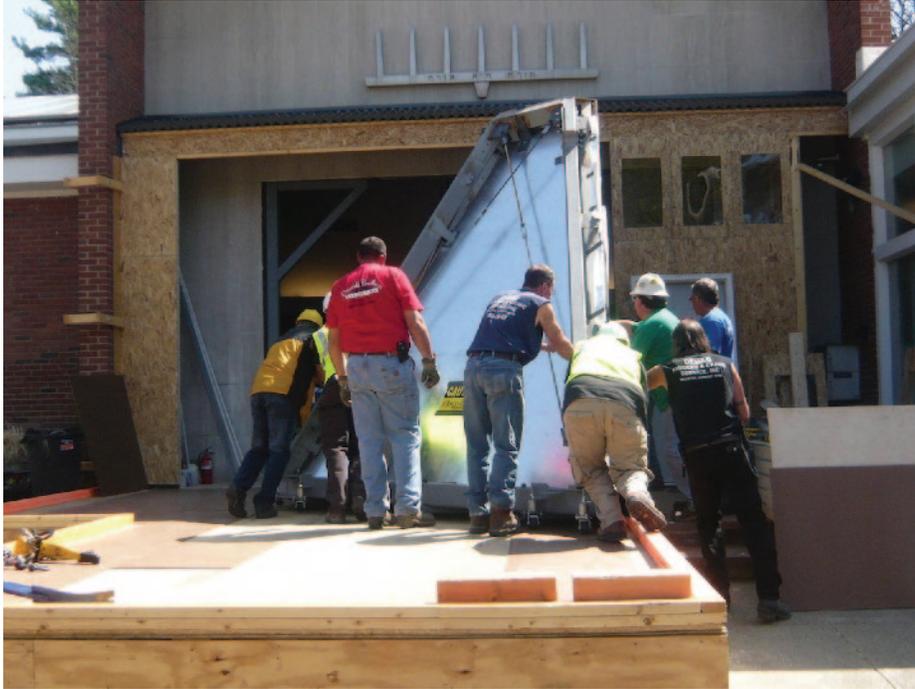
Fig. 18. Mural being rolled into the building (Courtesy of Bob Neeld, PE)

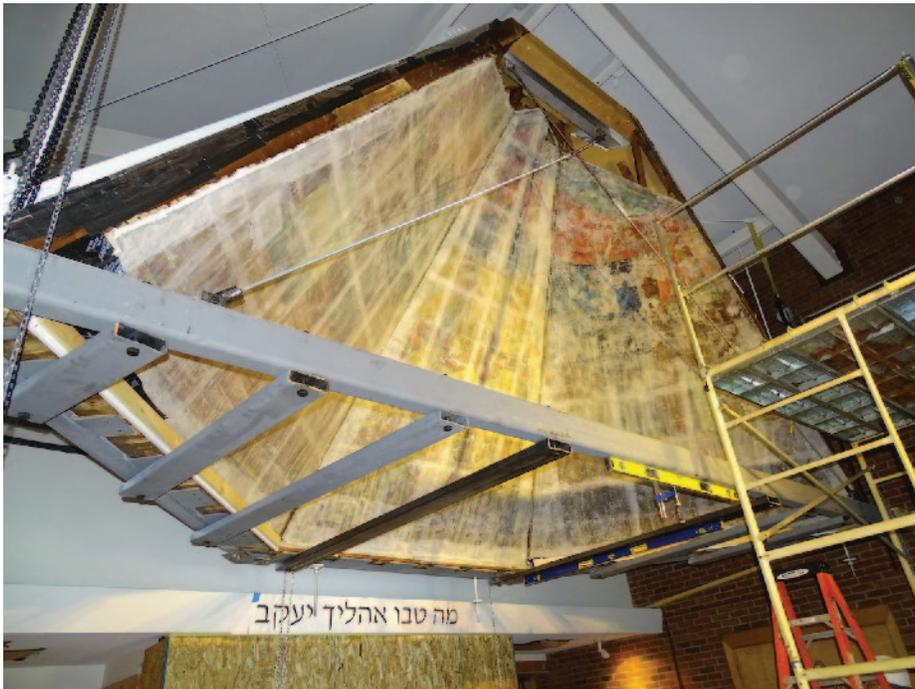
A week later, four chain lifts were suspended from the steel support beams and the steel framework containing the mural was lifted to its permanent viewing height of 11 feet, the same height from which it was last viewed by men praying in the Chai Adam Synagogue in 1939. The mural was suspended from five 3/4-inch diameter steel rods, each of which alone could support the 6,500-pound weight of the mural. The foam pads were carefully removed and there was no evidence of any loosening or detachment

of the plaster substrate. The plywood floor was removed and the front stiffening beam and floor steel supports were unbolted from the rest of the structure (fig. 19).

Fig. 19. Mural lifted to viewing height and steel floor support being removed (Courtesy of Bob Neeld, PE)

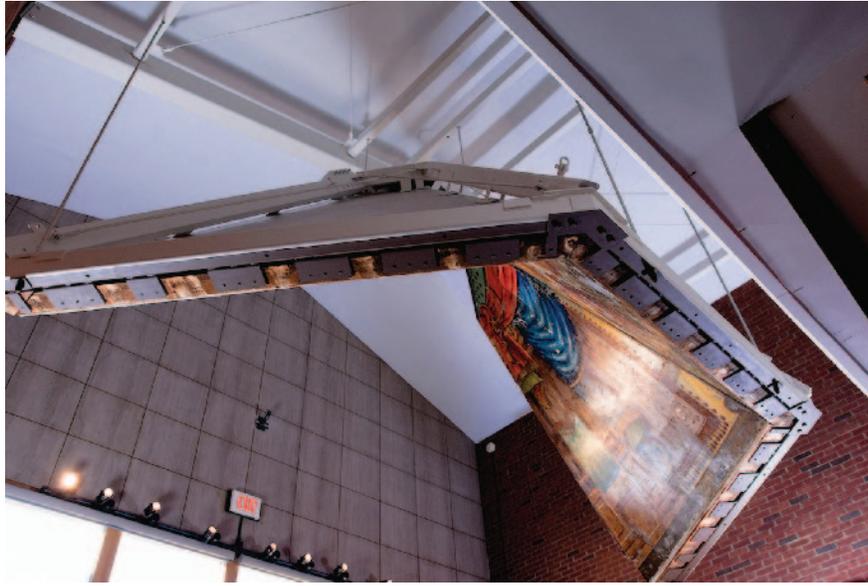
The conservators had predicted that the cyclododecane would sublime in about three months, so the grand unveiling was planned for early August. Figure 20 shows the back of the mural assembly, the

Fig. 20. Mural suspended at viewing height in final configuration (Courtesy of Bob Neeld, PE)

steel framework and suspending rods. Lighting Services Inc. LumeLEX 2024 dedicated LED track lights are visible on the west wall, as are Hunter Douglas designer screen shades that block 90% of the western light when lowered in the late afternoon (fig. 20). As the temperature at the height of the mural was about 15°F warmer than at occupant level, a destratification fan was mounted at the ceiling peak to ensure even mixing of the air. Real-time temperature and humidity readings from sensors mounted high and low on the wall are transmitted to the Internet by a Hobo RX3000 Remote Monitoring Station. These data are used to optimize the speed of the fan for effective mixing and low noise. A PEM2 data logger and eClimateNotebook are also used to monitor environmental conditions.

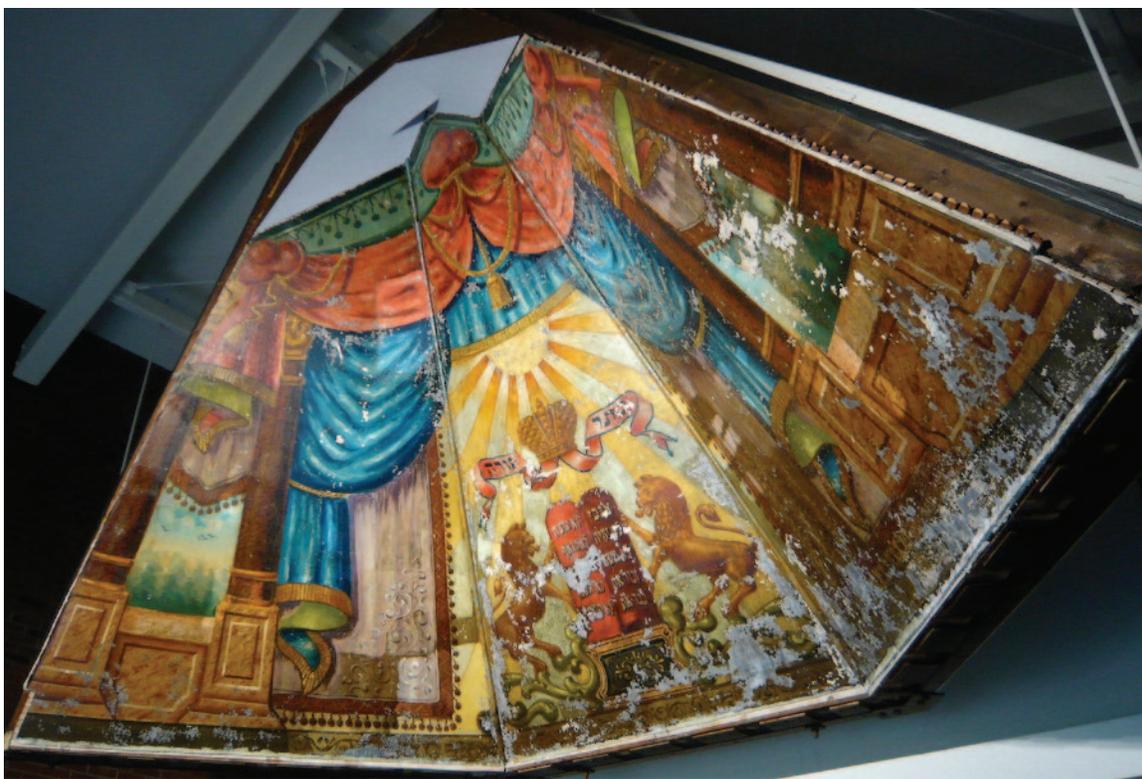
The two-year rescue of the mural is complete. The mural assembly supported by its metal framework is safely suspended in its permanent exhibition space (fig. 21). The new owners of the Lost Shul Mural are pleased with the suspended presentation of the mural and do not intend to further integrate the century-old mural assembly into the mid-century building lobby. Decisions are still being

Fig. 21. Lost Shul Mural, final configuration in lobby of Ohavi Zedek Synagogue, May 2016 (Courtesy Richard Kerschner)
