Source: *Objects Specialty Group Postprints, Volume Twenty-Three, 2016*

RED FLAMES, SILVER LININGS

MIMI LEVEQUE AND ERIC WOLIN

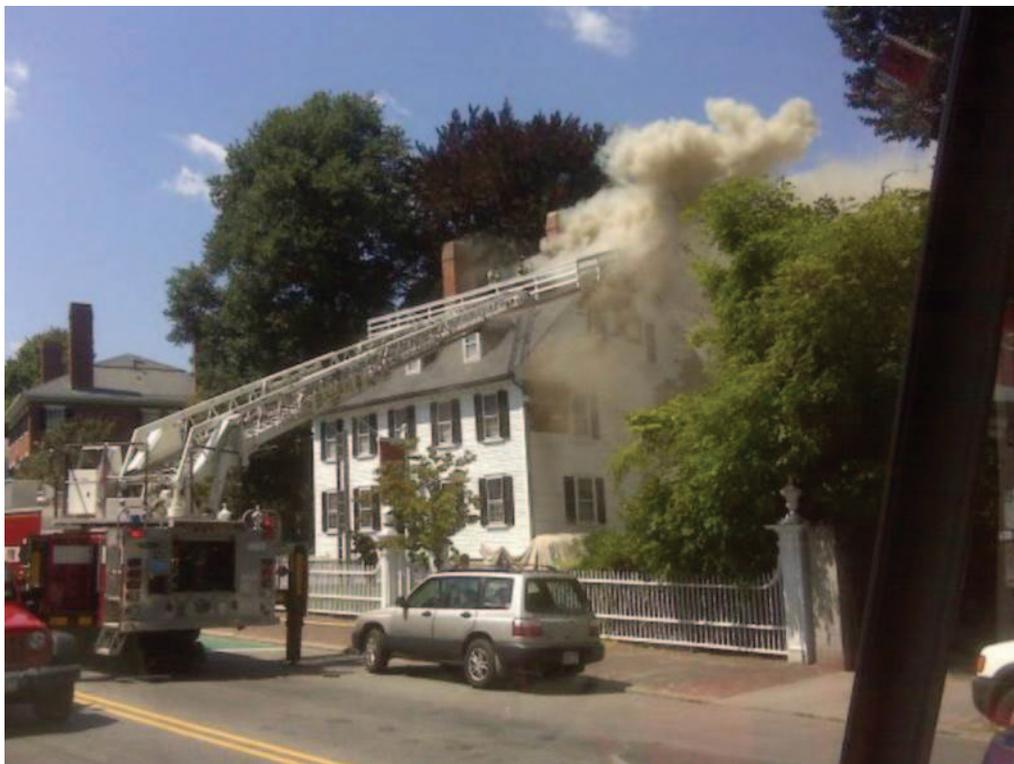
Fig. 2. Fire department responding to the fire (Courtesy of Frank Cutietta)

Around noon, during the painters' lunch break, a member of the museum's security staff arrived at Ropes to open and inspect the house prior to a scheduled tour at 1 p.m. As the guard initiated his protocols, the fire alarm sounded. The alarm, linked to the museum's security operations center, triggered an immediate call to the Salem Fire Department. Within minutes, a dispatched unit arrived at Ropes (fig. 2). Owing to the close relationship that PEM has established with Salem first responders, fostered by the Salem chapter of the Coordinated Statewide Emergency Preparedness in Massachusetts (COSTEP MA), the fire department was aware of the property and its needs upon arrival and they were prepared to be proactive to preserve the collection.¹

Importantly, the fire department knew that no one resided at the Ropes Mansion, and hearing from the PEM security guard that no one was inside the house, fire personnel immediately began the work to extinguish the fire. The few minutes saved by this exchange likely prevented the fire from spreading beyond the attic of the house.

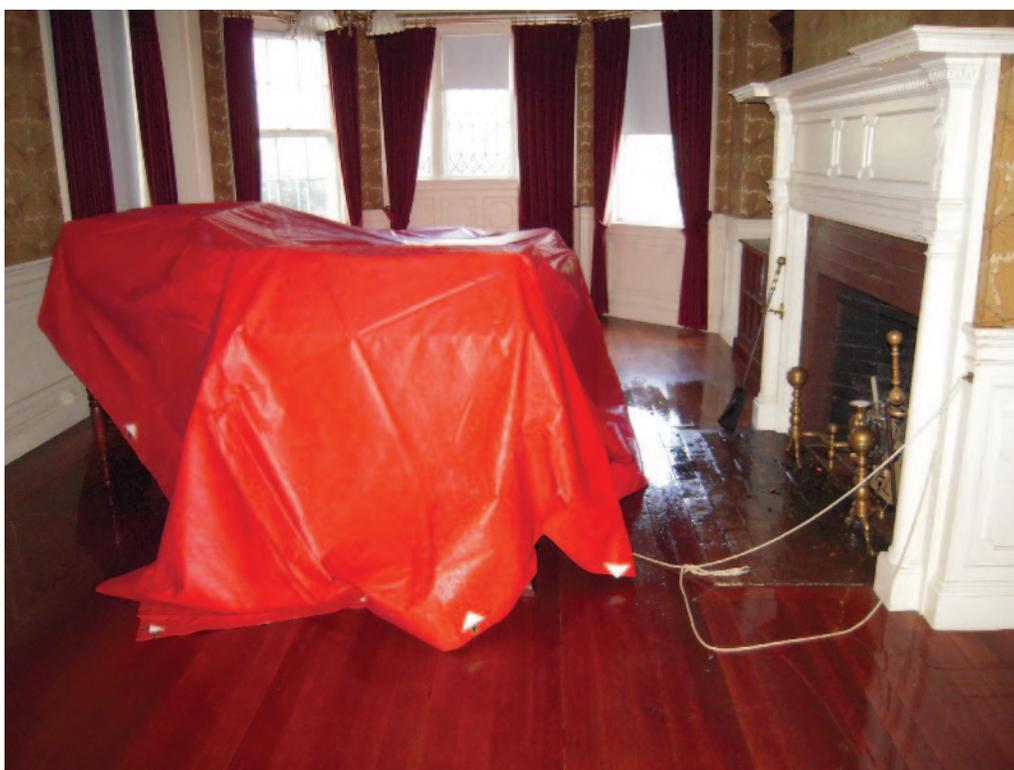
Fig. 3. Dining room furnishings moved and tarped by the Salem Fire Department (Courtesy of PEM staff)

Long before any PEM staff had mobilized, fire department personnel were taking steps to safeguard the collection from water and smoke damage. Their efforts were chiefly focused on carefully moving furnishings from the edges of each room to the center and covering them with protective tarps (fig. 3) based on protocols established with the PEM.

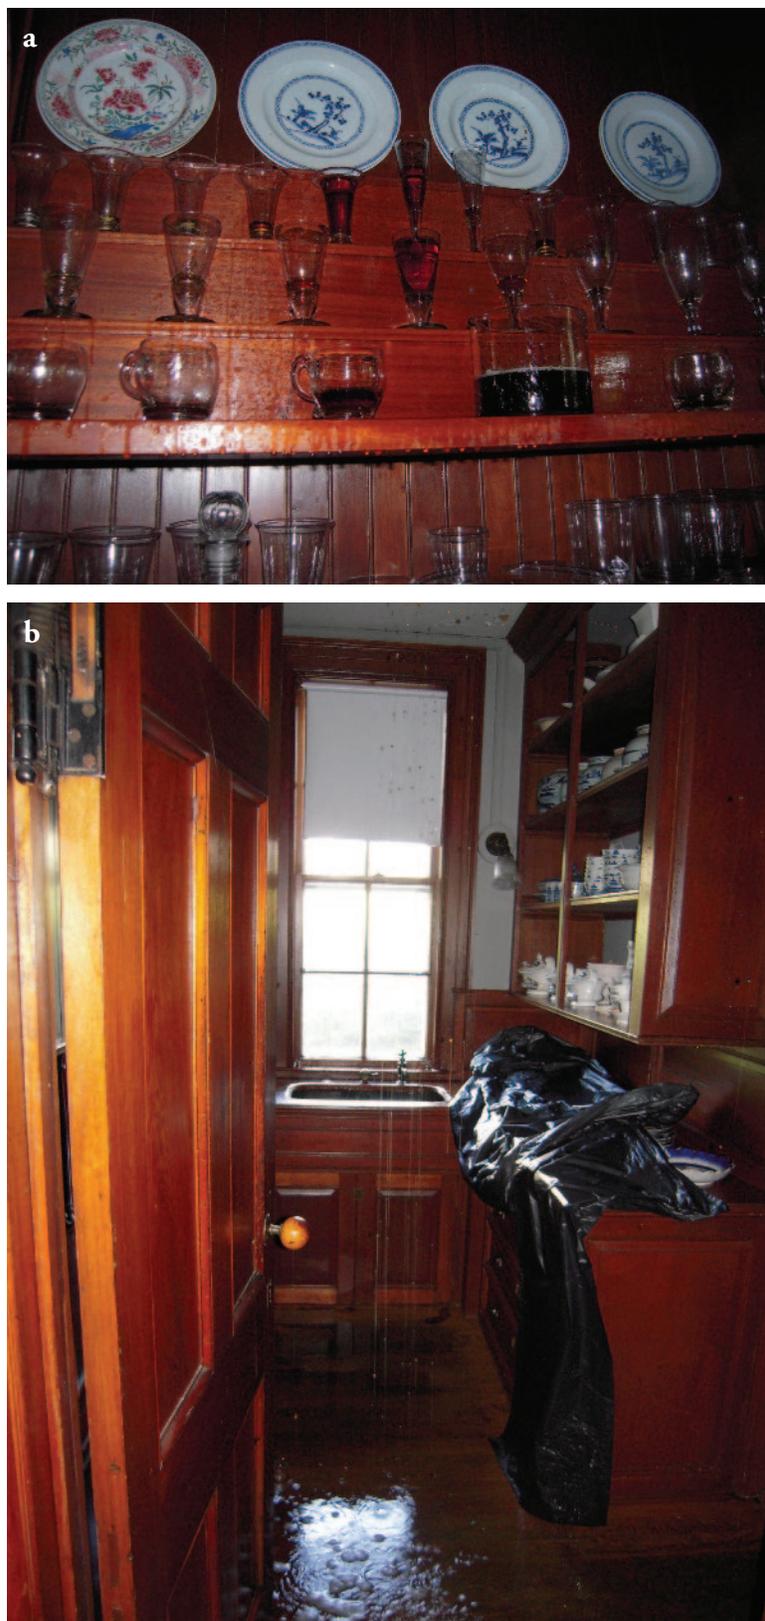
The volume of water required to extinguish the fire had permeated most areas and floors of the house. It poured down from the attic behind walls and through gaps in floors and ceilings, soaking carpeting, upholstery, wallpaper, and objects along its path. Not everything had been protected by the tarps—objects in pantries and cupboards were soaked, and mirrors and other framed pieces on the walls had been too large or cumbersome to be moved, so there was extensive wetting of those objects (figs. 4a, 4b).

Fig. 4a. Glassware in wall cabinets filled with contaminated water in the ground floor's china room; 4b. Water cascading into the ground floor's butler's pantry (Courtesy of PEM staff)

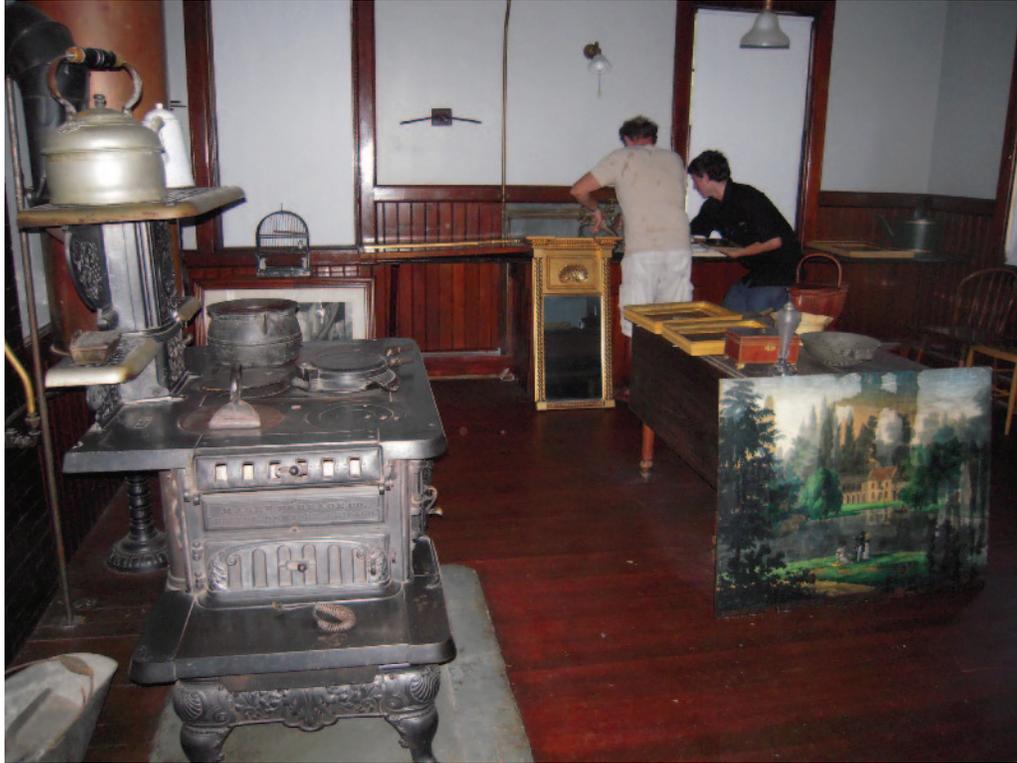
Fig. 5. Triage in the kitchen (Courtesy of PEM staff)

The initial assessment revealed that PEM personnel were not sufficiently equipped or staffed to address the urgency and scale of this task alone. A call was quickly placed to a Salem-based moving company, T.E. Andresen, with whom PEM has strong ties. By amazing luck, they had the capacity to immediately provide packing materials, trucks, and brawn to assist in the evacuation of objects from Ropes. As additional resources were en route, PEM staff began to triage especially vulnerable or precious objects (fig. 5).

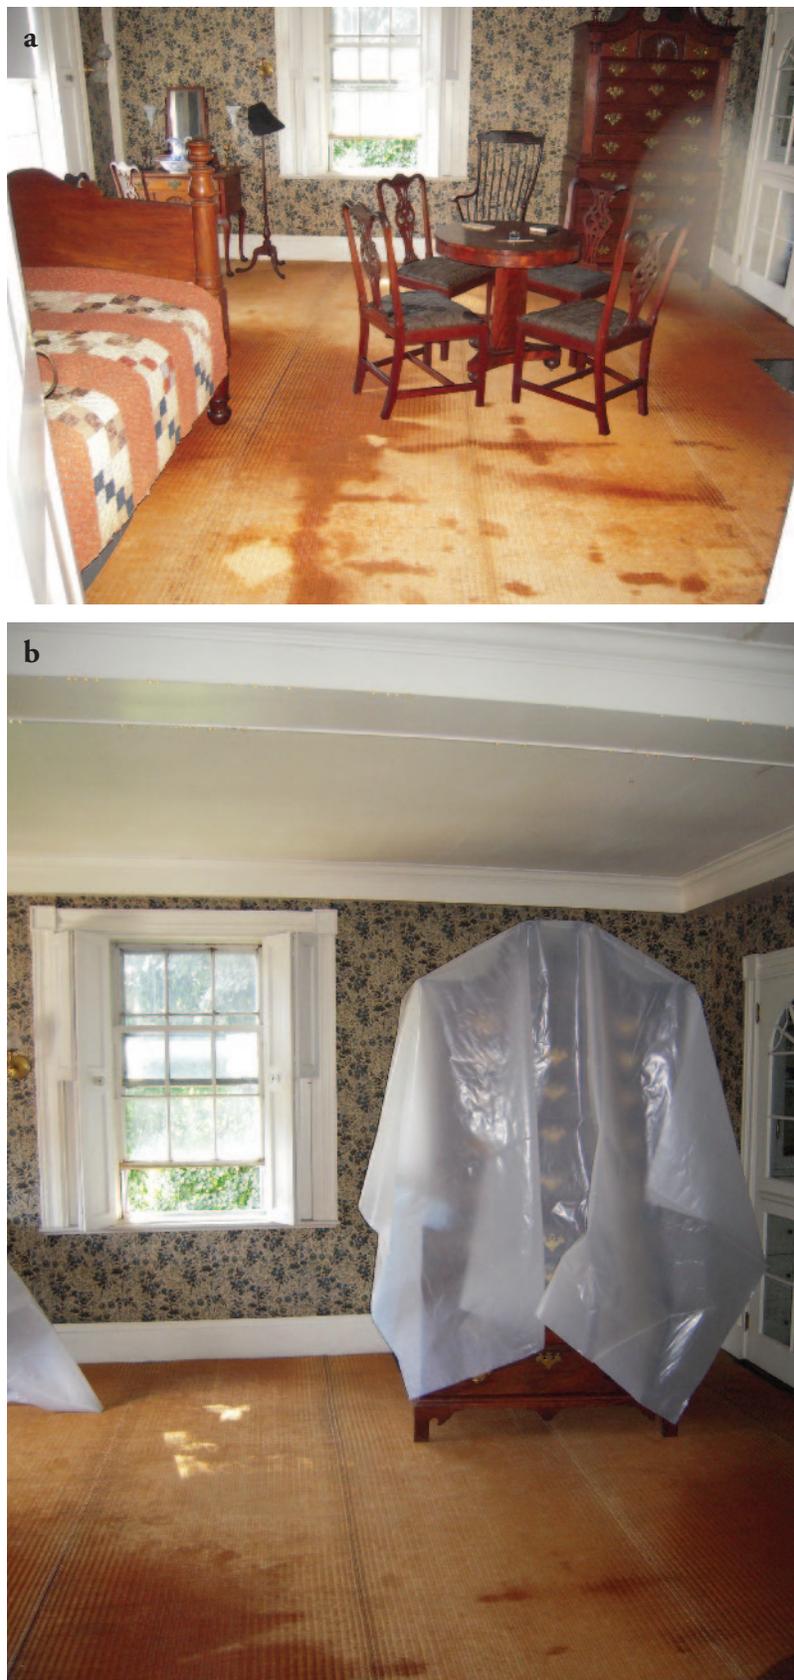
Fig. 6a. Chest on stand in bedroom after the fire; 6b. Draped chest on stand (Courtesy of PEM staff)

Not every object required an immediate or exhaustive intervention. For example, simply drying an important Queen Anne chest-on-chest in situ, then draping it with polyethylene sheeting provided sufficient protection to allow staff to address higher priorities elsewhere. The chest-on-chest was safely moved as soon as there was adequate clearance (figs. 6a, 6b).

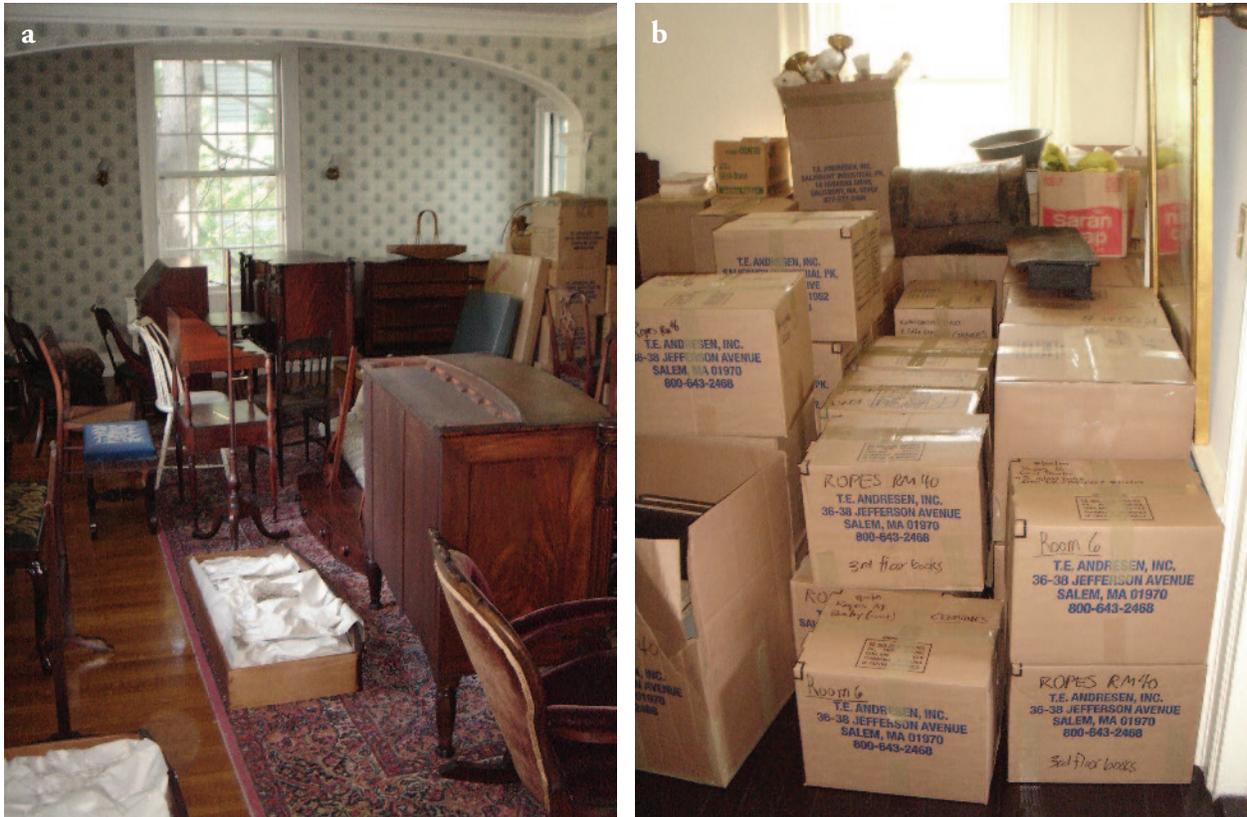
Fig. 7a. Furniture placed in the Cotting-Smith parlor; 7b. Packed boxes stored in an upstairs room at Cotting-Smith (Courtesy of Katie White)

The majority of the objects large and small were dried, packed, and delivered to the Cotting-Smith Assembly House, another 18th century property owned by PEM just a few blocks away from Ropes.² Of the many silver linings, the fact that this popular venue for summer weddings had not been rented the day of the fire is particularly striking. Teams formed at Ropes to efficiently containerize and load out objects; while at Cotting-Smith, teams received objects, recycled certain transit containers, and populated the largely empty first and second floors of the house with furniture (fig. 7a) and packed boxes (fig. 7b).

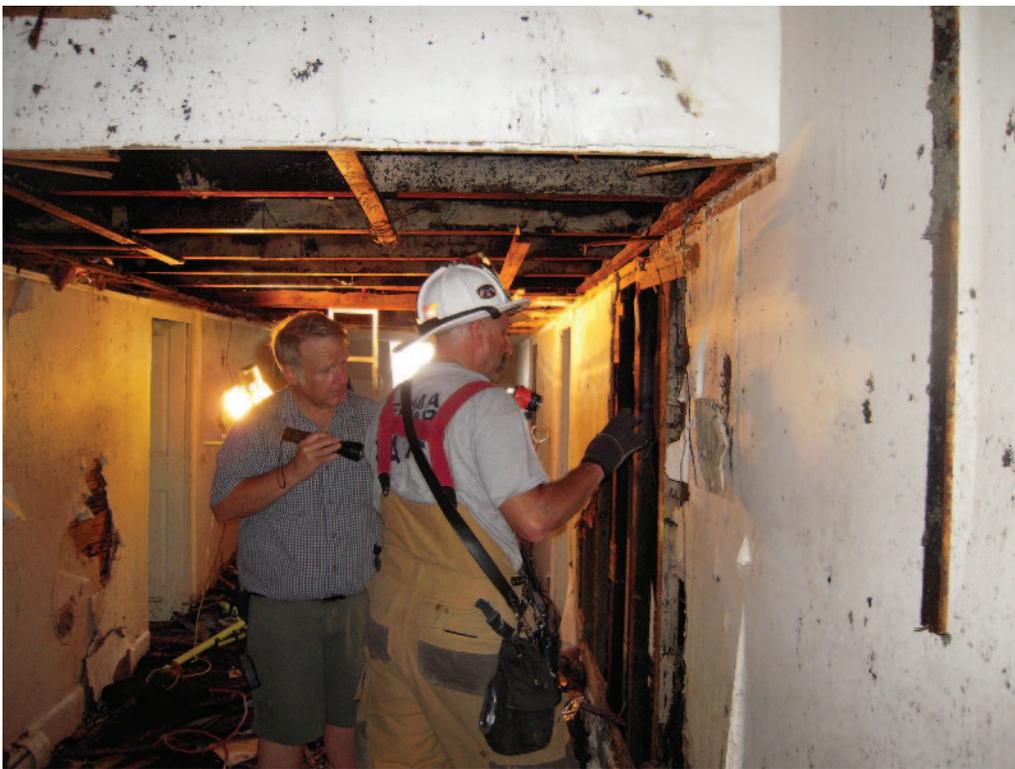
Fig. 8. Bob Monk, PEM's Director of Facilities, inspects attic spaces with the fire department (Courtesy of PEM staff)

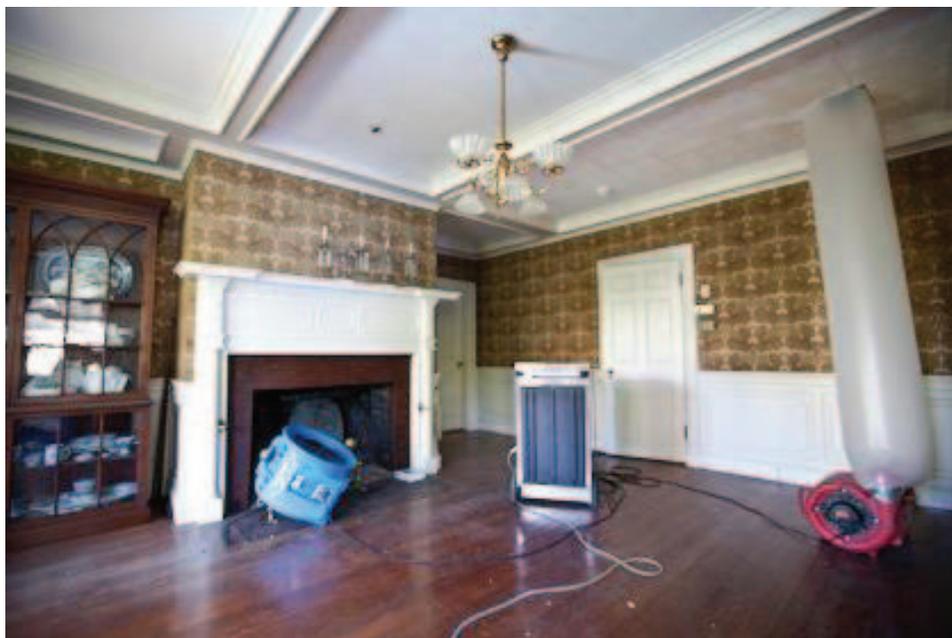
Fig. 9. Dehumidifiers and blowers in place to reduce humidity (Courtesy of Kathy Tarantola)

Beyond first responders, PEM staff, and local movers, additional resources were called in to address critical needs. Again, with great good fortune, every resource—electricians, structural engineers, steeplejacks, and water damage mitigation professionals—prioritized PEM’s needs and provided immediate support to the response and recovery effort. On the day of the fire, once the building was completely checked (fig. 8), the structural recovery of Ropes commenced. The roof was stabilized and patched to ensure that it was structurally stable and water tight. Additionally, fans, dehumidifiers, and blowers circulating hot, dry air through networks of flexible plastic tubes placed in strategically cut holes in ceilings removed moisture and prevented the growth of mold (fig. 9).

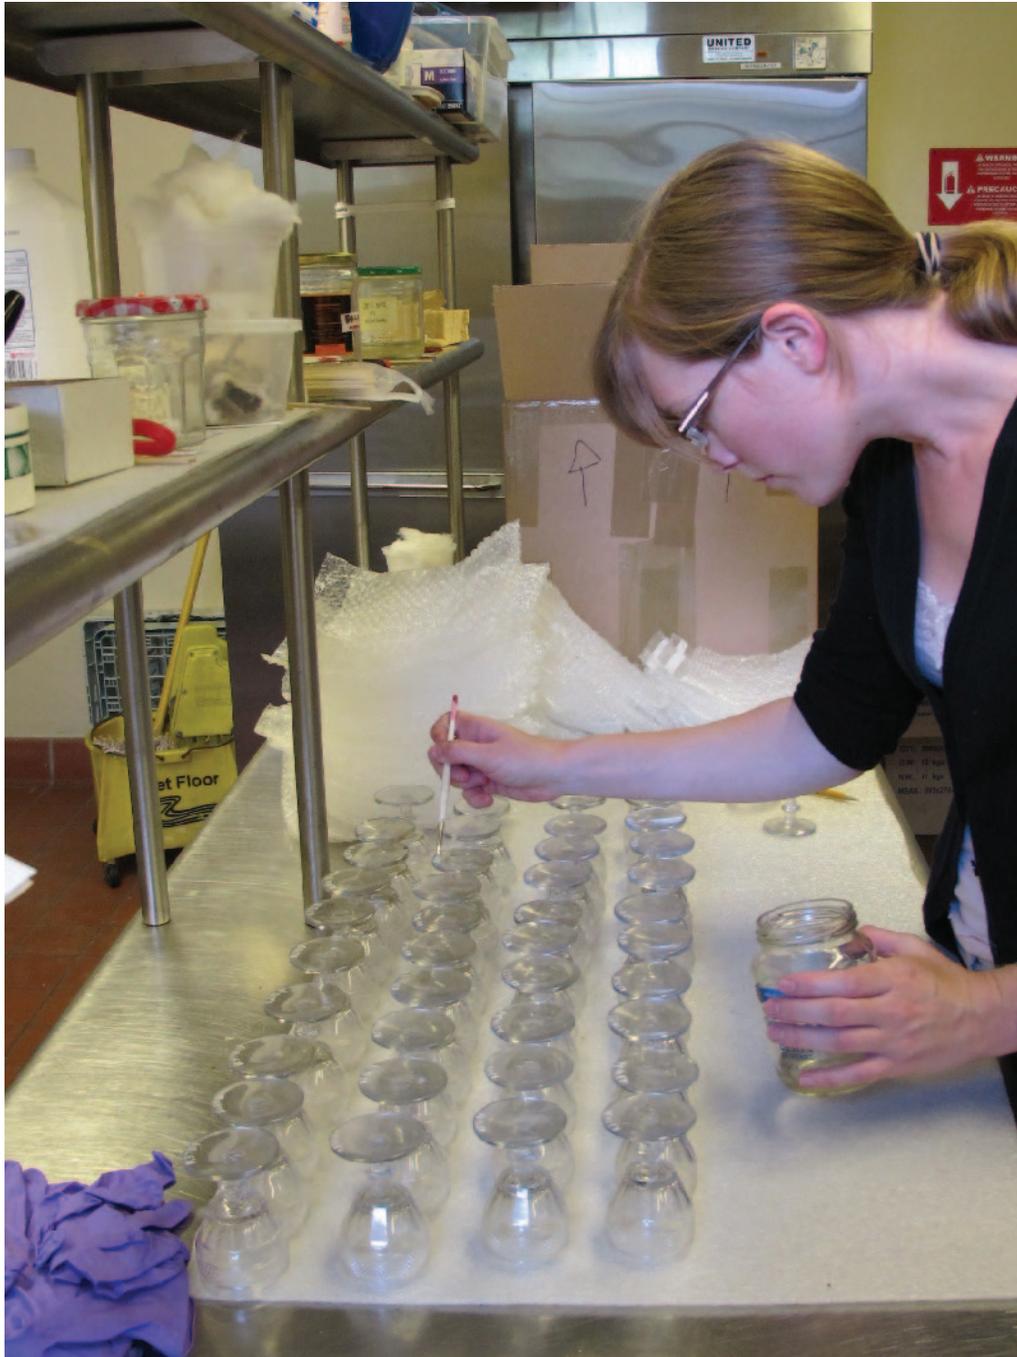
Fig. 11. Conservation intern Rebecca Barber numbering glassware (Courtesy of Mimi Leveque)

Everything needed to be unpacked, identified with the Ropes Mansion inventory, condition reported, and recorded. Each object was photographed and numbered when needed (fig. 11). Mimi kept a separate daily log of all objects treated and at what point in the treatment they were in. This proved to be very helpful for tracking complex objects whose treatments might span many weeks. We worked closely with the Curator of American Decorative Arts Dean Lahikainen and reviewed all treatment plans

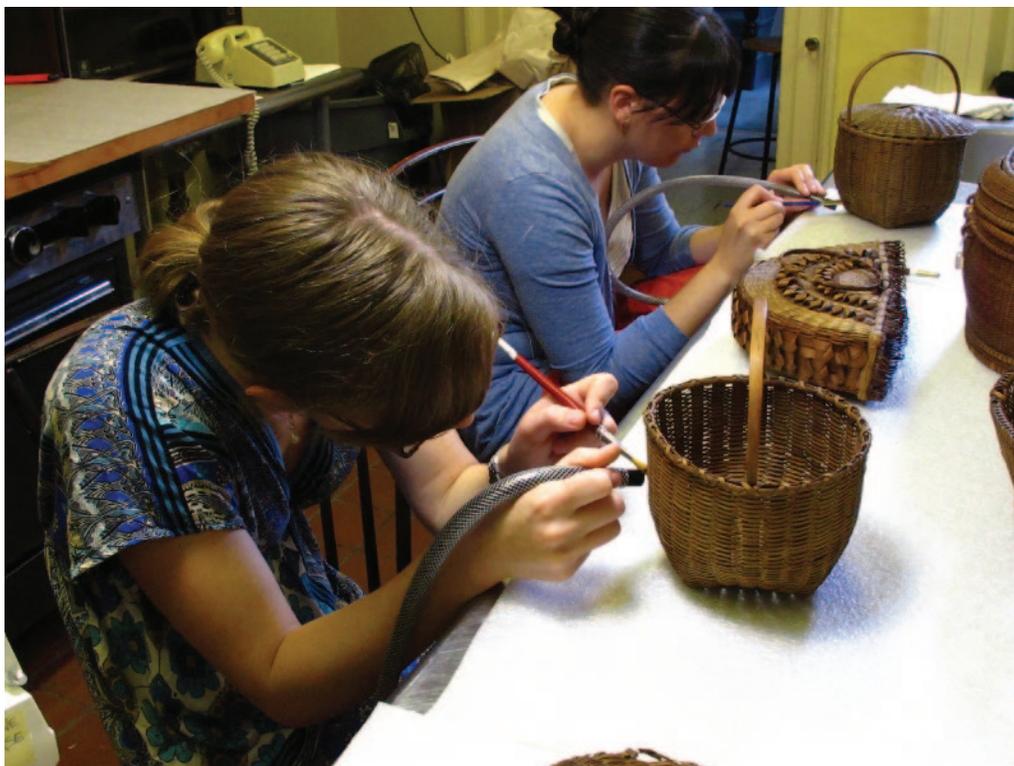
Fig. 12. Vacuuming baskets to remove soot and dust by Rebecca Barber and Katie White (Courtesy of Mimi Leveque)

exposure to soot or water combined with pre-existing issues. Each object was initially vacuumed to remove soot and dust (fig. 12). Soot combined with dust was most problematic on organic objects such as baskets; for some, vacuuming was inadequate and they required more thorough cleaning. Many inorganic objects could be washed, especially the enormous amounts of ceramics and glass; there were 300 pieces of Irish crystal, and one set of china alone had 345 pieces, which together comprised the largest surviving early 19th century set of tableware. The water from fire suppression had caused the failure of many old glued repairs, so those had to be treated.

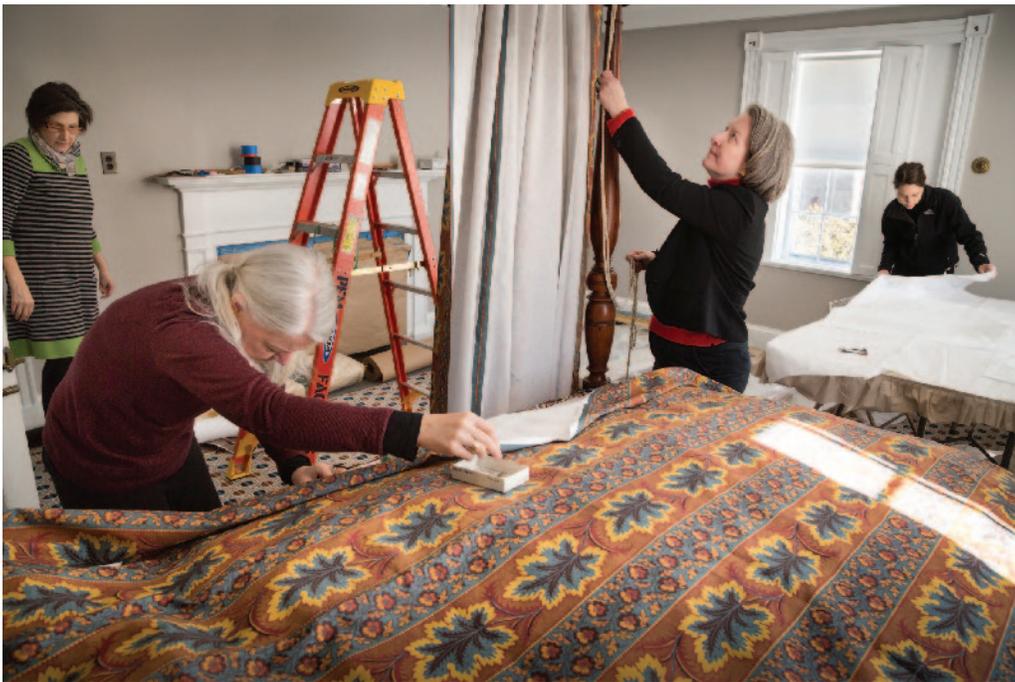
Fig. 14. Recreating the bed hangings with Elizabeth Lahikainen, Meegan Williams, Paula Richter, and Ani Geragosian (Courtesy of Walter Silver)

The large pieces of furniture had to be reconstructed inside the house. Pieces had to be carefully eased back together, as pegs and dowels had swollen when wetted and not gone back to their original sizes. Conservator and historic cabinetmaker Phil Lowe was brought in for that delicate task. We decided to reproduce the hangings, which then had to be fitted to the beds following the original hanging designs (fig. 14). This proved incredibly time consuming; it took 10 days to make the tester for one bed alone. The original straw and feather mattresses were used but encased in washed Tyvek to keep out pests.

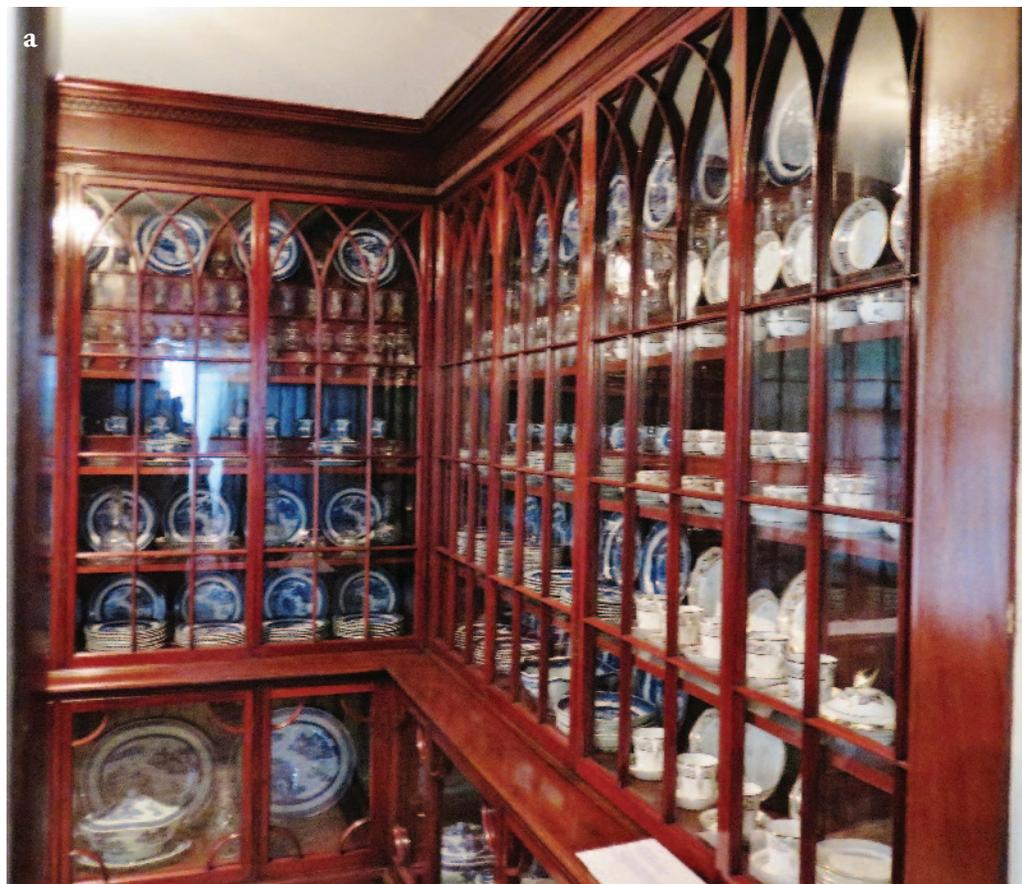
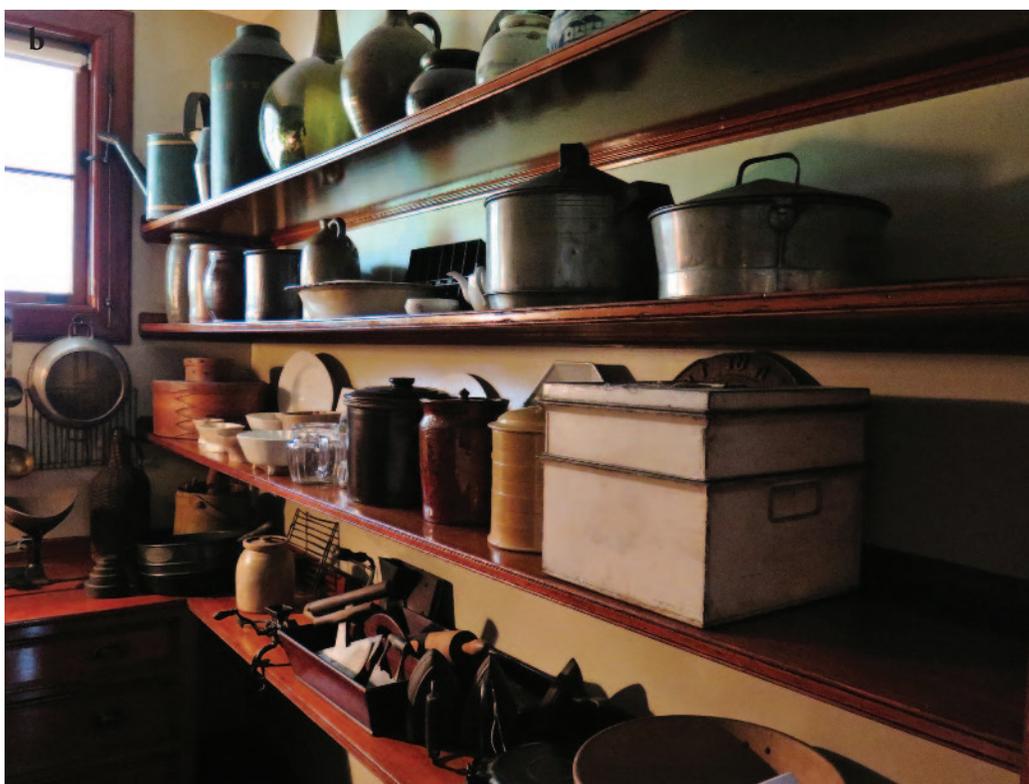
Fig. 15a. The reinstalled china room; 15b. A reinstalled pantry (Courtesy of Mimi Leveque)

The vast quantities of china and glass were moved back into their special room (fig. 15a), and all pantries were refitted with hundreds of kitchen items (fig. 15b).

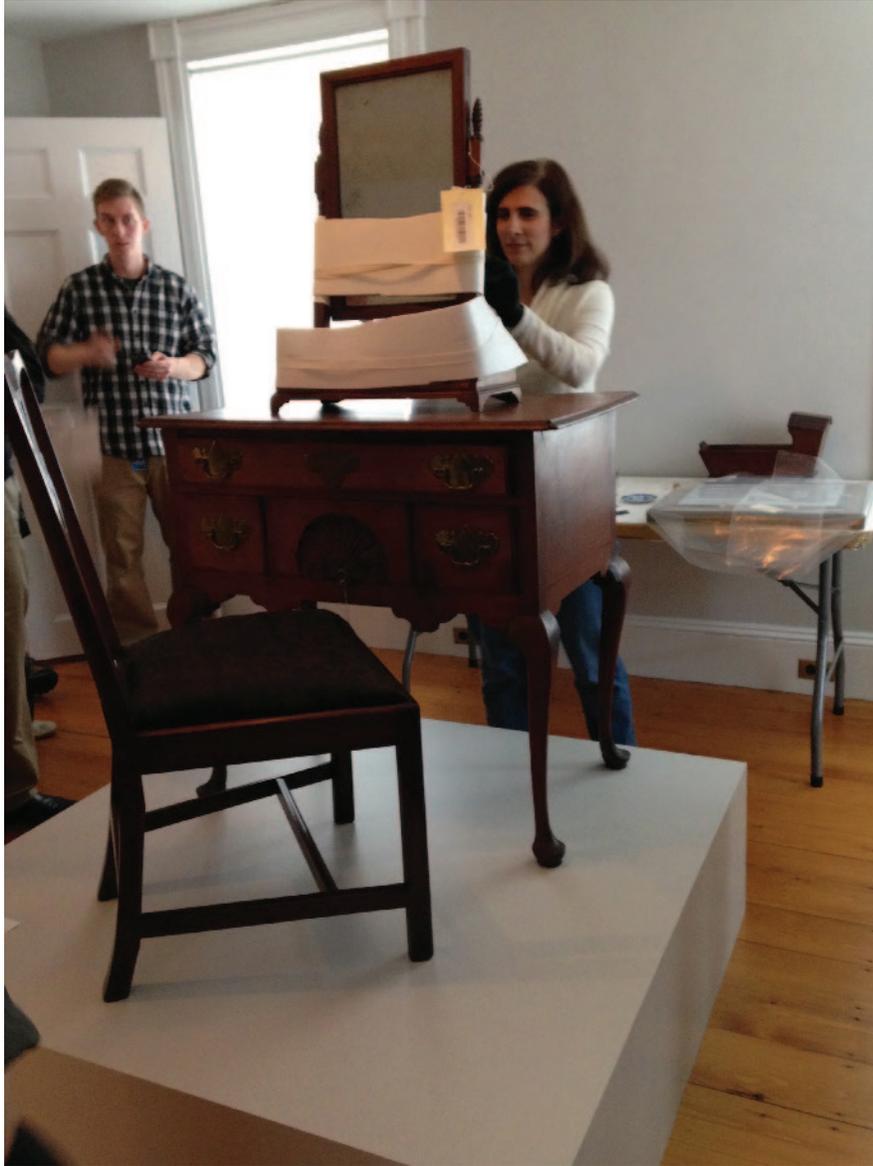
Fig. 16. Angela Segalla and Dave O’Ryan installing featured furniture on a platform in an exhibition room (Courtesy of Annie Lundsten)

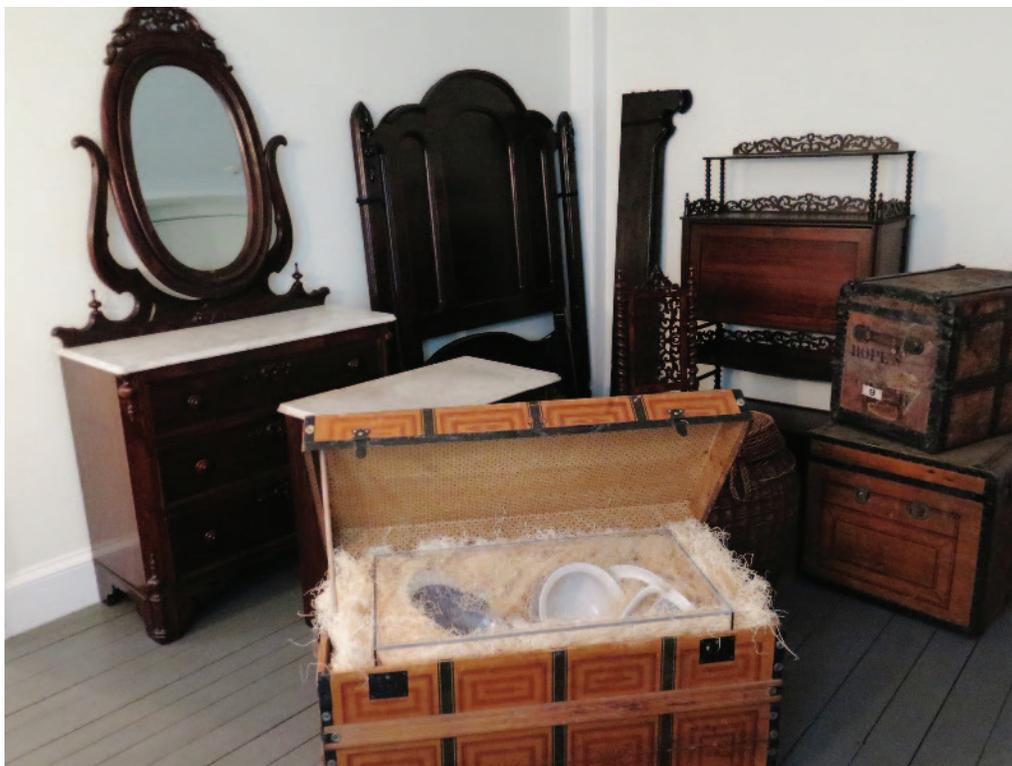
Fig. 17. Room depicting the family's travels with items in an open trunk protected by acrylic case inserts (Courtesy of Mimi Leveque)

Contrary to the typical approach for historic houses that are generally interpreted at just one particular time period, the reinterpretation team decided to open the house up to telling multiple stories of the family in a diverse way, covering many periods of time over the family's long history in the house. Some of the upstairs rooms were made into galleries with objects on platforms and in exhibition cases that can be changed periodically to tell other stories so that the house always has something fresh and new to show visitors (fig. 16). As the interpretive team wanted the public to be able to wander the house with self-guided tours, few docents, and minimal security, we had to come up with creative and aesthetic barriers, such as acrylic inserts for shelves and trunks that allow clear viewing but prevent theft (fig. 17).
